Client: S.W. Cole Engineering, Inc.**Project:** 93 Washington Avenue**SWCE Project #:** 18-0162**Date:** August 21, 2018**Subject:** Inspection of Field Welds and Bolted Connections**Report:** 001

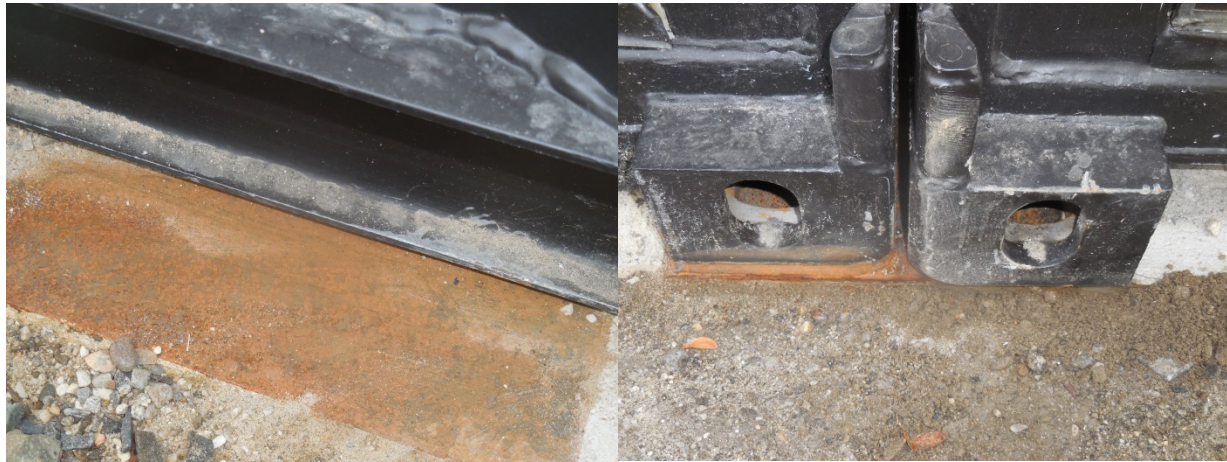
Welds were found to be acceptable per information provided with the following exceptions:

Weld missing on line 4

On line 1 the right support has approximately 2" of sound weld placed in the overhead position

It is recommended that the EOR visit the site and determine what corrective action may be required.

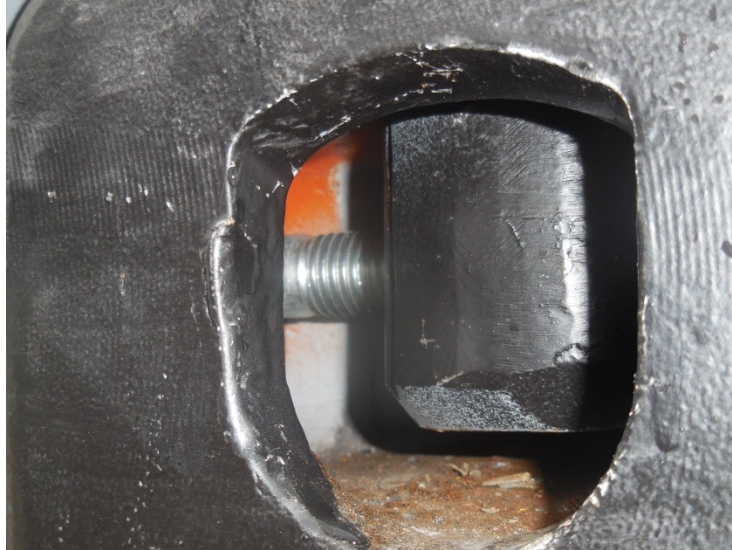
At corner connections on lines A and G it appears that bolts may thread into studs from parapet.

Corner connection for parapet

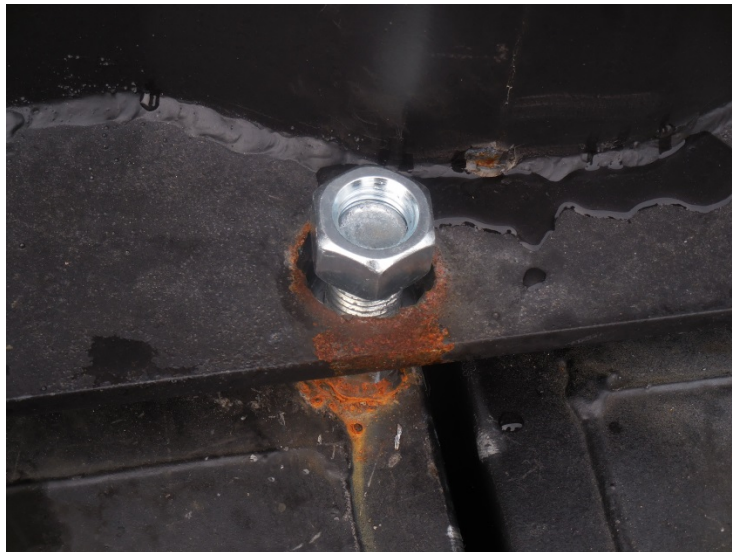
At the rear connections it appeared that threaded studs were welded to the containers. However the amount of weld used appears inadequate. It appears that nuts were then used as couplers and a section of threaded rod and nut installed anchoring the parapet to threaded rod on the container. Excessively large holes were cut in the parapet base causing the connection to be ineffective. Also, full nut engagement was not always obtained.

Connection at rear of parapet

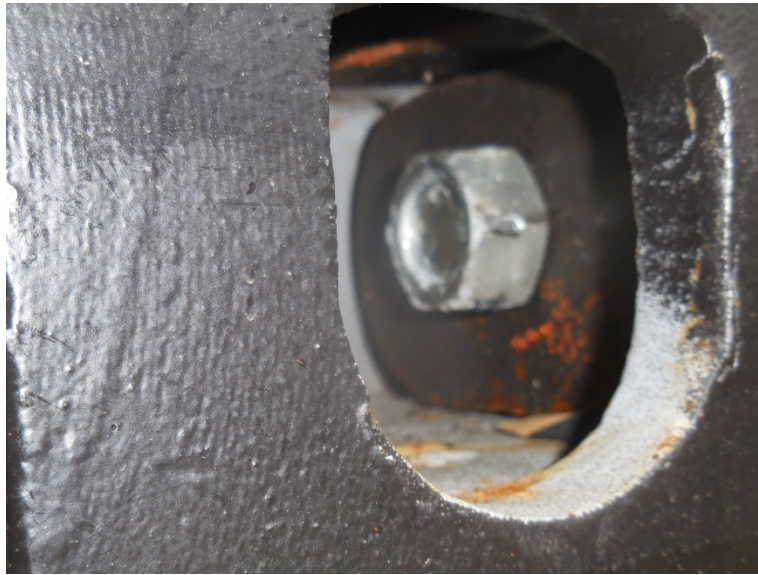
Bolted connections appear tight however it was observed that some bolts do not have full nut engagement.

Bolted connection without full nut engagement
