# Final Report of Structural Special Inspections

Project: *New 3-Unit Building*  
Location: *62 Cumberland Street; Portland Maine*  
Owner: *Eco Capital, LLC*  
Structural Design Professional in  
Responsible Charge: *David A. Price, PE / Price Structural Engineers, Inc.*  
Date: *July 19, 2011*

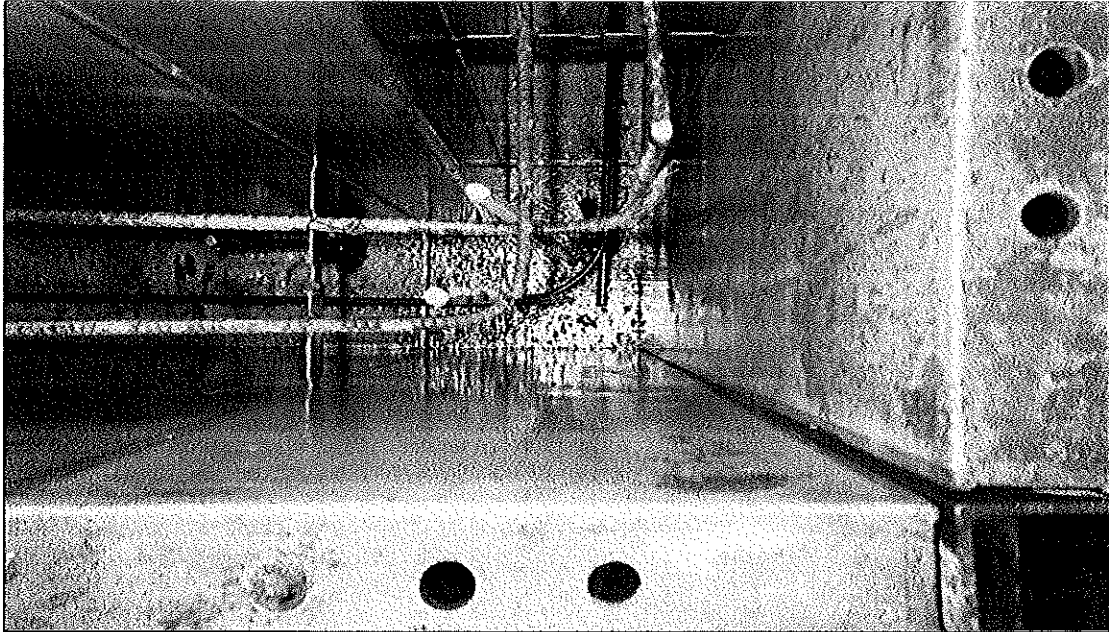
**Location:** Line 1 at Line C.9

Vertical bar placed at interior of corner, inconsistent with C3/S3.0  
Missing upper and lower horizontal interior and exterior bar laps.

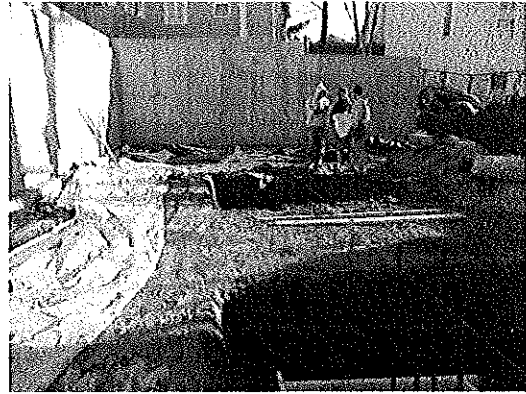
**Photo #4 – Foundation wall with beam pocket**

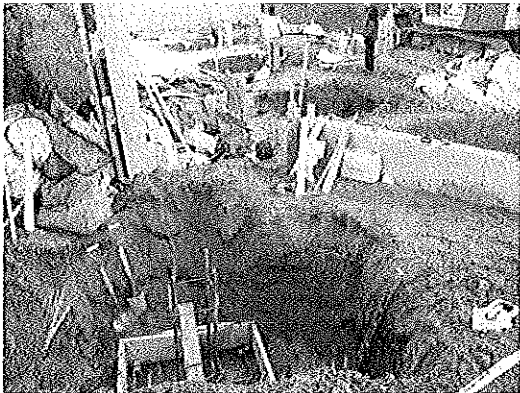
**Photo # 5 – Formwork for footing at grid A/1**

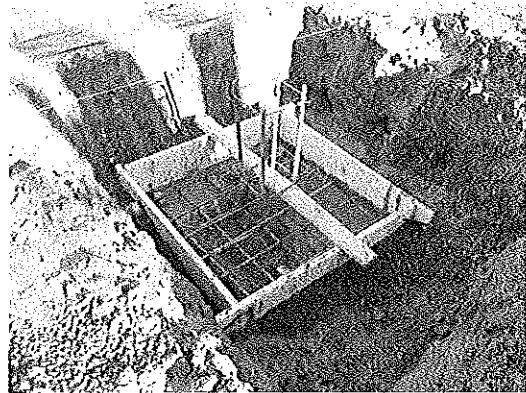
**Photo #6 – Formwork for interior A.9 footing**

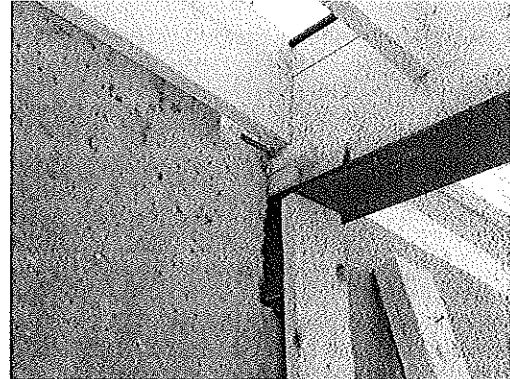
3. Deep snow currently providing frost protection for footings in addition to insulated blankets.
4. Concrete pocket for steel beam was installed too low at grid 11/A.9. See "Correction Items" below.

**Photo #2 – Concrete beam pocket was too low**

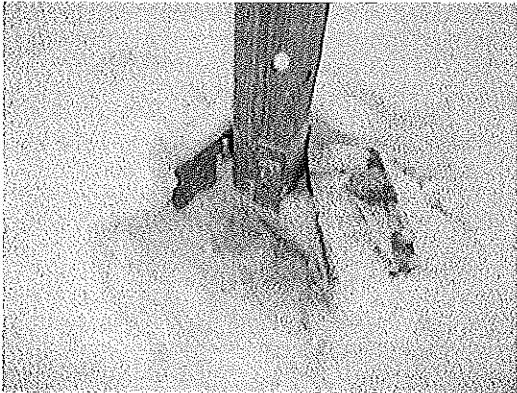
7. Bracket used to connect post at grid A/1 appears to be correct. Grout observed below steel columns.
8. Control joint installed at grid A (see photos), as a result diagonal cracking not observed in concrete walls.

**Photo # 3 – Simpson post base bracket as specified**

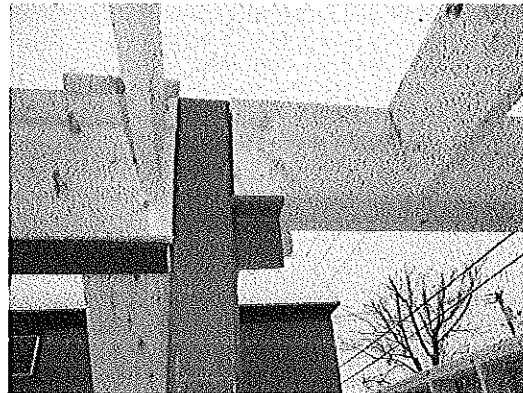
**Photo #4 – Beam connection at grid 2.1/A.9**

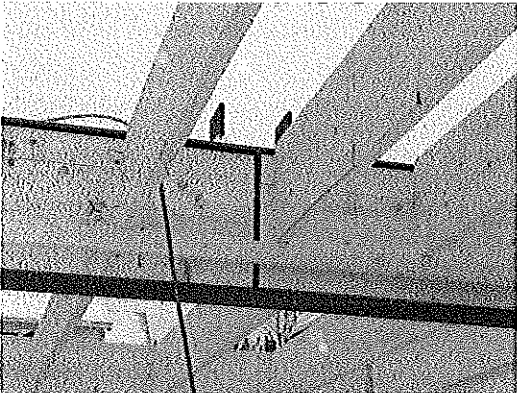
**Photo # 5 – Bracket on steel beam with stiffeners below**

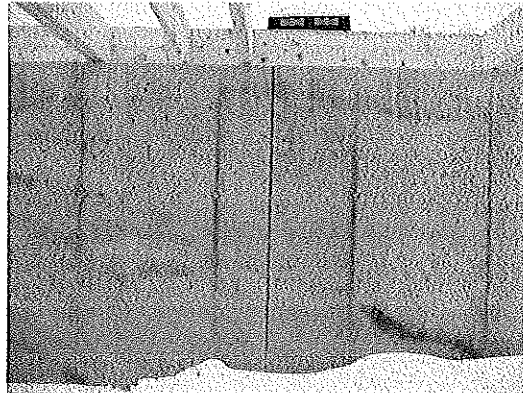
**Photo #6 – Vertical concrete control joint installed**

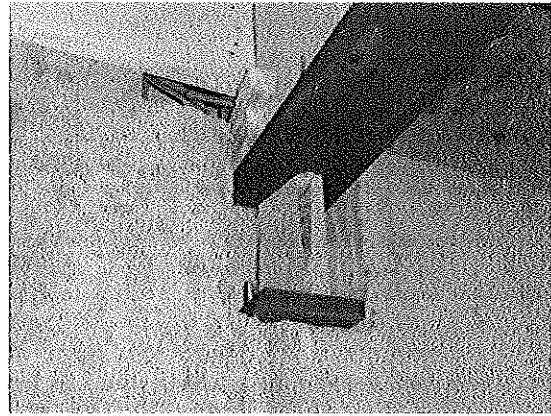
**Photo #2 – Unacceptable steel beam support**

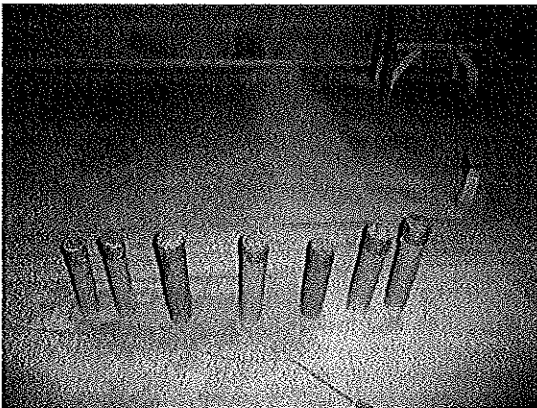
**Photo # 3 – Utilities at Slab Penetrations**

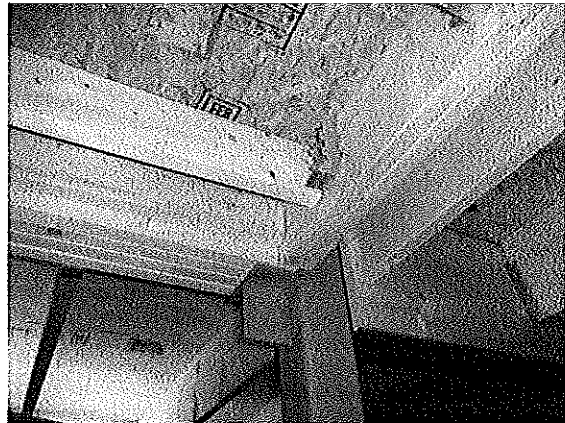
**Photo #4 – Hangers missing at some joists**

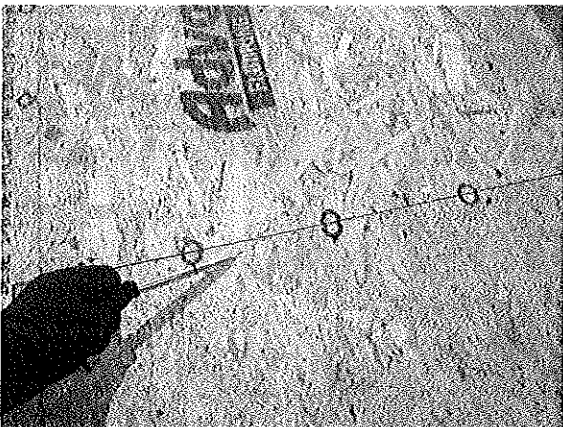
**Photo # 5 – Nail spacing at floor sheathing edges**

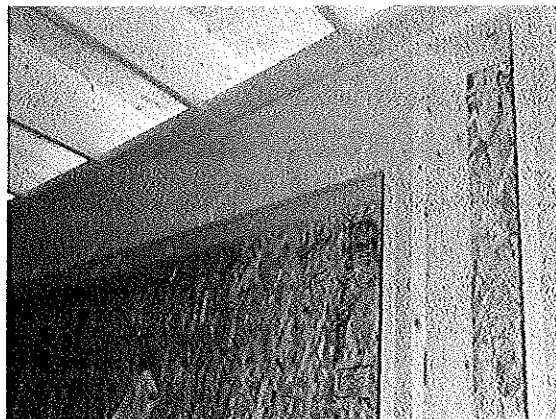
**Photo #6 – Double jack studs at garage lintels**

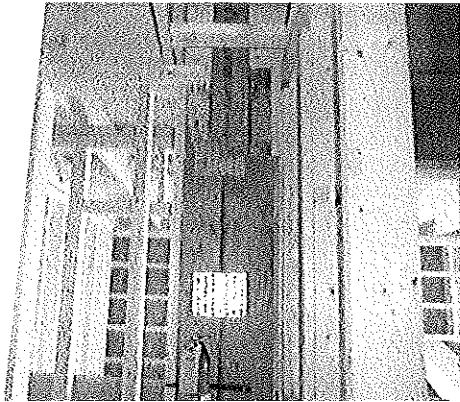
**Photo # 1 – Replace spliced column**

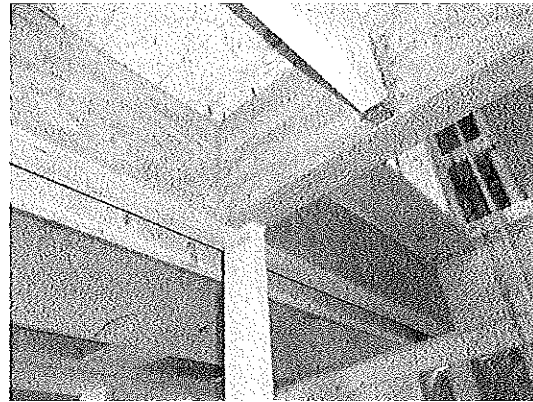
**Photo #2 – Missing beam hanger**

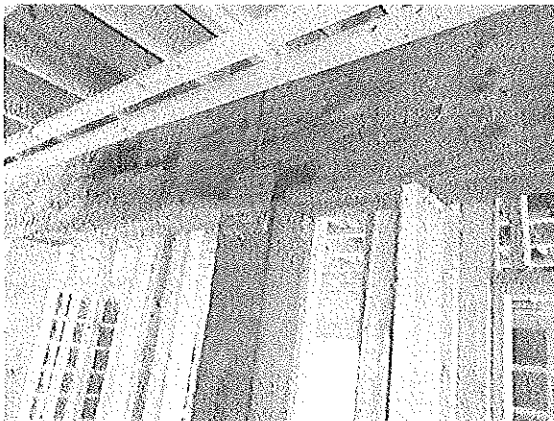
**Photo # 3 – Nails missing at beam/column connectors**

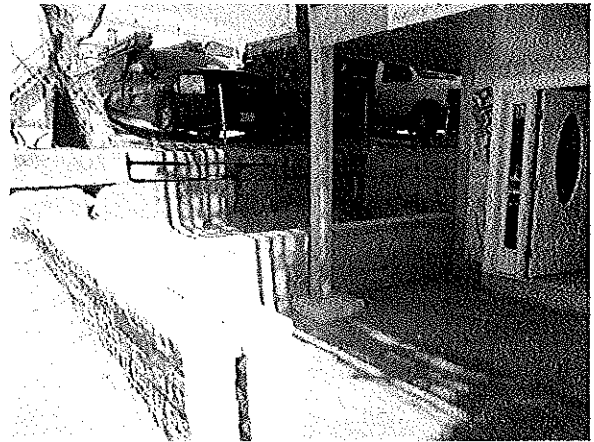
**Photo #4 – North entrance – note post base anchor**

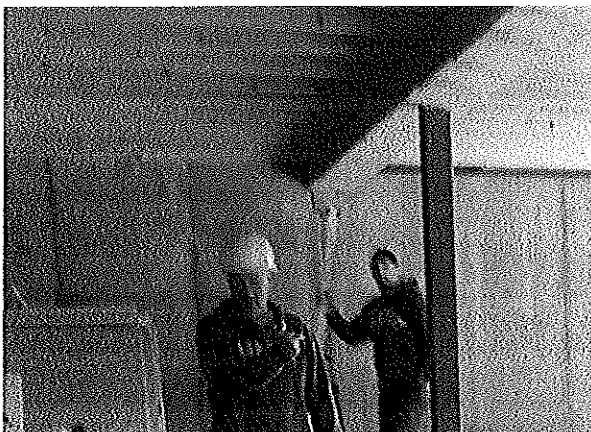
**Photo # 5 – Steel beam pocket filled in with concrete**

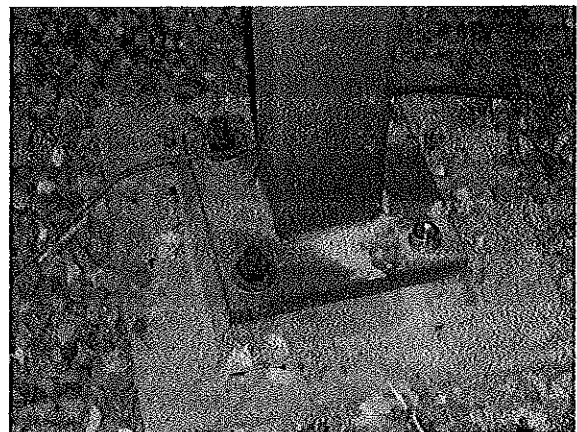
**Photo #6 – Expansion bolt replaces missing anchor**

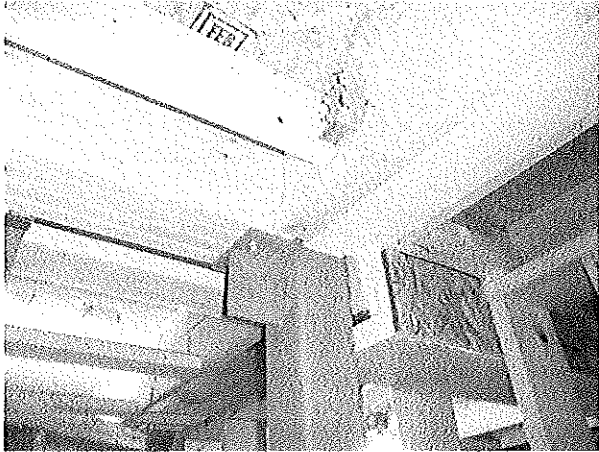
**Photo # 7 –Joist needs hanger; double 2x beam needs post**

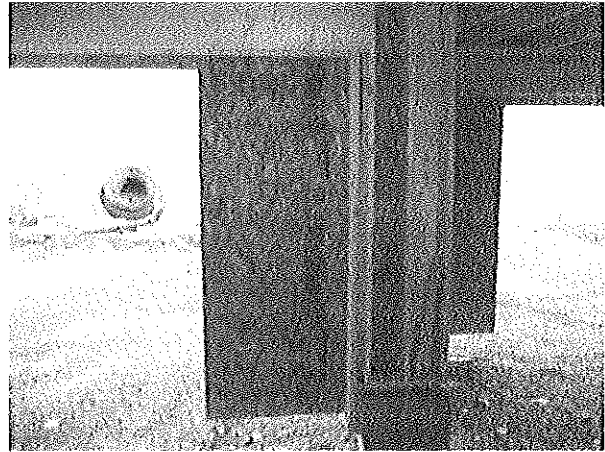
**Photo #8 – Jack studs must be pressure treated**

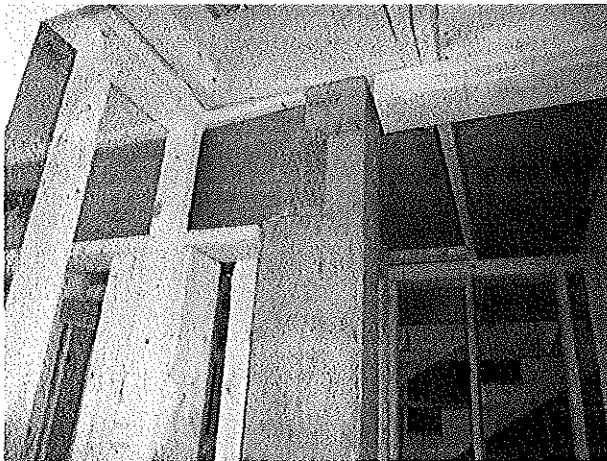
**Photo # 9 – 1<sup>st</sup> Flr: Spliced column replaced correctly**

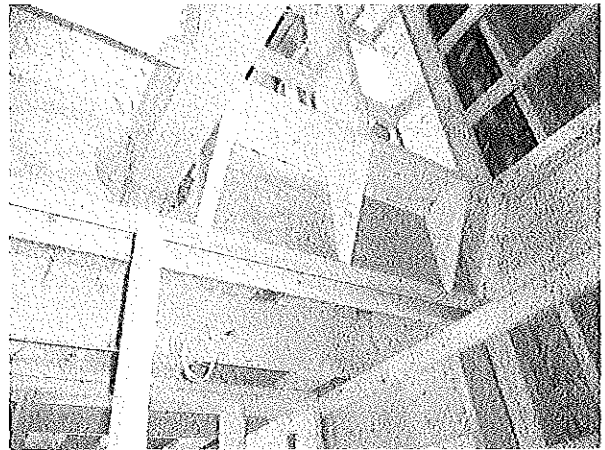
**Photo #10 – 1<sup>st</sup> Flr: Inadequate wall support**

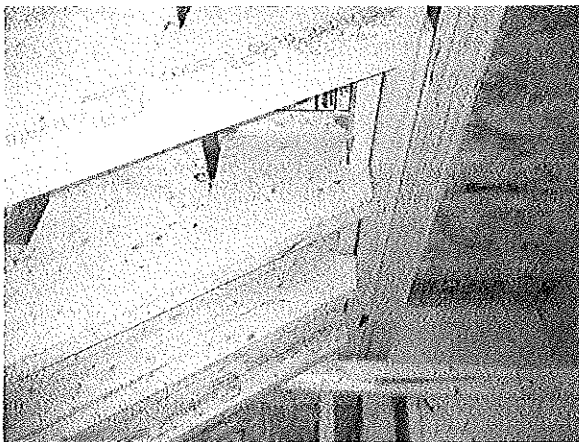
**Photo # 11 – 1<sup>st</sup> Flr: Inadequate stringer connection**

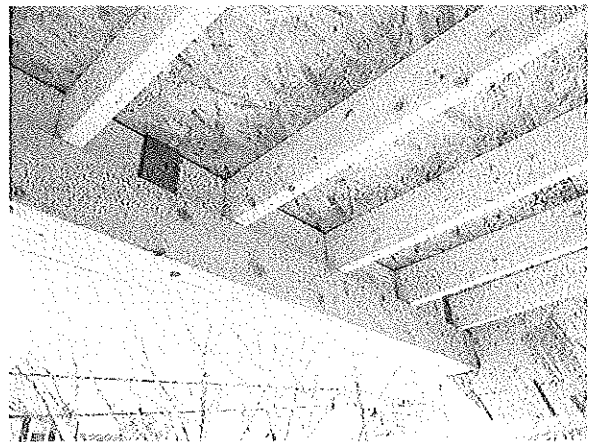
**Photo #12 – 1<sup>st</sup> Flr: Guardrail @ reduced beam**

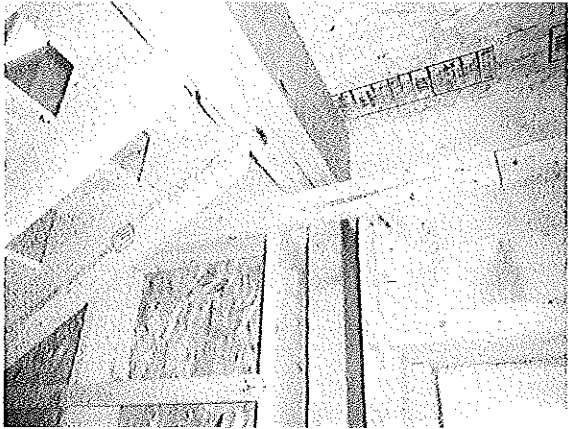
**Photo # 13 – 1<sup>st</sup> Flr: LVL 6" Stringer sisters required**

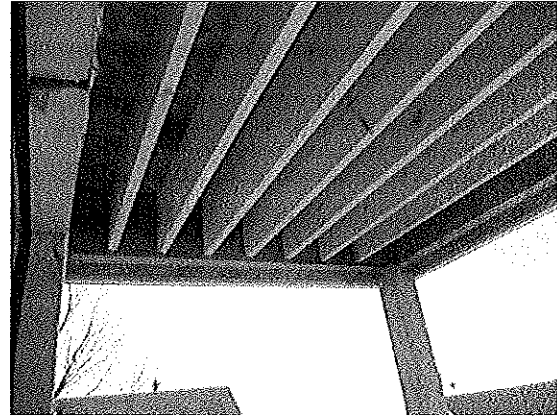
**Photo #14 – 2<sup>nd</sup> Flr: Porch hangers needed**

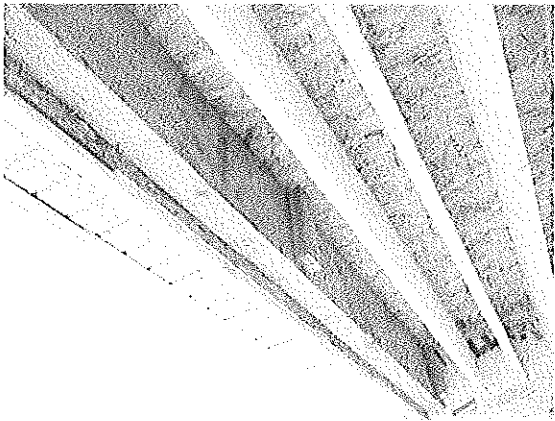
**Photo # 15 – 2<sup>nd</sup> Flr: Blocking needed @ guardrail post**

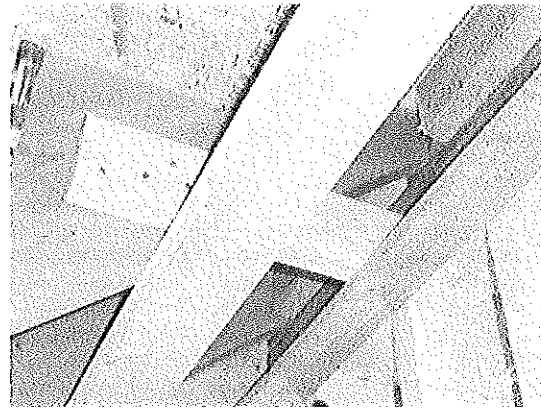
**Photo #16 – 2<sup>nd</sup> Flr: Center stringer needs ledger**

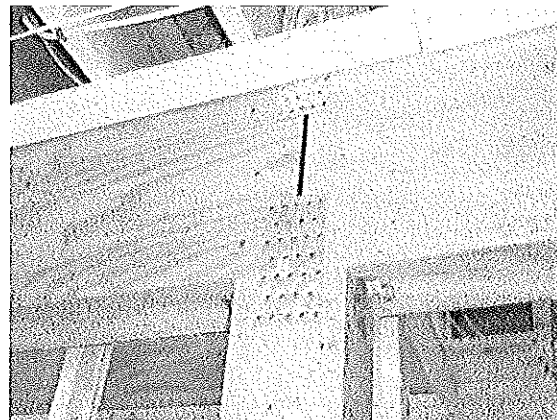
**Photo #18 – 2<sup>nd</sup> Flr: Beam to column connection**

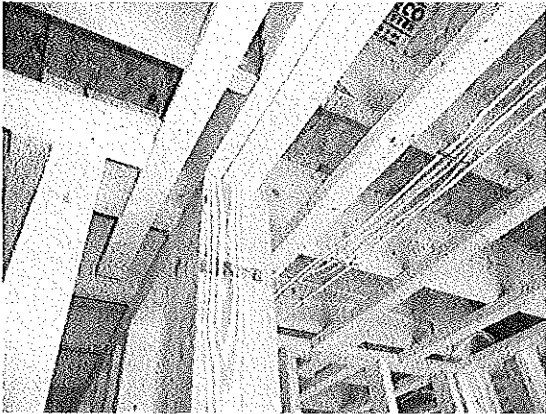
Photo # 21 – 3<sup>rd</sup> Flr: Missing beam/column connector

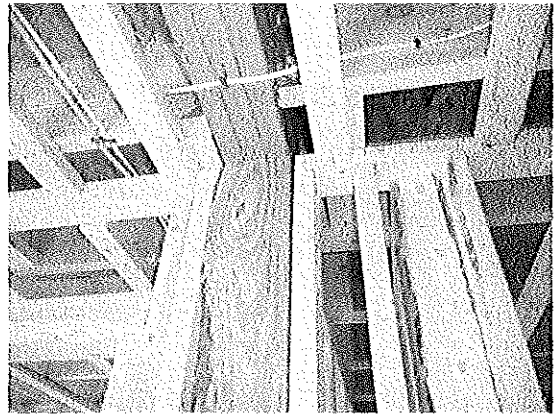
Photo #22 – 3<sup>rd</sup> Flr: Missing beam/column connector

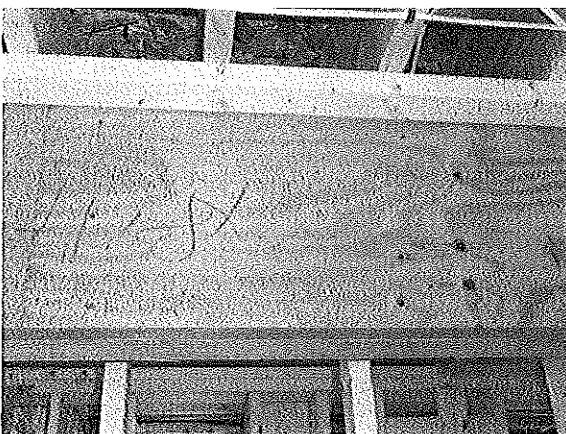
Photo # 23 – 3<sup>rd</sup> Flr: Top loaded multi-ply beam

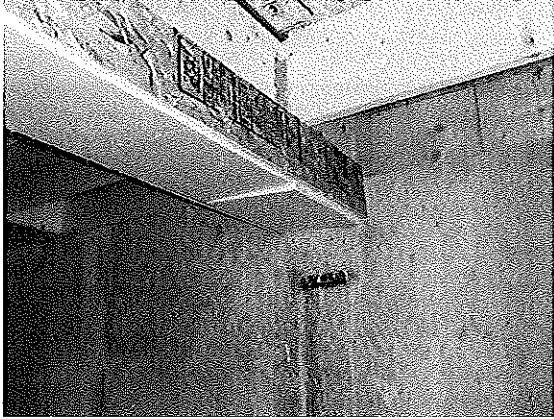
Photo # 1 – Steel beam Pocket filled w/ concrete

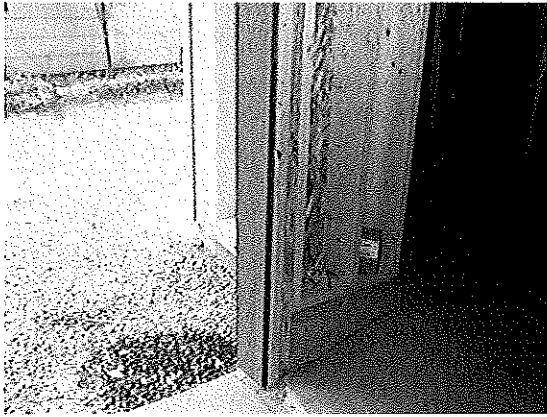
Photo #2 – Pressure treated jack studs at doors

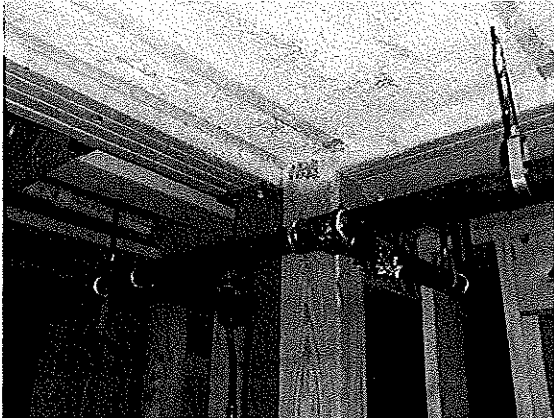
Photo # 3 – Post supporting 1<sup>st</sup> floor beam

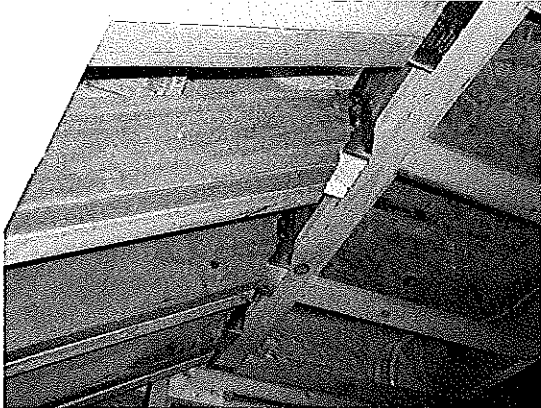
Photo #4 – Stair stringer supports

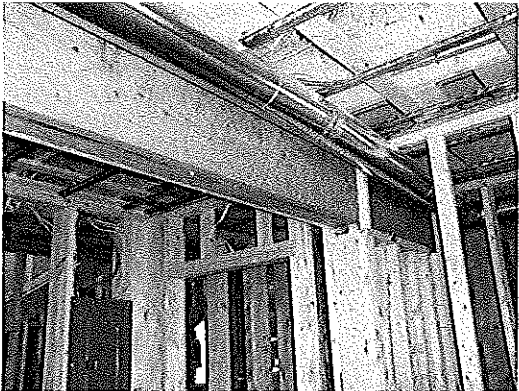
Photo # 5 –VLAM sister added @ 1<sup>st</sup> floor beam

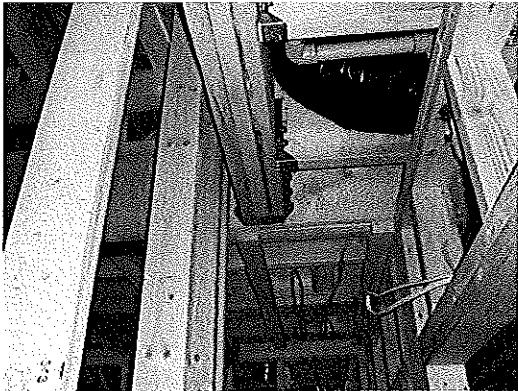
Photo #6 – Beam Hangers added near elevator

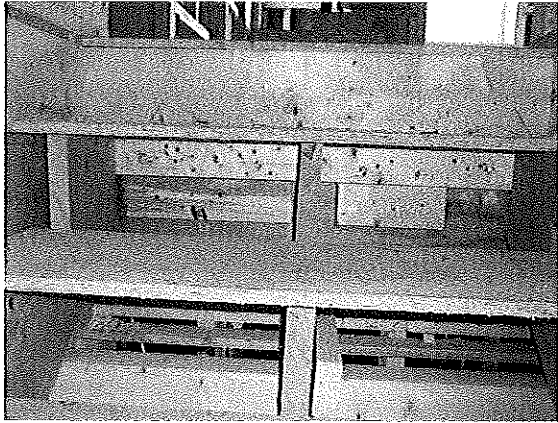
Photo # 7 – Ledger added below stringer- top stair

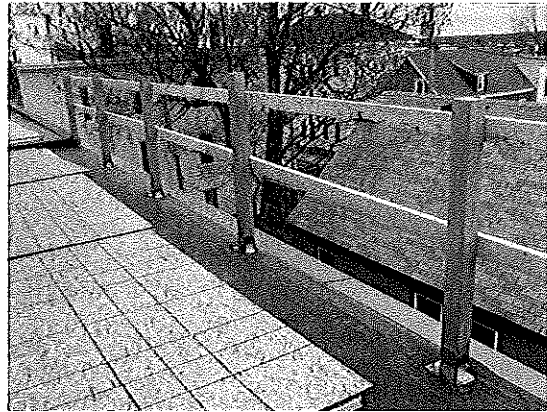
Photo #8 – Guardrail post base reinforcement

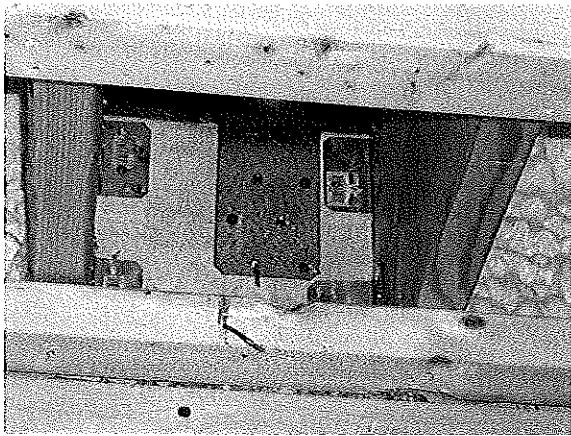
Photo # 9 – Guardrail post base reinforcement (below)

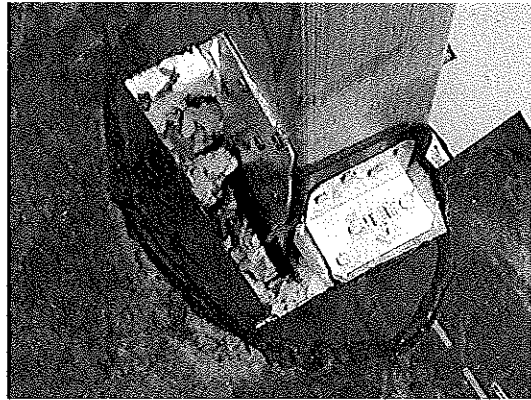
Photo #10 – Guardrail post base reinforcement

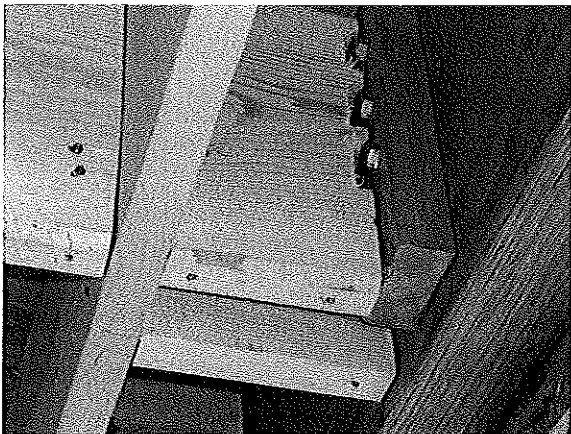
Photo # 11 – Guardrail post base reinforcement
