FIELD OBSERVATION REPORT
Price Structural Engineers, Inc.

Project: 3 – Unit Apartment
Location: 62 Cumberland St.; Portland, ME
Date: January 26, 2010
Time: 1:00 PM

Project Items to be Observed:

Steel Installation and Initial Wood Framing

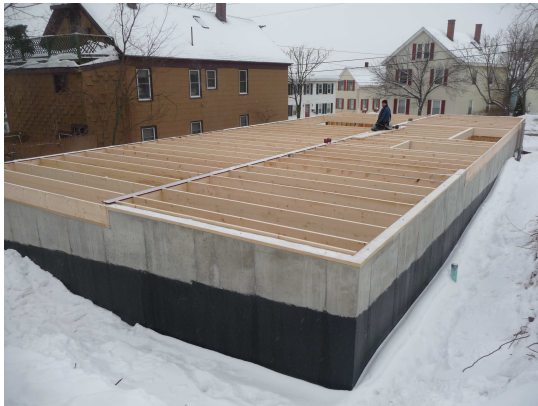
1. Steel beams and columns have been installed. Beam / column connections covered with wood.
2. Contractor installing 2x12 joists during site visit. Sill plate appeared to pressure treated.

Photo # 1 – Joist installation

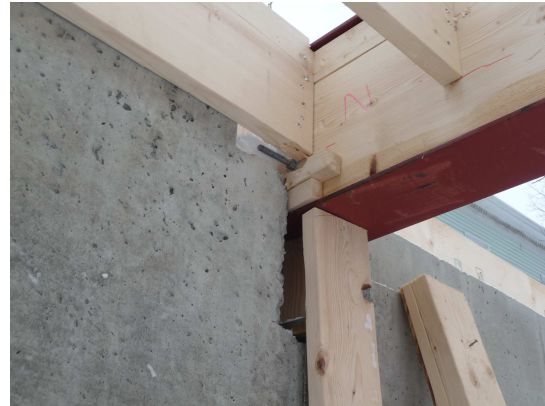
3. Deep snow currently providing frost protection for footings in addition to insulated blankets.
4. Concrete pocket for steel beam was installed too low at grid 11/A.9. See "Correction Items" below.

Photo #2 – Concrete beam pocket was too low

1. Steel beam pocket at grid 11/A.9 was placed too low. Contractor shall provide adequate temporary support of steel beam and infill void below beam with solid concrete (f'c = 4000 psi). The temporary shoring shall remain in place until concrete has cured a minimum of 7 continuous days unless 2% accelerator or "high early" concrete is used in concrete mix design which would reduce curing period to 3 days.
2. Missing anchor bolts – install 3/4" diameter Hilti Kwik bolts with 4" embedment in concrete per Hilti requirements including, but not limited to hole diameter, cleaning of hole and nut tightness.

1. GC coordinated steel beam lengths to accommodate previous concrete piers that were not accurately placed per drawings

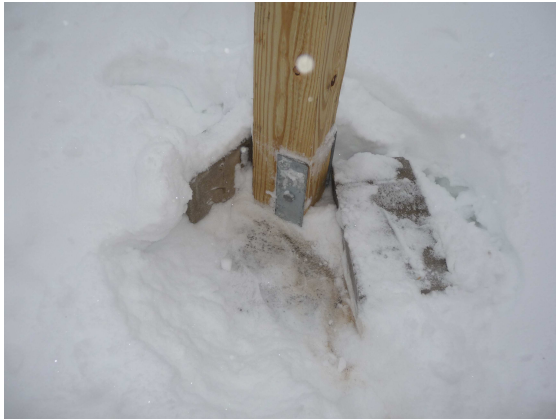
7. Bracket used to connect post at grid A/1 appears to be correct. Grout observed below steel columns.
8. Control joint installed at grid A (see photos), as a result diagonal cracking not observed in concrete walls.

Photo # 3 – Simpson post base bracket as specified

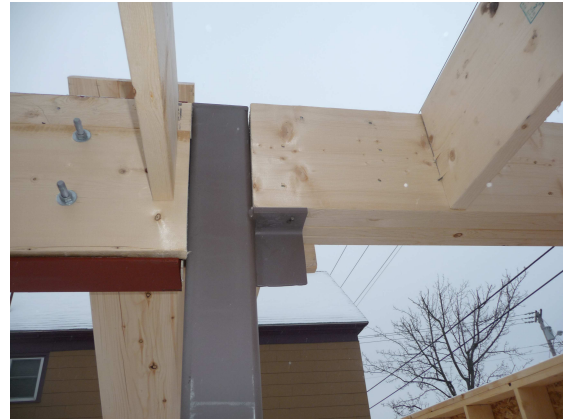
Photo #4 – Beam connection at grid 2.1/A.9

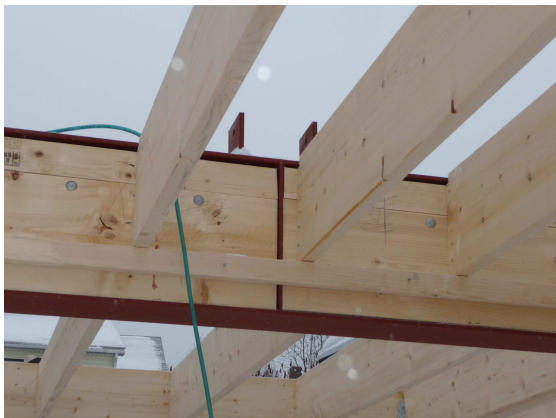
Photo # 5 – Bracket on steel beam with stiffeners below

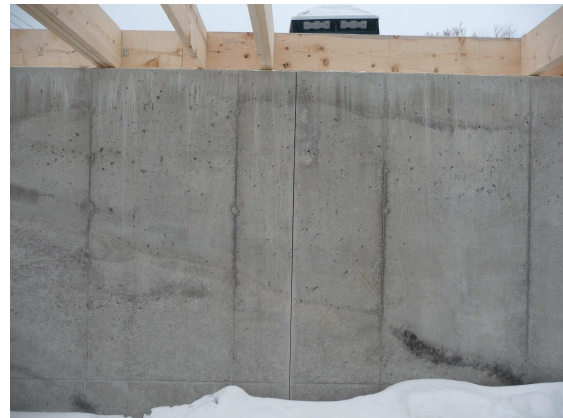
Photo #6 – Vertical concrete control joint installed
