FIELD OBSERVATION REPORT
Price Structural Engineers, Inc.

Project: 3 – Unit Apartment
Location: 62 Cumberland St.; Portland, ME
Date: December 14, 2010
Time: 12:30 PM

Preparations for concrete spread footing placement

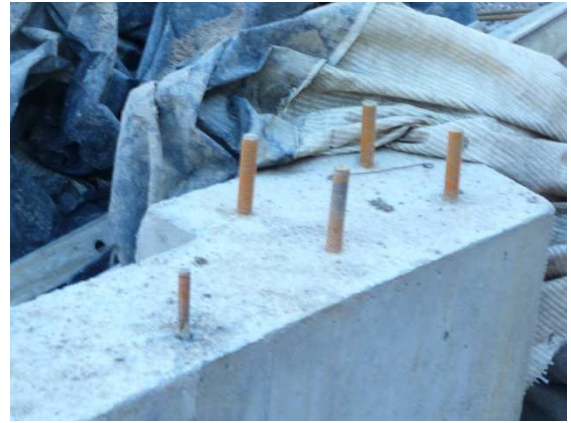
1. Vertical #8 reinforcement dowels not adequately secured or aligned which could cause problems for concrete cover during future pier placement.
2. String-lines not observed for horizontal positioning of footings.
3. GC reported concerns that previous concrete piers were not accurately placed per drawings

Photo #2 – Concrete pier placed previously

1. Steps to position and secure vertical #8 bars taken by concrete contractor during site visit
2. String lines used for alignment.
3. GC surveyed existing piers and submitted request for relocation of some gridlines

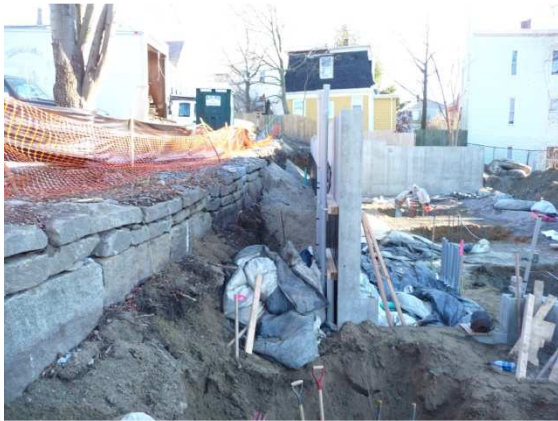
Photo # 3 – Existing retaining wall at left

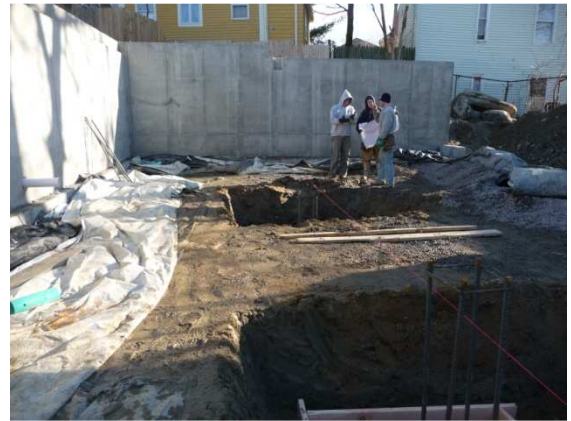
Photo #4 – Foundation wall with beam pocket

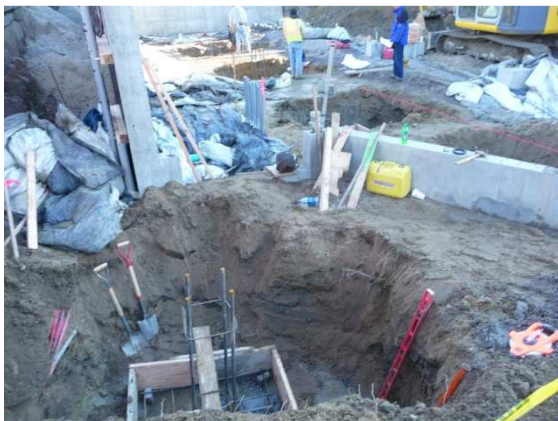
Photo # 5 – Formwork for footing at grid A/1

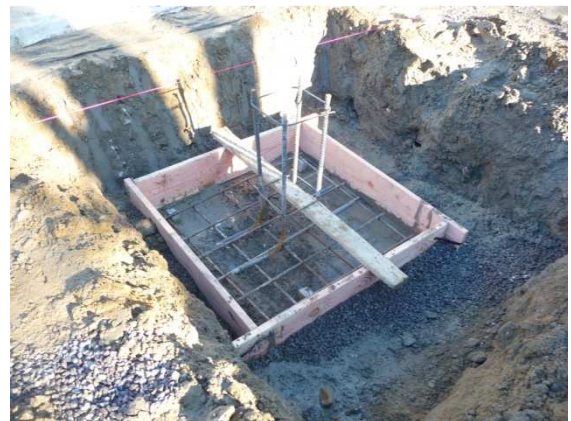
Photo #6 – Formwork for interior A.9 footing
