FIELD OBSERVATION REPORT
Price Structural Engineers, Inc.

Project: 3 – Unit Apartment
Location: 62 Cumberland St.; Portland, ME
Date: February 19, 2011
Time: 9:30 PM

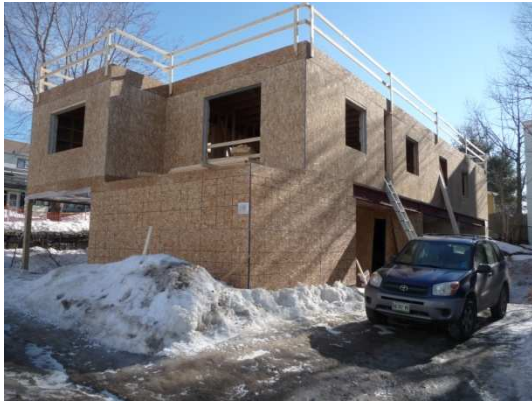
Photo # 1 – Overall View

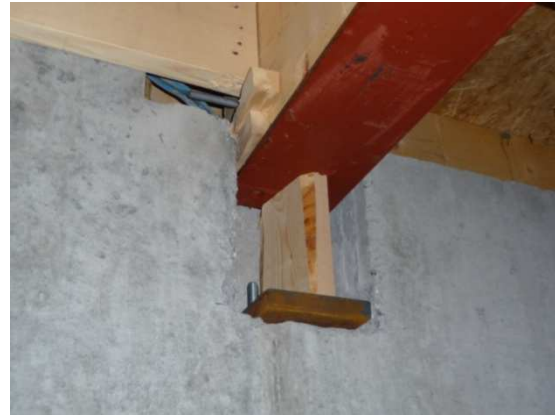
Photo #2 – Unacceptable steel beam support

1. Steel beam pocket at grid 11/A.9 was placed too low. Contractor shall provide adequate temporary support of steel beam and infill void below beam with solid concrete (f'c = 4000 psi). The temporary shoring shall remain in place until concrete has cured a minimum of 7 continuous days unless 2% accelerator or "high early" concrete is used in concrete mix design which would reduce curing period to 3 days.
2. Missing anchor bolts – install 3/4" diameter Hilti Kwik bolts with 4" embedment in concrete per Hilti requirements including, but not limited to hole diameter, cleaning of hole and nut tightness.
3. Joist and beams hangers missing at some joists and beams.
4. Nails missing from some joist and beam hangers.

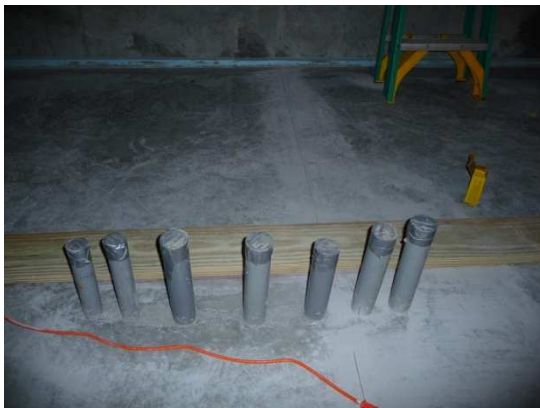
Photo # 3 – Utilities at Slab Penetrations

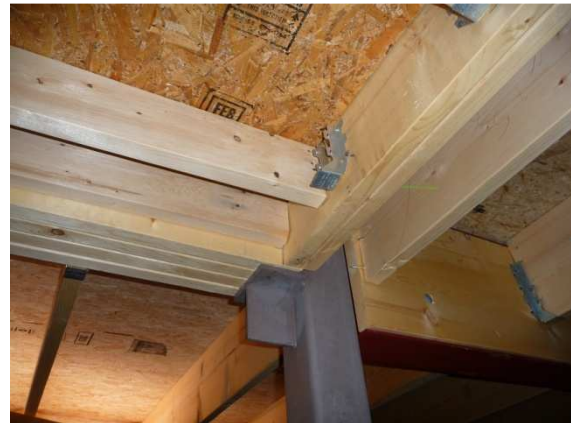
Photo #4 – Hangers missing at some joists

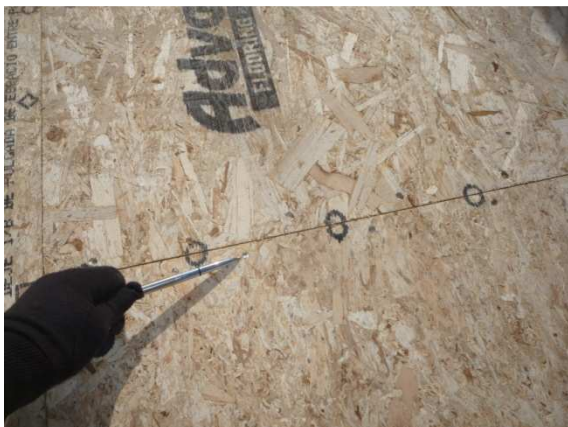
Photo # 5 – Nail spacing at floor sheathing edges

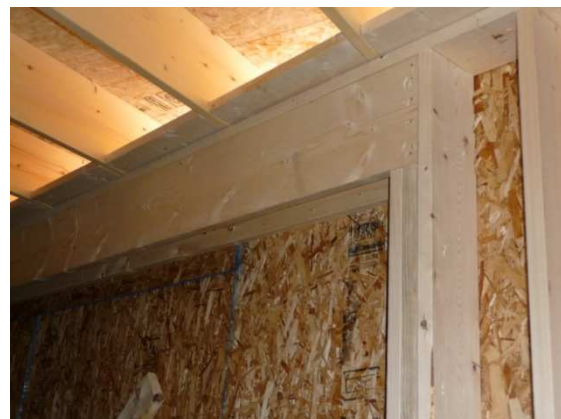
Photo #6 – Double jack studs at garage lintels
