FIELD OBSERVATION REPORT
Price Structural Engineers, Inc.

Project: 3 – Unit Apartment
Location: 62 Cumberland St.; Portland, ME
Date: March 29, 2011
Time: 10:30 PM

Project Items to be Observed:

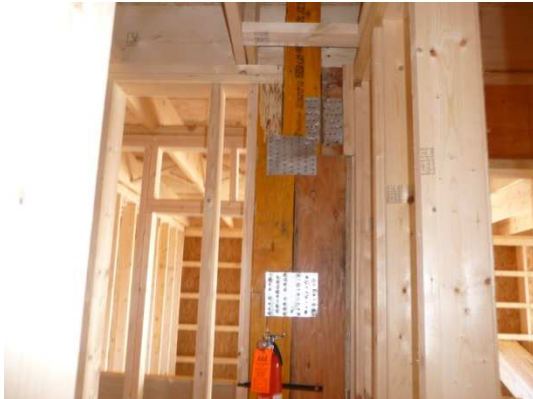
Photo # 1 – Replace spliced column

6. Replace column where it is spliced between 1st and 2nd elevated floors with 5.25"x9.25" VLAM beam (placed vertically) as discussed at jobsite.
7. Incorrect stair stringers installed at elevated floors. Add a 1.75"x 6" (w/Fb=3100 psi) VLAM sister (ripped to 6") to each stringer at elevated floors. Fasten with (2) 16d nails at 8" oc,

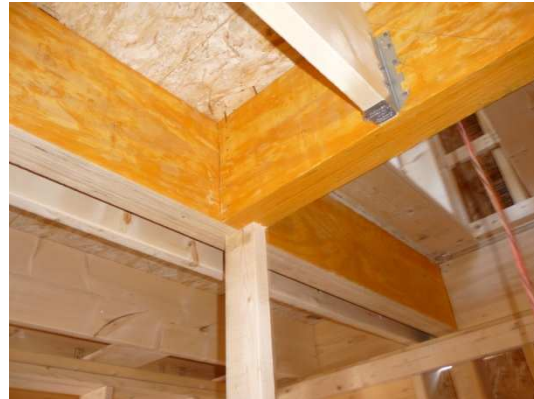
Photo #2 – Missing beam hanger

8. Install remaining beam and joist hangers where missing.
9. Not all holes in joist, beam and columns connectors have nails. Each hole must have a fastener and it needs to be the fastener size specified for the specific connector.

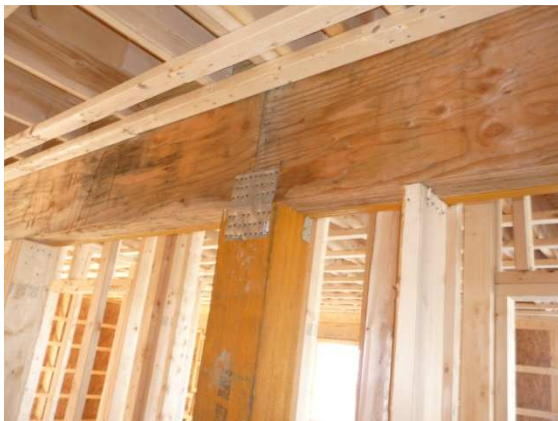
Photo # 3 – Nails missing at beam/column connectors
