FIELD OBSERVATION REPORT
Price Structural Engineers, Inc. (PSE)

Project: 3 – Unit Apartment
Location: 62 Cumberland St.; Portland, ME
Date: April 7, 2011
Time: 2:00 PM

Project Items to be Observed:
Wood Framing

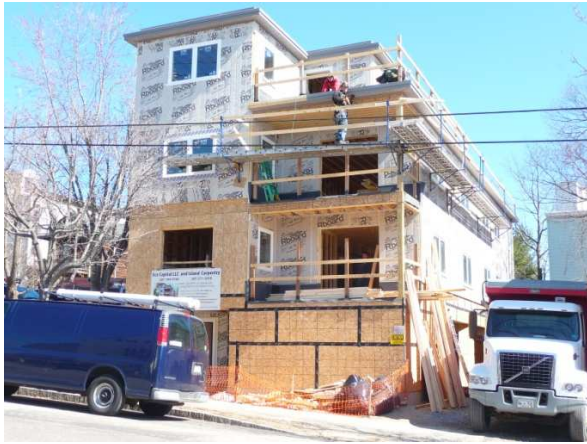
Photo # 1 – North elevation

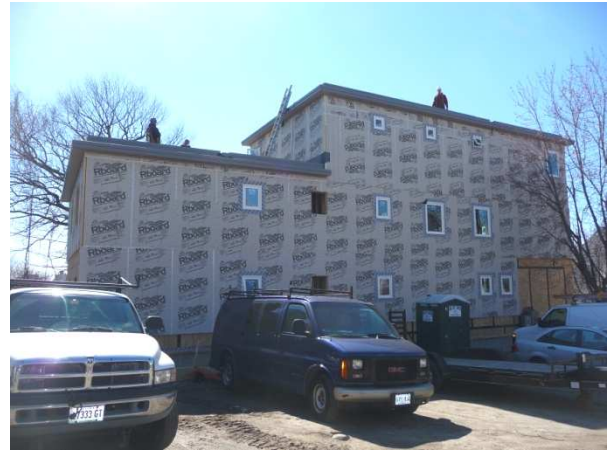
Photo #2 – East elevation

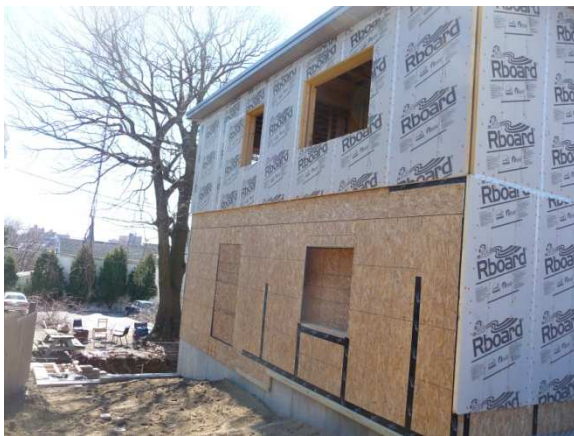
Photo # 3 – South elevation

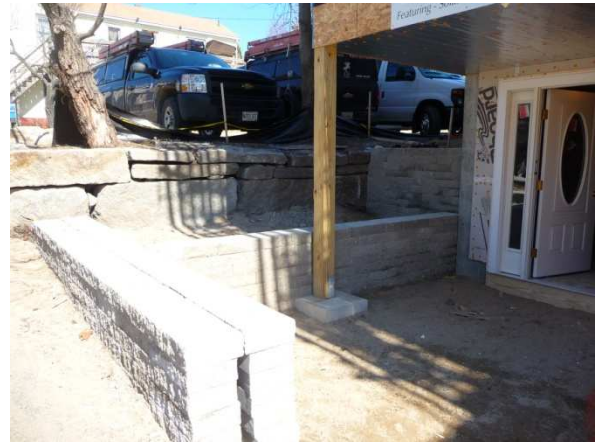
Photo #4 – North entrance – note post base anchor

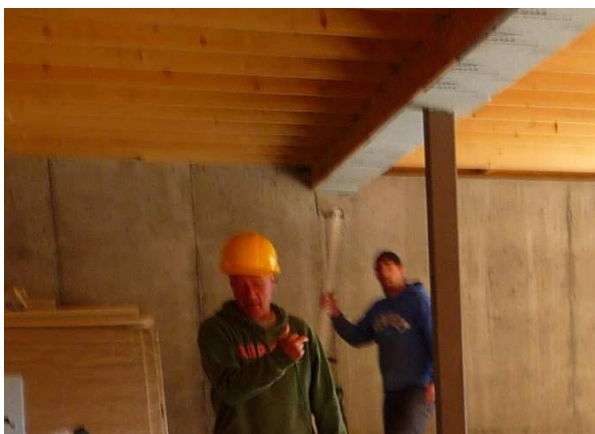
Photo # 5 – Steel beam pocket filled in with concrete

1. Steel beam pocket at grid 11/A.9 filled in with concrete below steel beam
2. Replacement of missing anchor bolts is acceptable
3. Missing joist hangers and fasteners have been installed except where noted above.
4. Missing beam hangers and fasteners have been installed except where noted above.
5. Missing beam to column connectors have been installed except where noted above.
6. Built-up beams with multiple LVL's fastened together.
7. Spliced column on 1st floor has been replaced with 5.25"x9.25" VLAM as discussed at jobsite.

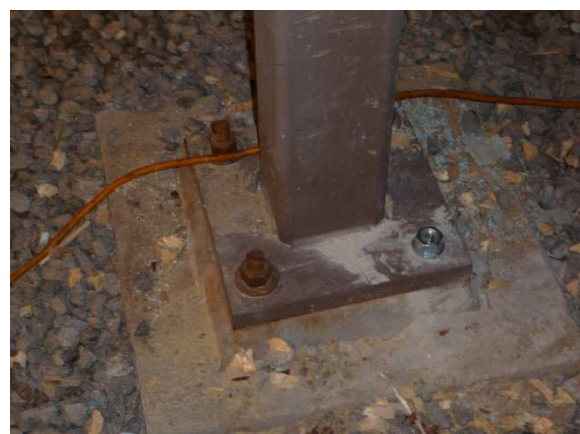
1. Drainage stone was being installed in preparation for placement of basement slab.
2. Missing anchor bolts adequately replaced with expansion bolts.
3. Steel beam at south end in concrete wall pocket appeared to be adequately supported by concrete bearing.

Photo #6 – Expansion bolt replaces missing anchor

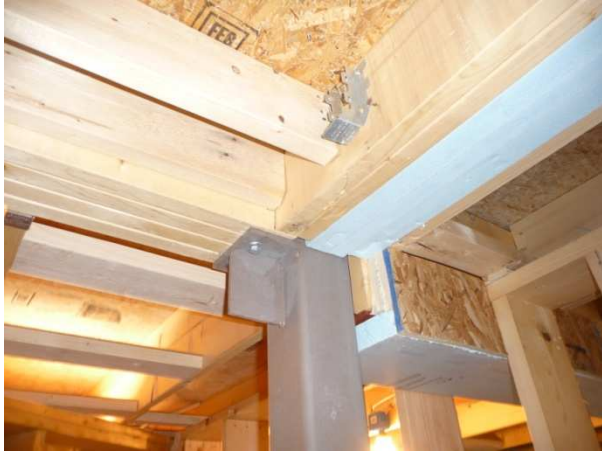
1. A double 2x10 beam supporting the front porch was not adequately supported at the east end near the steel column at B/2. This beam needs to be supported by a wood 4x4 column underneath. The 4x4 will need to be pressure treated if it bears on concrete.
2. At the same area as above each deck and floor joist needs to be checked to be sure they are supported by a joist hanger that is fully nailed.
3. Non pressure -treated door jambs observed adjacent to the garage door openings. These need to be replaced with pressure treated jambs.

Photo # 7 –Joist needs hanger; double 2x beam needs post

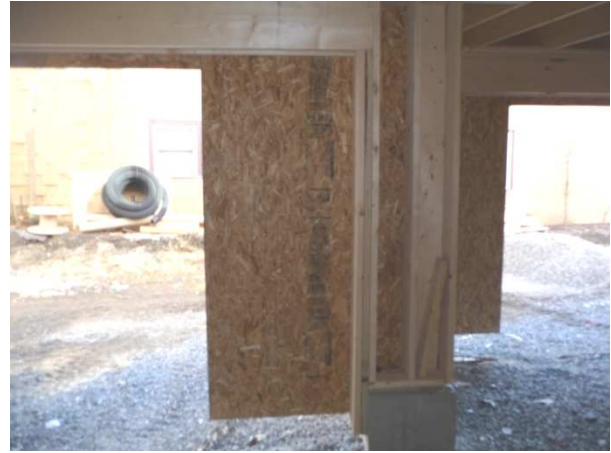
Photo #8 – Jack studs must be pressure treated

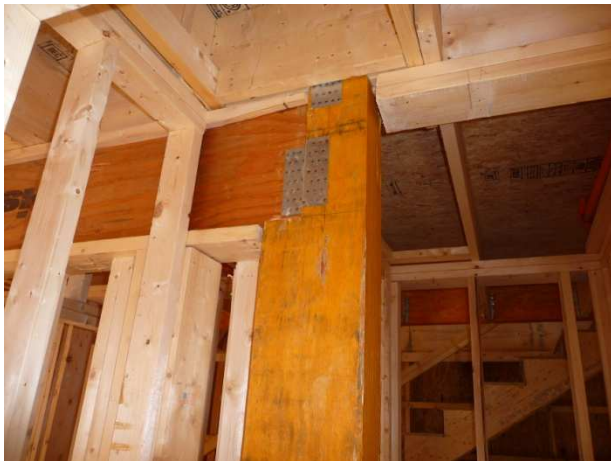
1. Joist sizes, spacing and hangers were checked and in general appeared acceptable.
2. Bridging observed.
3. Spliced column noted during previous site visit has been replaced by a single piece column which appeared to be acceptable.
4. The beam between B/5 and B/6 was not as large as what was specified on drawing S4.1.
5. Except for beam between B/5 and B/6, beam sizes were checked and in general appeared acceptable.
6. Lintel sizes were checked and in general appeared acceptable.
7. Deck guardrail posts appeared to be a concern.
8. Contractor reported that beam at deck had been reduced in size with the top of one 2x12 removed and the other 2x12's were full size. A check was made and the beam was found to be adequate in its current state.

Photo # 9 – 1st Flr: Spliced column replaced correctly

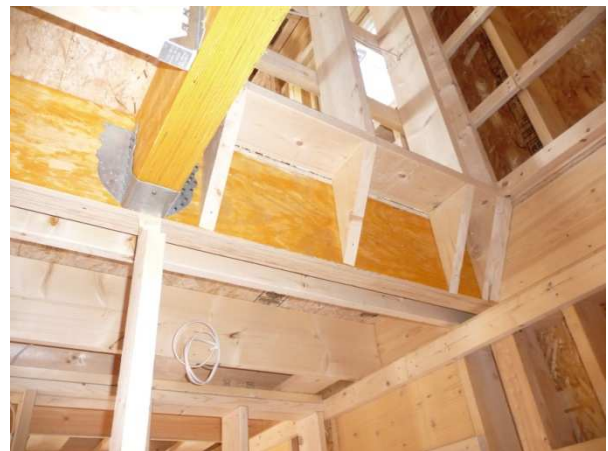
5. Triangular blocking was supporting a wall at the north end of the stair opening and this support is inadequate. The blocking may remain; however, a 2x4 ledger needs to be installed below the wall plate between the blocking to support the wall. Face nail the ledger to the beam at the north end of the stair with (2) 16 penny nails at 4" on center.

Photo #10 – 1st Flr: Inadequate wall support

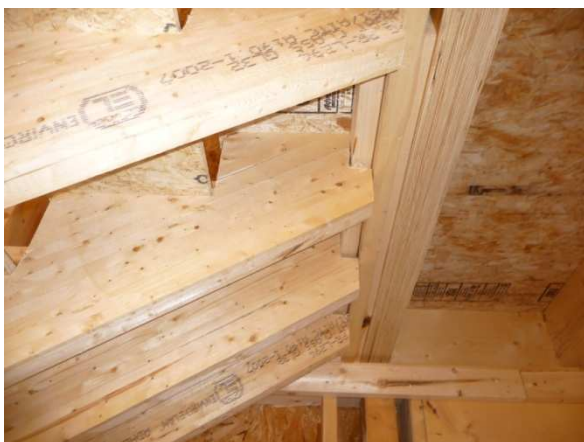
3. Stair stringer connection at top of stairs does not conform to Detail E4/S5.0 and is not adequate. Stairs must not be covered with finishes until a connection repair detail stamped by PSE engineers has been prepared and the repair installed.

Photo # 11 – 1st Flr: Inadequate stringer connection

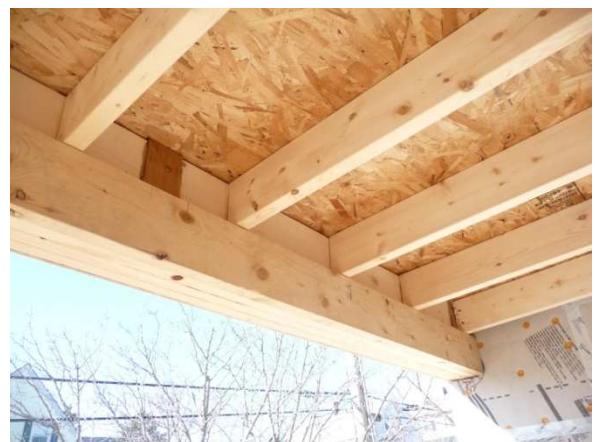
1. The guardrail posts were not installed in accordance with Detail C1/S5.1 and do not satisfy code requirements with regard to strength. The base of the posts were reduced in size to 1.75"x3.5" causing the posts to be significantly overstressed. These life/safety components will need to satisfy code requirements.

Photo #12 – 1st Flr: Guardrail @ reduced beam

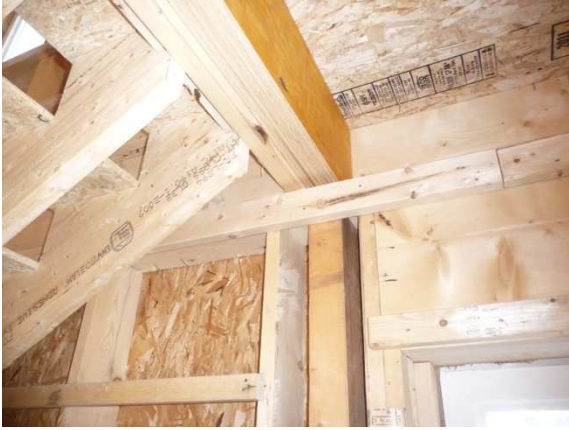
2. Incorrect stair stringers were installed that do not conform to Detail C1/S5.0. Add a 1.75"x 6" (w/Fb=3100 psi) VLAM sister (ripped to 6") to stringers. Fasten with (2) 16d nails at 8" oc,

Photo # 13 – 1st Flr: LVL 6’ Stringer sisters required

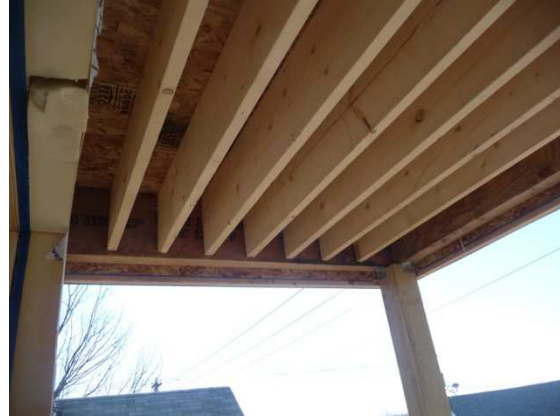
Photo #14 – 2nd Flr: Porch hangers needed

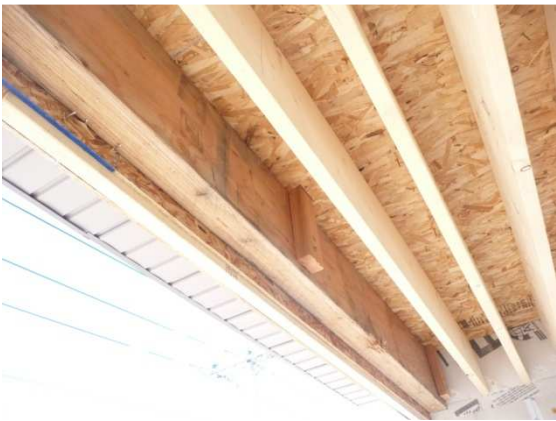
1. The guardrail posts were not installed in accordance with Detail C1/S5.1 and do not satisfy code requirements with regard to strength. At areas where posts could be observed, the base of the posts were reduced in size to 1.75"x3.5" causing the posts to be significantly overstressed. These are life/safety components that will need to satisfy code requirements.
2. The ceiling joists at the west side of the building are not adequately nailed to the sloped rafters. Fasten ceiling joists to rafters with 10d nails at 24".
3. The triple 2x beam at the west side of the elevator was not connected with beam hangers at each end. Add these hangers.
4. A floor joist at the west side of the elevator was not connected with a joist hanger which will need to be added.
5. The center stringer leading to the 3rd floor needs to have a ledger underneath at the connection near the top of the stair.

Photo # 15 – 2nd Flr: Blocking needed @ guardrail post

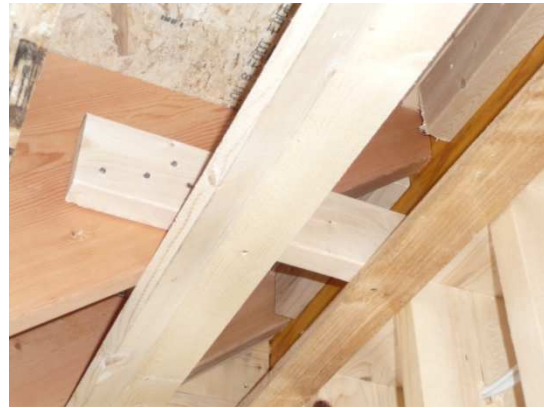
1. Stair stringers were supported at mid-span which is acceptable, however the center stair stringer was not adequately supported at the top, see Corrections section.
2. Bridging observed.
3. Joist sizes, spacing and hangers were checked and in general appeared acceptable.
4. Beam sizes were checked and in general appeared acceptable.
5. Lintel sizes were checked and in general appeared acceptable.

Photo #16 – 2nd Flr: Center stringer needs ledger

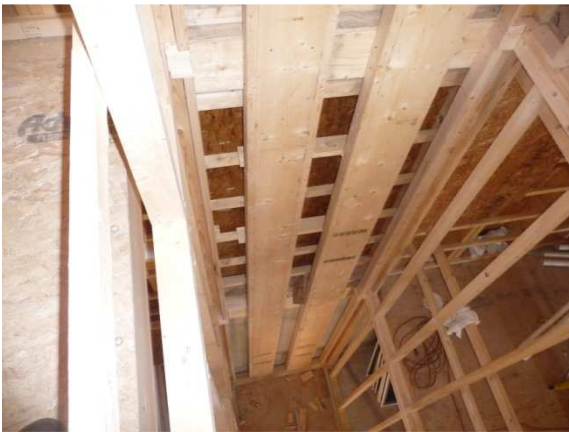
Photo # 17 – 2nd Flr: Elevator shaft framing

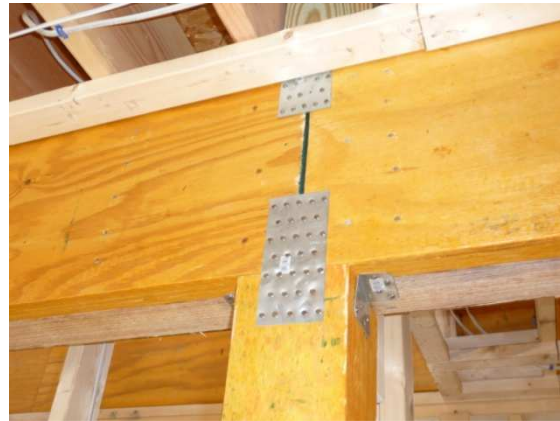
Photo #18 – 2nd Flr: Beam to column connection

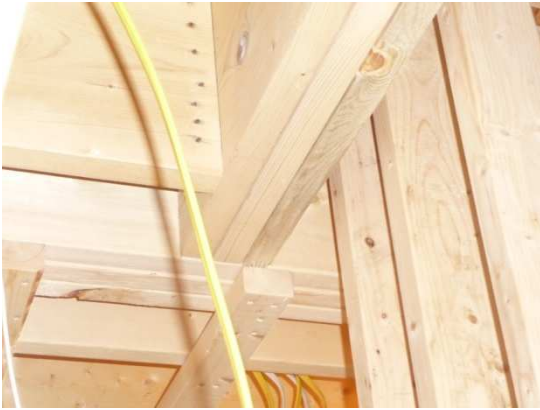
Photo # 29 – 2nd Flr: Missing beam and joist hangers

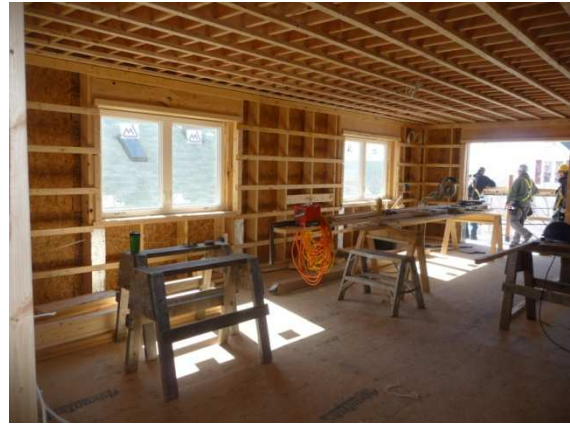
Photo #20 – 2nd Flr: View looking north

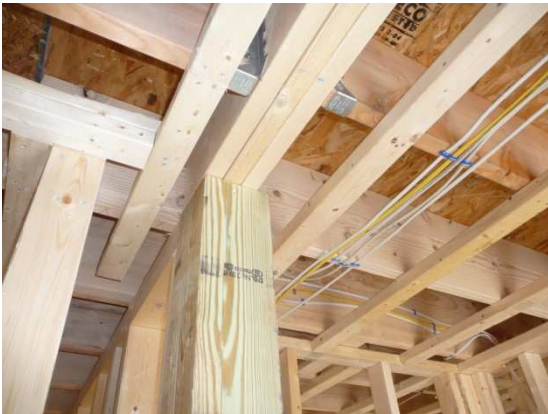
1. The beam to column connection at grid B/5 and B/6 is not adequate. These connections should conform to Details G1/S5.1 and G2/S5.1.

Photo # 21 – 3rd Flr: Missing beam/column connector

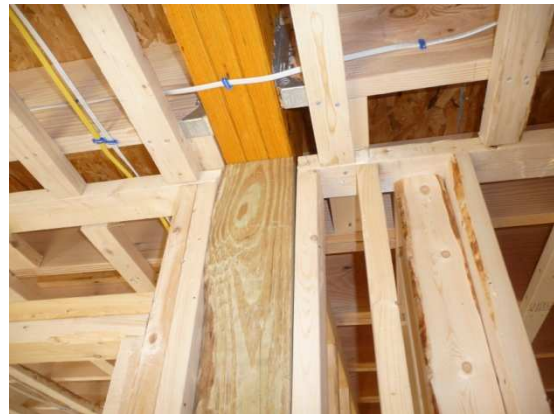
Photo #22 – 3rd Flr: Missing beam/column connector

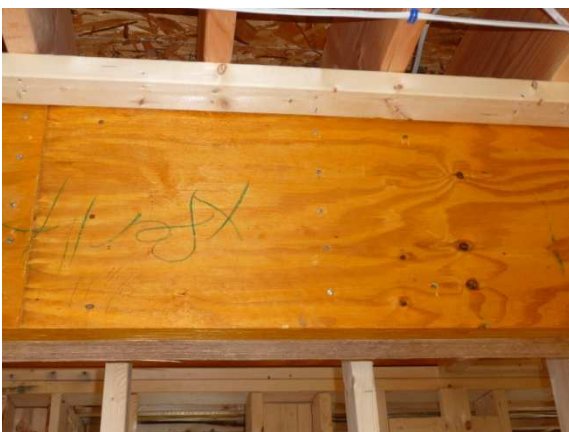
Photo # 23 – 3rd Flr: Top loaded multi-ply beam

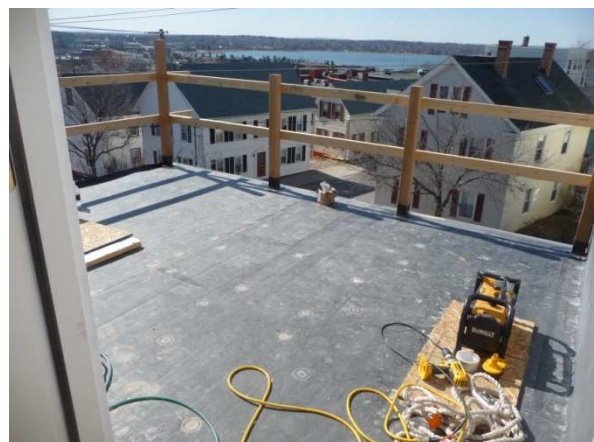
Photo #24 – 3rd Flr: View looking at Back Cove
