FIELD OBSERVATION REPORT
Price Structural Engineers, Inc. (PSE)

Project: 3 – Unit Apartment
Location: 62 Cumberland St.; Portland, ME
Date: Apr. 29 & May 10, 2011
Time: 11:00 AM

Final Structural Site visits

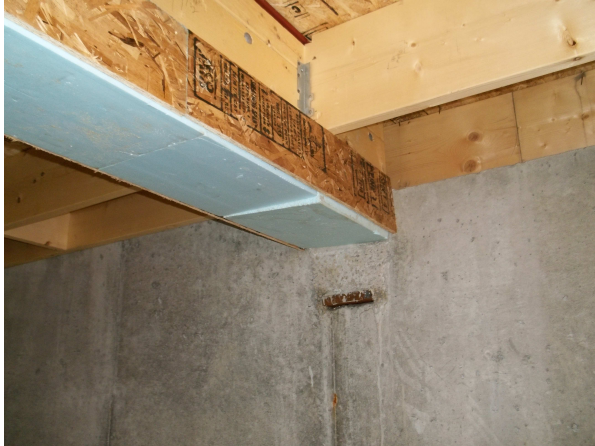
Photo # 1 – Steel beam Pocket filled w/ concrete

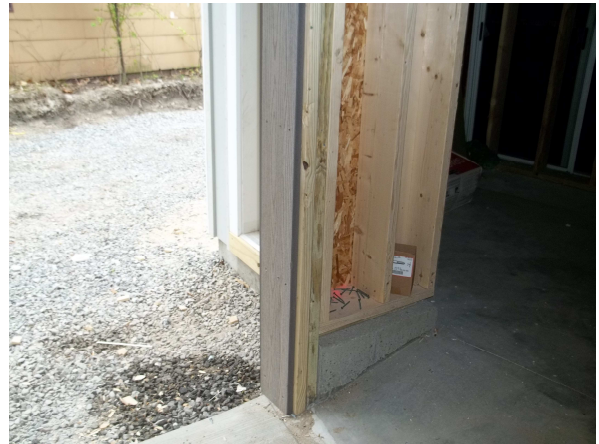
Photo #2 – Pressure treated jack studs at doors

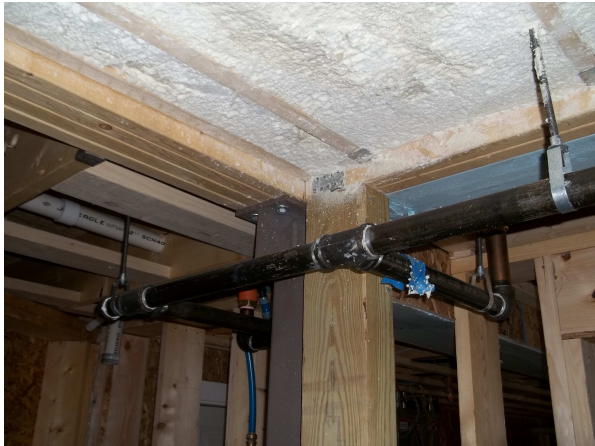
Photo # 3 – Post supporting 1st floor beam

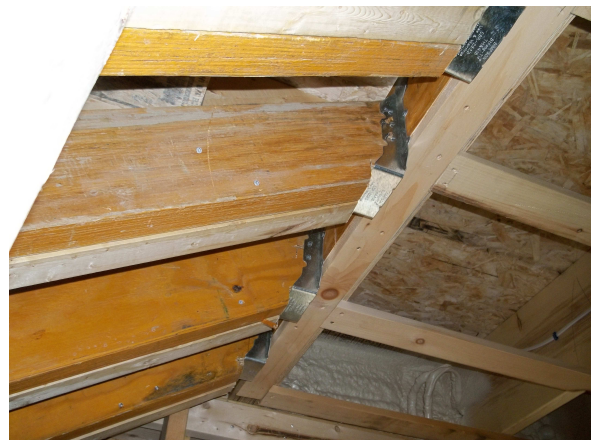
Photo #4 – Stair stringer supports

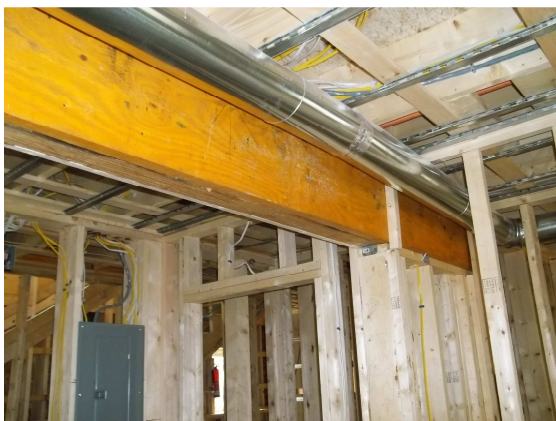
Photo # 5 –VLAM sister added @ 1st floor beam

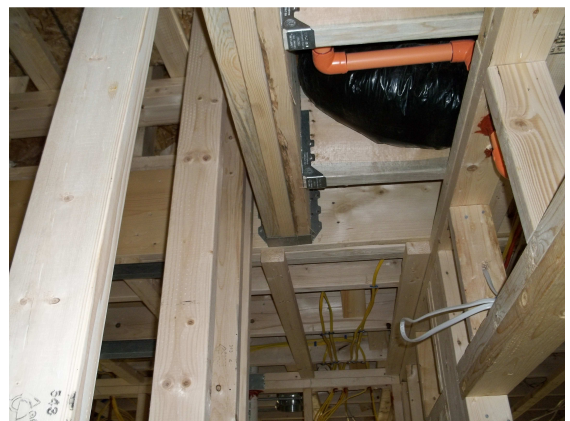
Photo #6 – Beam Hangers added near elevator

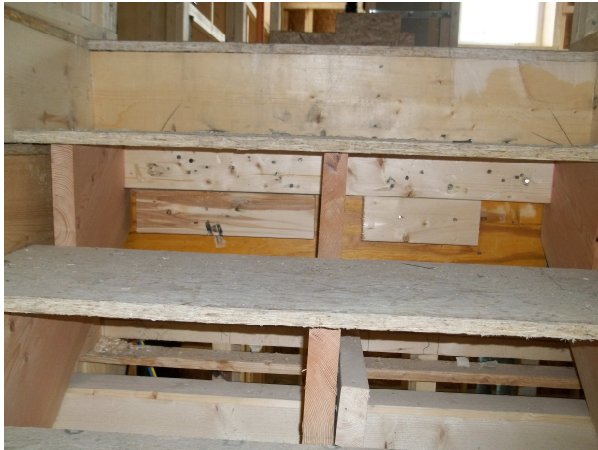
Photo # 7 –Ledger added below stringer- top stair

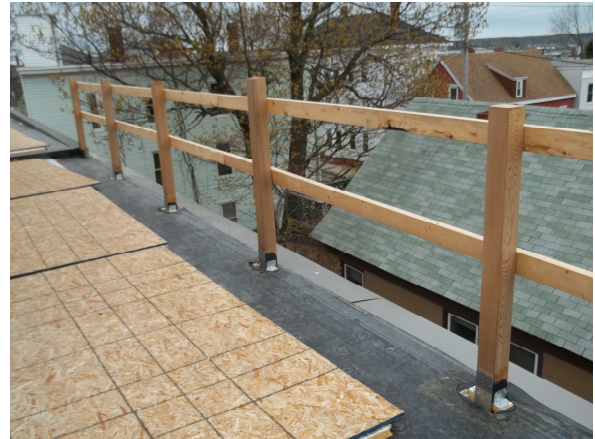
Photo #8 – Guardrail post base reinforcement

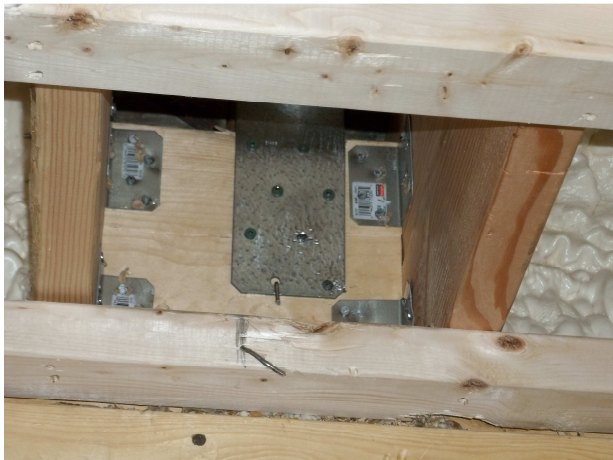
Photo # 9 – Guardrail post base reinforcement (below)

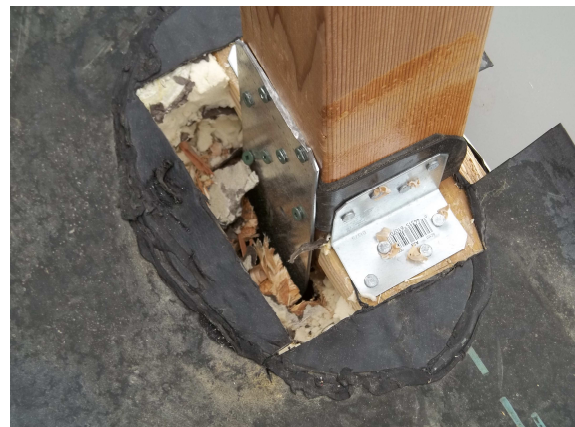
Photo #10 – Guardrail post base reinforcement

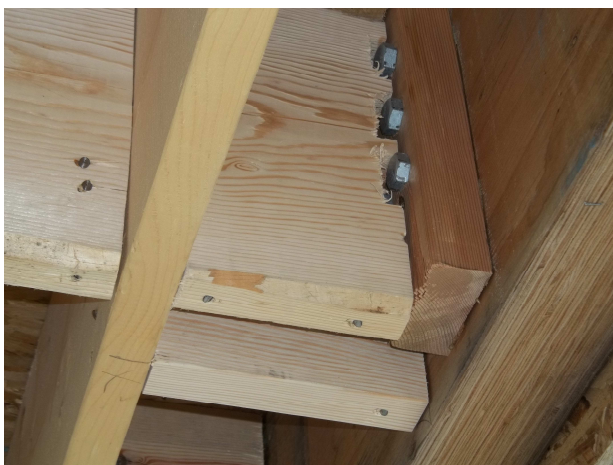
Photo # 11 – Guardrail post base reinforcement

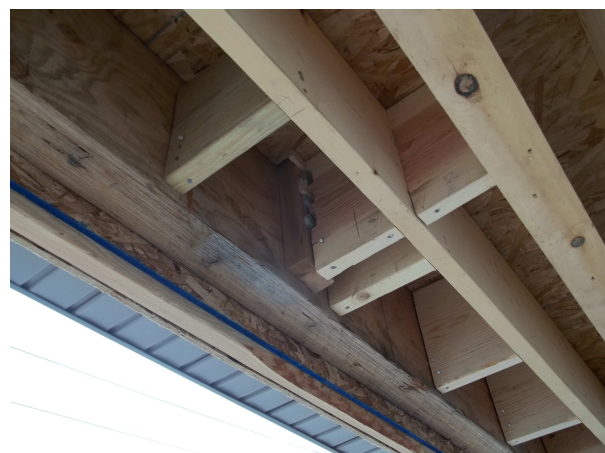
Photo #12 –Similar area as previous
