Rear 80 CUMBERLAND AVENUE

File: BP 48/171 (80 Cumberland
Avenue, rear)-1

Subject: demolition of city-owned building at the rear of 80
Cumberland Avenue

Subject: Conditions on city-owned lot at the rear of 30 Cumberland Avenue where building has been demolished—reply to your memorandum of April 15

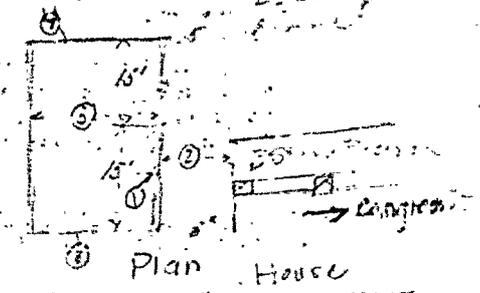
① base 4 1/2" brick wall
+ 1/2" in mortar.
② ground base in bc.
concrete card and cast fill

③ depth abt 4' filled in
with soil.
