December 12, 2013

RE: 33 Atlantic Street Ridge Beam  
Portland, Maine

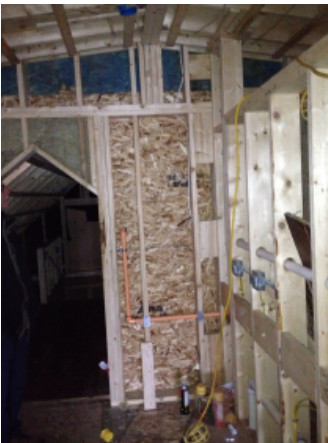
On Monday December 4, 2013 I visited the above location to review and evaluate the rough framing of the roof at the rear of the building. Specifically I reviewed the ridge beam and ridge beam support framing in the vicinity of the added dormers.

The ridge beam is supported by built-up common roof rafters at one end and a wood stud bearing wall at the other end. After field review, I have instructed Mr. Gan to add 4-2x4 ganged studs beneath the rear bearing wall supporting the ridge beam to maintain the load path. The current framing does not have a continuous load path as the studs are discontinuous at the wall plate. The ganged studs will need to be ripped to a depth of 3" to fit behind the residential sprinkler line currently installed. The sprinkler line will need to be temporarily relocated or removed in order to install the additional studs. Please refer to the attached photo.

With this modification in place, it is my opinion that the existing dormer ridge beam framing is adequate to support the code required roof loads in this vicinity and that there are sufficient load paths to distribute this load through the existing framing.
