<b>Project</b>	OCEAN GATEWAY PARKING GARAGE	<b>Report No.</b>	16
<b>Location</b>	PORTLAND, MAINE	<b>Period From</b>	3 September 2007
		<b>To</b>	7 September 2007
<b>Client</b>	RIVERWALK, LLC.	<b>Page</b>	1 of 4
<b>Contractor</b>	LEDGEWOOD CONSTRUCTION (CM) SHAW BROTHERS CONSTRUCTION (EARTHWORK) G. DONALDSON CONSTRUCTION (PILE DRIVING)	<b>File No.</b>	30322-030

**WEEKLY FIELD REPORT**

**HALEY & ALDRICH** OCEAN GATEWAY PARKING GARAGE  
MIDDLE STREET  
PORTLAND, MAINE

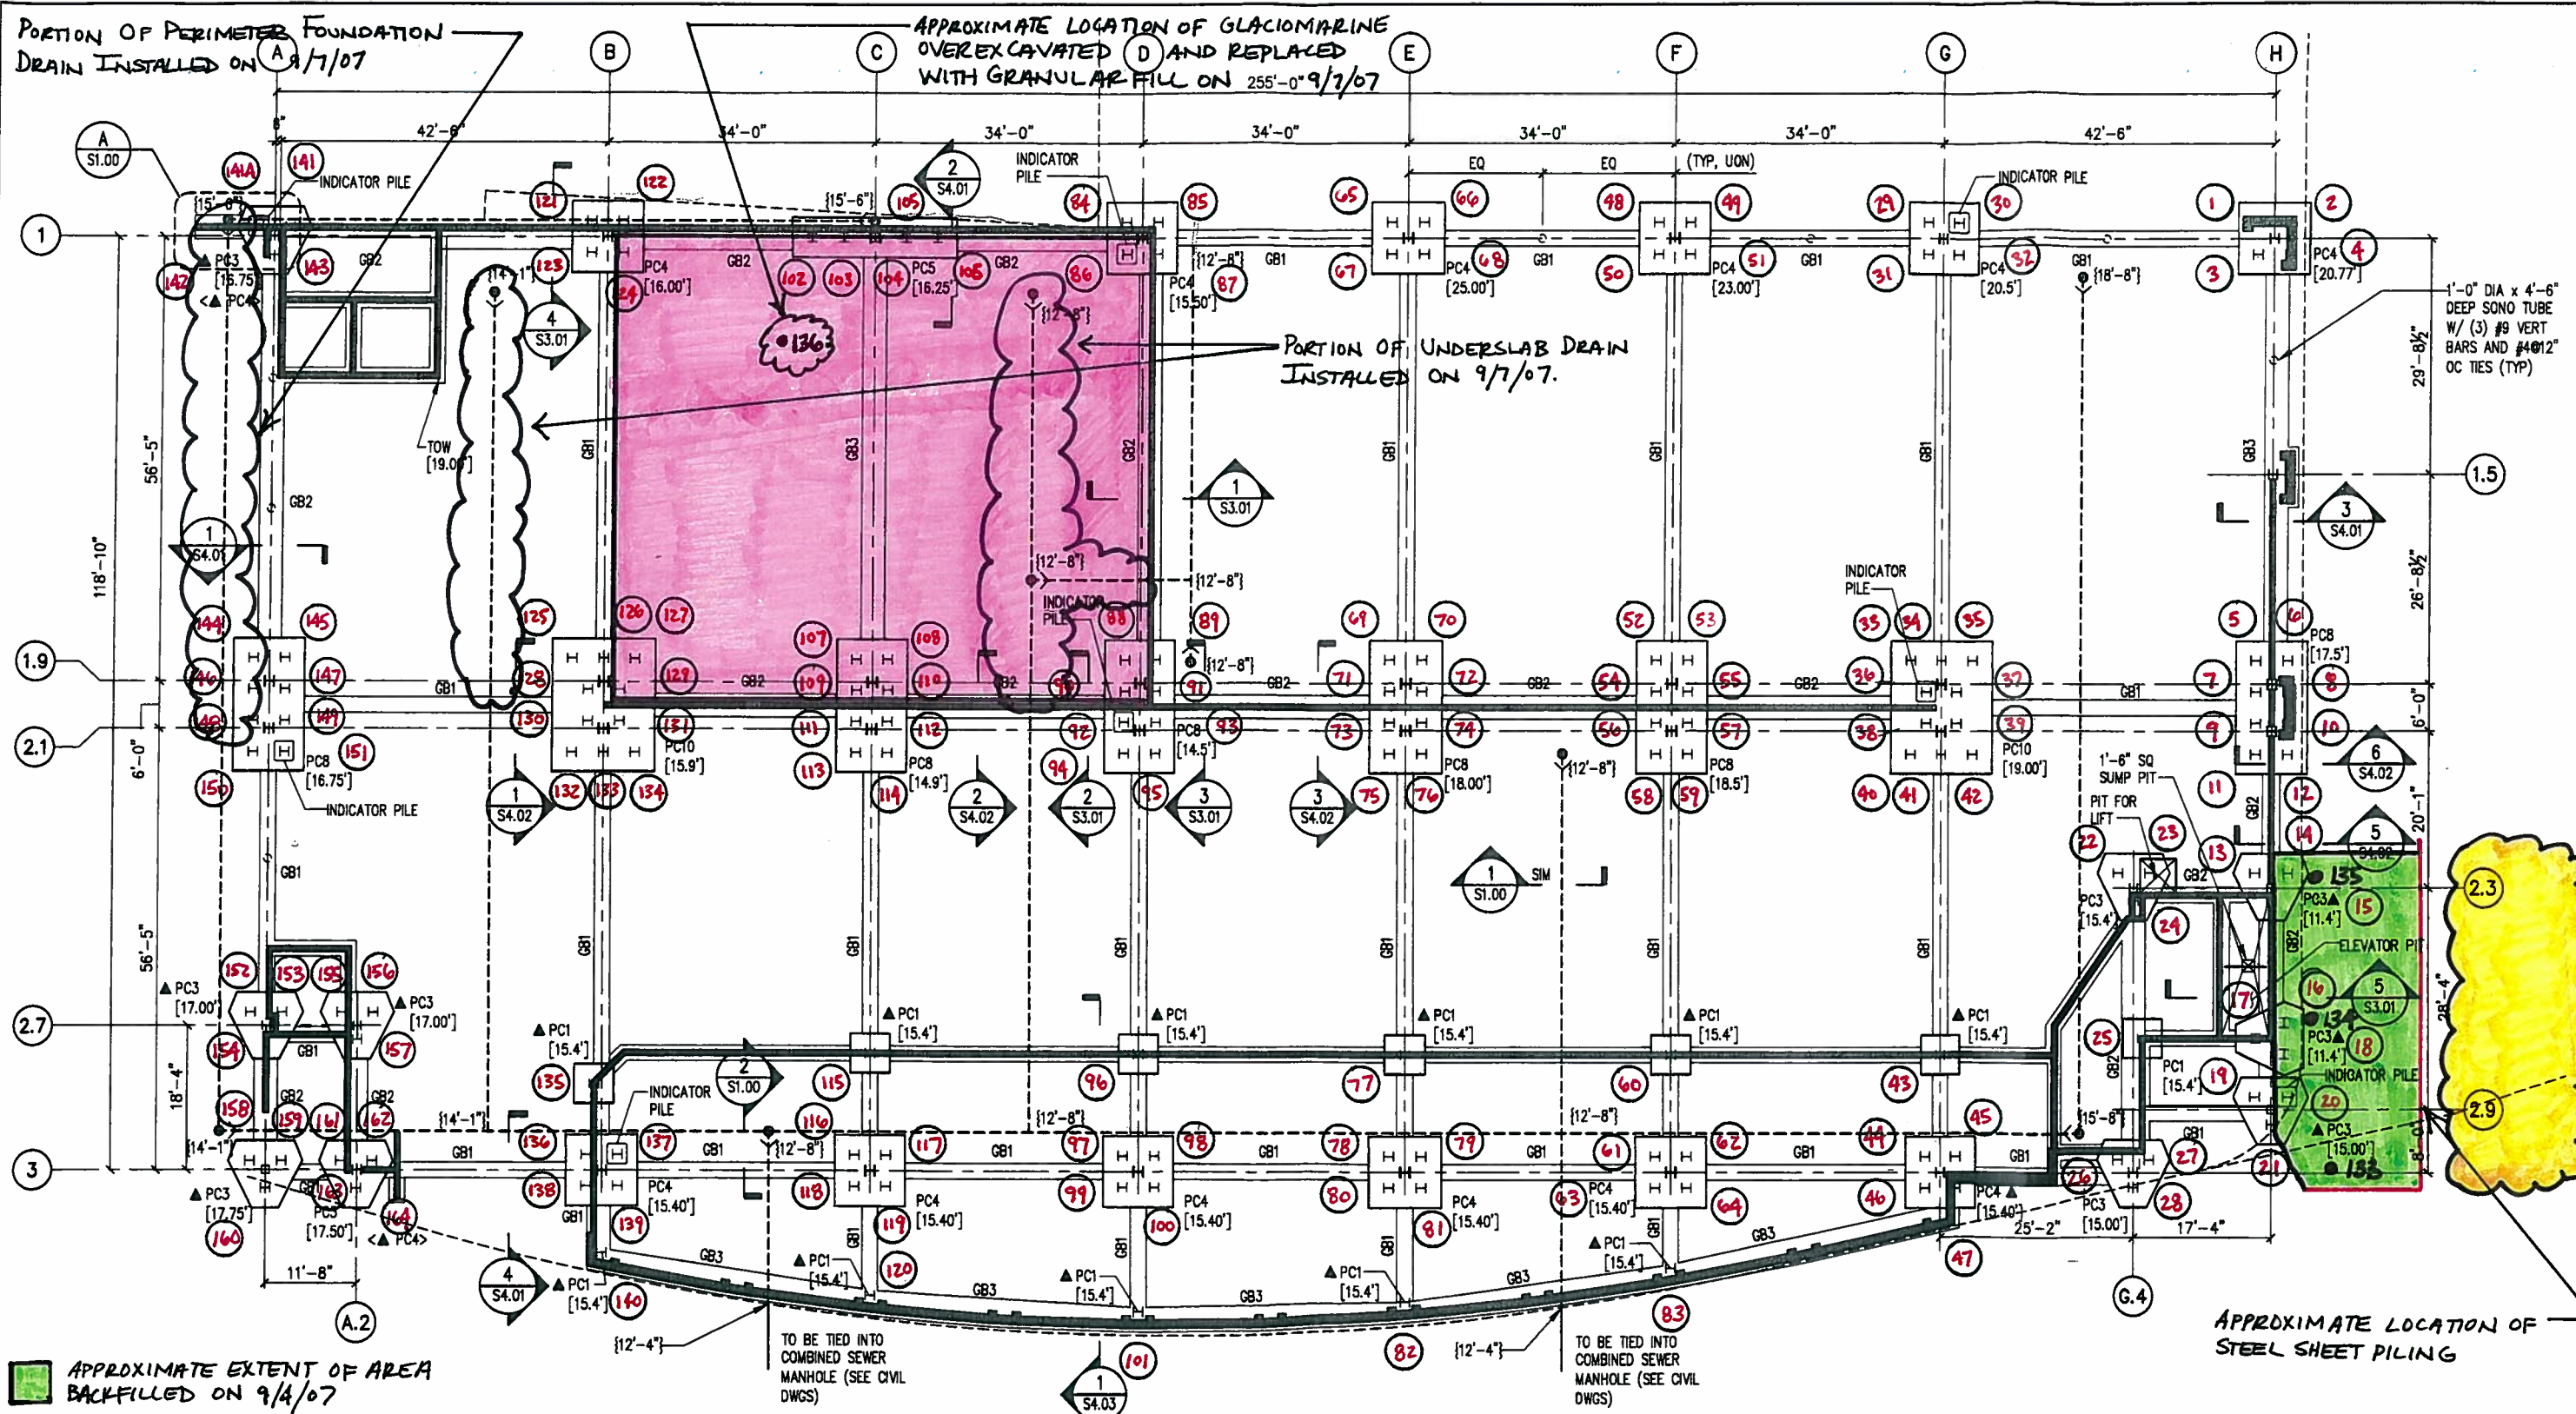
**FIGURE 1**

1. Shaw Bros. previously (prior to Field Representatives arrival at site) backfilled the area north of column H, between column line 2.3 and column line 3 (see Figure 1 and photographs). The area was backfilled up to approximately El. 15 in order to allow the removal of the concrete jersey barrier deadmen and continuous steel waler installed for the adjacent support of excavation system. The backfill material consisted of granular fill imported to the site from Shaw Bros. Dayton Pit.

1. Shaw Bros. previously (prior to Field Representatives arrival at site) excavated and removed the concrete jersey barrier deadmen north of the support of excavation system in the northeast corner of the garage (see Figure 1 and photographs).

1. Shaw Bros. installed portions of the underslab drain between column lines C, D, 1 and 1.9/2.1 and A, B, 1 and 1.9/2.1 and a portion of the perimeter foundation drain south of column line A, between column line 1 and column line 1.9/2.1 (see Figure 1). The perimeter/underslab drains consisted of a 4-in. diameter perforated HDPE plastic pipe and was installed with the perforations oriented down. The pipe was embedded in 4-in. of ¾-in. crushed stone and was entirely wrapped in geosynthetic separation fabric (Mirafi 140N). The pipe was installed at the invert elevation shown on the plans. The pipe was backfilled with granular fill imported to the site from Shaw Bros. Dayton Pit.

3. Shaw Bros. placed Type D subbase gravel in the area bound by column lines B, D, 1 and 1.9/2.1 (see Figure 1). The Type D subbase gravel was imported to the site from Shaw Bros. H-Pit and was spread in one 12-in. thick (loose measure) lift with a CAT D5C bulldozer. The lift of subbase gravel was compacted with 3 passes of a BOMAG BW 172D-2 smooth drum vibratory roller.

1. Field Representative spoke with representatives from Shaw Bros. regarding the methodology used to backfill the area described under Contractor's Activities, Item No. 1 on Tuesday and shown on Figure 1. Field Representative confirmed that the granular fill was placed and compacted in approximate 12-in. thick (loose measure) lifts and compacted with 4 to 5 passes of a self-propelled vibratory plate compactor. Field Representative used a Humboldt 5001EZ nuclear density gauge to monitor relative compaction of the top 12-in. of material (approximately El. 14 to El. 15). In-situ density tests indicated the fill material met the minimum compaction specifications (see Table 1, test nos. 133 to 135 for results and Figure 1 for density test locations).

1. Field Representative observed and inspected the installation of the sections of perimeter and underslab drains described under Contractors Activities, Item No. 1 on Friday and shown on Figure 1. Field Representative judged that the sections of the perimeter and underslab drains were installed as shown on the construction drawings.

2. Field Representative observed the removal of disturbed marine clay from the area described under Contractors Activities, Item No. 2 on Friday and shown on Figure 1. Field Representative verified that all unsuitable material was removed down to firm subgrade soil. Field Representative observed the placement and compaction of granular backfill. Fill material consisted of imported granular soil from Shaw Bros. Dayton Pit. Field Representative used a Humboldt 5001EZ nuclear density gauge to monitor relative compaction during fill placement. The granular fill appeared stable under the compactive effort of a self propelled vibratory plate compactor. In-situ density tests indicated the fill material met the minimum compaction specifications (see Table 1, test no. 136 for results and Figure 1 for density test locations).

3. Field Representative observed placement of Type D subbase gravel in the area described under Contractors Activities, Item No. 2 on Friday and shown on Figure 1. Fill material consisted of imported granular soil from Shaw Bros. H-Pit. Field Representative used a Humboldt 5001EZ nuclear density gauge to monitor relative compaction during fill placement. The granular fill appeared stable under the compactive effort of a BOMAG BW172D-2 smooth drum vibratory roller. In-situ density tests indicated the subbase material did not meet the minimum compaction specifications due to low water content.

4. Field Representative spoke with Mr. Fairweather regarding compaction of the subbase gravel described under Item No. 3, above. Field Representative explained to Mr. Fairweather that the material was several percent under the optimum water content and that water would have to be added to the material and re-compacted in order to meet the minimum compaction specification. Mr. Fairweather suggested that rain forecasted for this weekend would help to aid moisture since no other source of water was available. Mr. Fairweather suggested waiting until Monday (9/10) to re-compact (and re-test) the subbase gravel. Field Representative agreed with Mr. Fairweather.

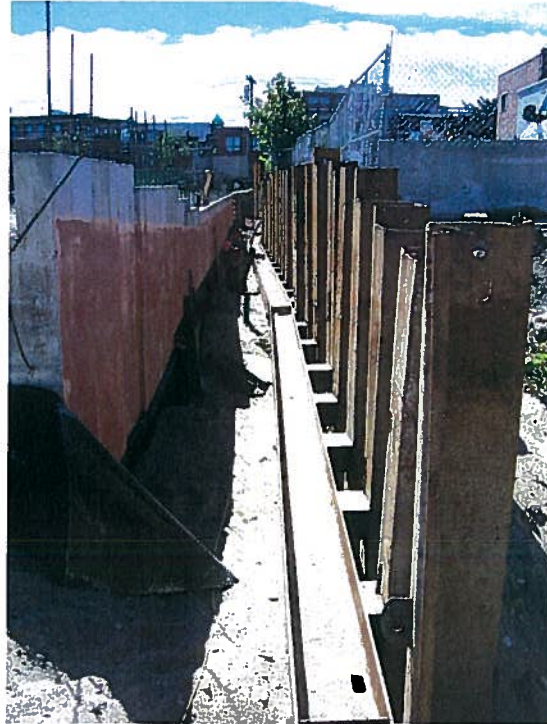
*Photograph 1. Removal of rakers for the support of excavation system along column line 1, looking south (9/4/07).*

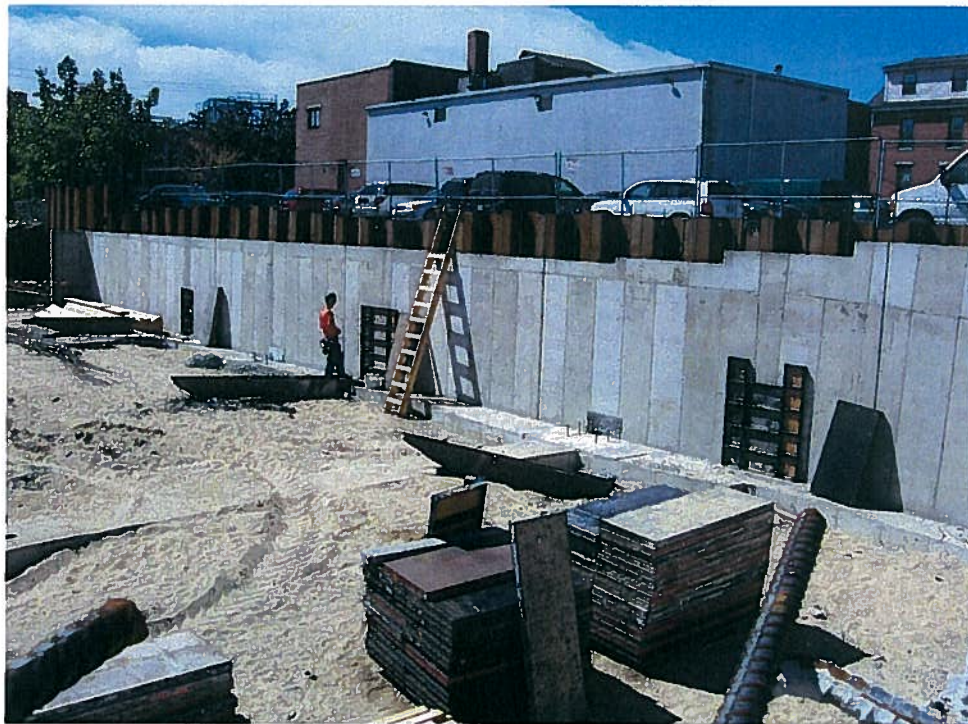
4. Previously (prior to Field Representatives arrival at site) installed waterproofing and drainage board over the "box-outs" in the foundation wall along column line 1 that were provided for the rakers that were part of the support of excavation system.

*Photograph 2. Forming of cutouts in the foundation wall after removal of the rakers for the support of excavation system along column line 1, looking southwest (9/4/07).*

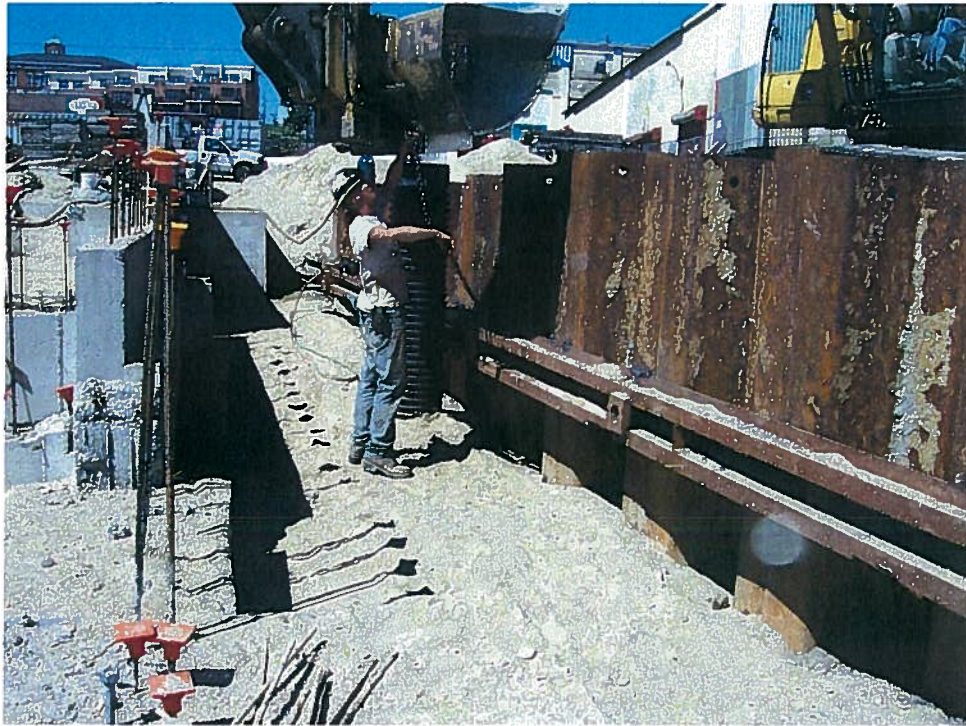
*Photograph 3. Removal of the continuous steel waler from the support of excavation system north of the elevator pit in the northeast building corner, looking west (9/4/07).*

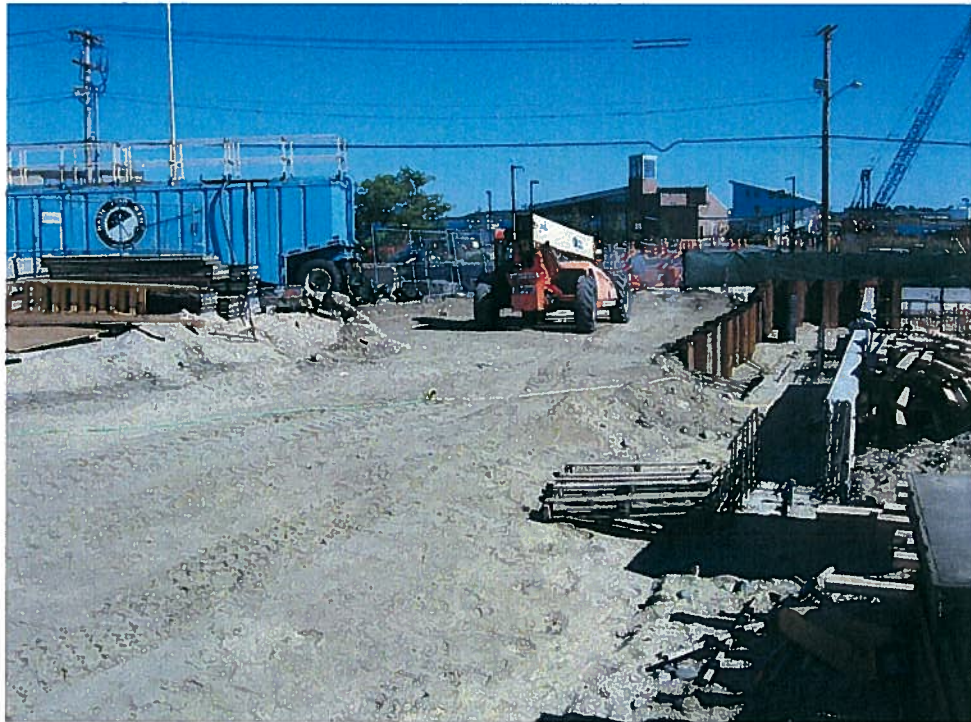
*Photograph 4. Area north of the support of excavation system in the northeast building corner after removal of the concrete jersey barrier deadmen, looking east (9/5/07).*
