Project	OCEAN GATEWAY PARKING GARAGE	Report No.	18
Location	PORTLAND, MAINE	Period From	17 September 2007
		To	21 September 2007
Client	RIVERWALK, LLC.	Page	1 of 2
Contractor	LEDGEWOOD CONSTRUCTION (CM) SHAW BROTHERS CONSTRUCTION (EARTHWORK) G. DONALDSON CONSTRUCTION (PILE DRIVING)	File No.	30322-030

FOUNDATION PLAN (SHEET NO. S1.00)
WEEKLY FIELD REPORT NO.: 18

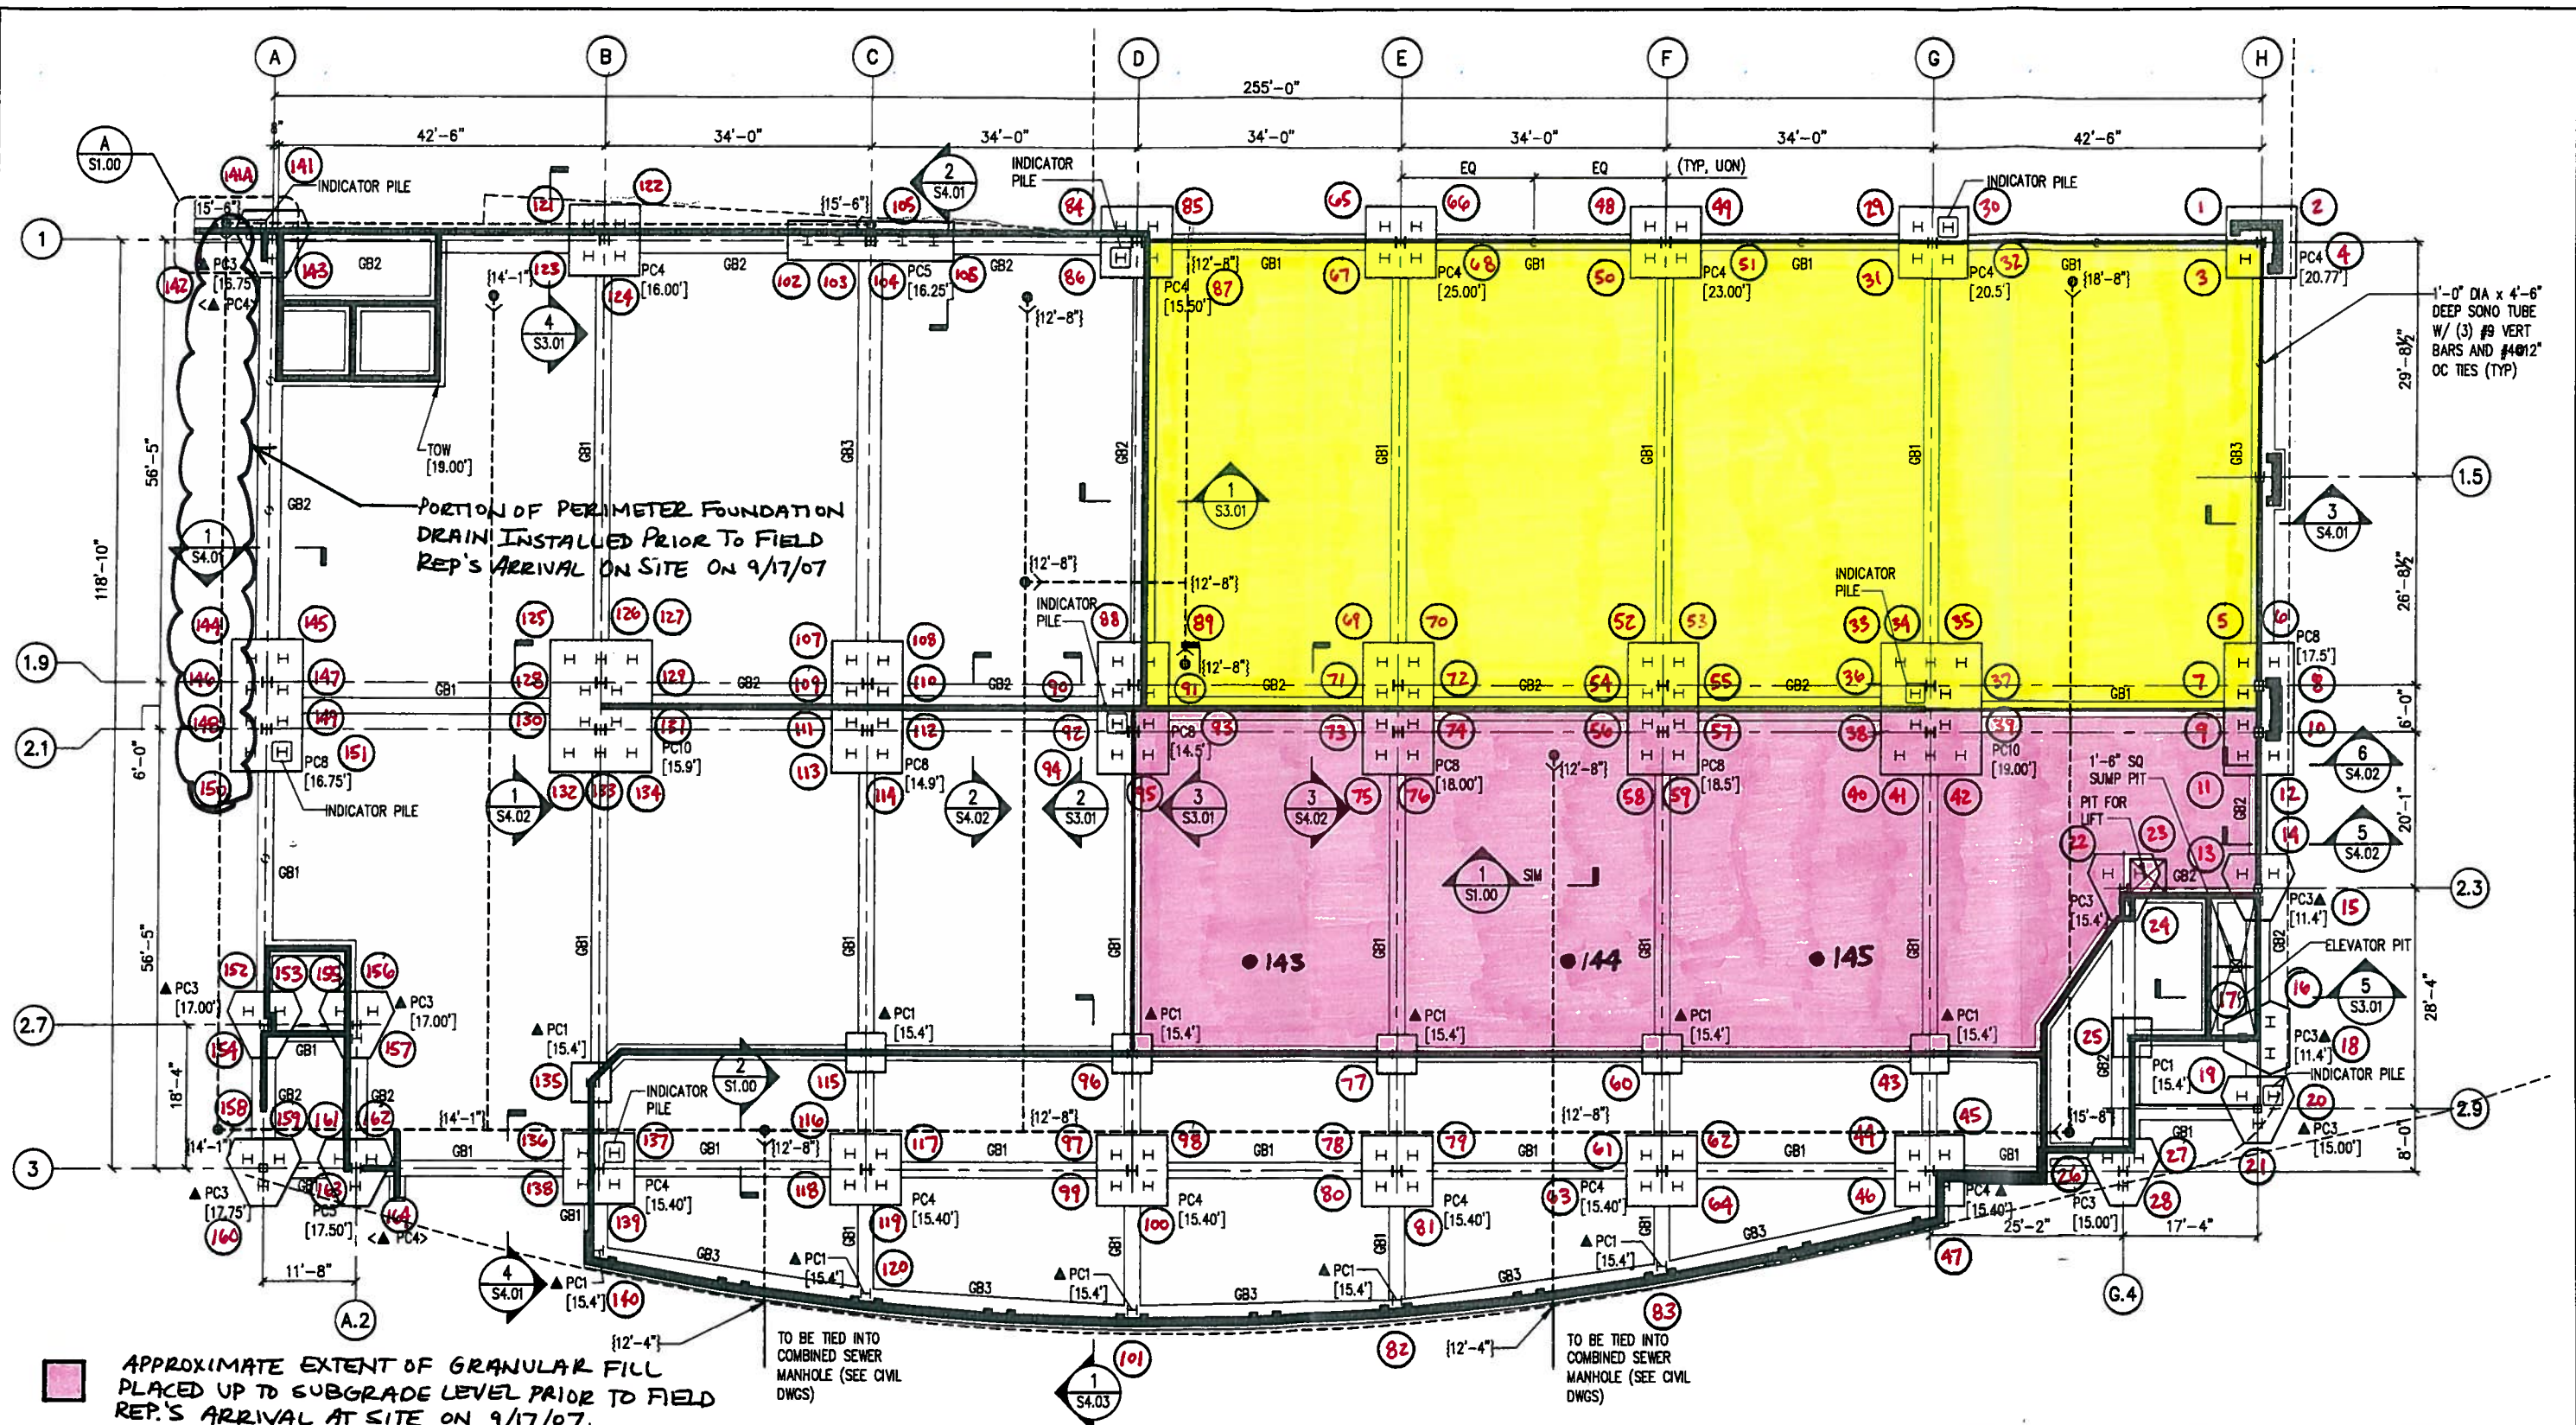
FIGURE I

1. Shaw Bros. previously (prior to Field Representatives arrival at site) installed waterproofing (Procor® 75 Spray Grade) and 2-in. thick insulation board on the interior (parking garage) side of the foundation wall along column line 2.8 (see Figure 1 and photographs).

2. Shaw Bros. previously (prior to Field Representatives arrival at site) spread lifts of granular fill in the area bound by column lines 1.9/2.1, 2.8, D and H (see Figure 1 and photographs). The area was backfilled up to pavement subgrade level (between approximately El. 17 and El. 20 depending on location) with one or two (depending on location) 12-in. thick (loose measure) lifts. Each lift was compacted using a BOMAG BW172D-2 smooth drum vibratory roller prior to Field Representatives arrival at site (see Field Representative's Activities, Item No. 3).

3. Shaw Bros. previously (prior to Field Representatives arrival at site) installed the portion of perimeter foundation drain south of column line A, between column line 1 and column line 1.9/2.1 (see Figure 1).

4. Shaw Bros. began spreading a lift of granular fill up to pavement subgrade level in the area bound by column lines 1, 1.9/2.1, D and H with a CAT D5C bulldozer (see Figure 1 and photographs). The fill material consisted of granular soil imported to the site from Shaw Bros. Dayton Pit. The material was placed in one, approximate 8 to 10-in. (loose measure) lift up to pavement subgrade level (between approximately El. 19 and El. 26, depending on location).

4. Field Representative spoke with representatives from Shaw Bros. regarding the methodology used during fill placement in the area described under Contractor's Activities, Item No. 2 on Monday and shown on Figure 1. Field Representative confirmed that the granular fill was placed and compacted in approximate 12-in. thick (loose measure) lifts. Field Representative confirmed that each lift of granular fill within 2 to 3 ft of the foundation wall along column line 2.8 was compacted with 4 to 5 passes of a self-propelled vibratory plate compactor. The remaining portion of the fill was compacted with 3 passes of a BOMAG BW172D-2 smooth drum vibratory roller. Field Representative used a Humboldt 5001EZ nuclear density gauge to measure relative compaction of the top 12-in. of previously placed material (approximately El. 18 to El. 20). In-situ density tests indicated the top 12 in. of fill material met the minimum compaction specifications (see Table 1, test nos. 143 to 145 for results and Figure 1 for density test locations).

5. Field Representative spoke with representatives from Shaw Bros. regarding the methodology used to install the portion of the perimeter foundation drain described under Contractor's Activities, Item No. 3 on Monday and shown on Figure 1. Field Representative confirmed that the portion of the underslab drain consisted of a 4-in. diameter perforated HDPE plastic pipe and was installed with the perforations oriented down and laid flat. The pipe was embedded in a minimum of 4-in. of ¾-in. crushed stone (all around) and was completely wrapped in geosynthetic separation fabric (Mirafi 140N). The pipe was installed at the invert elevation shown on the plans (El. 15.5). The perimeter drain was backfilled with granular fill imported to the site from Shaw Bros. Dayton Pit.

6. Field Representative observed placement of granular fill in the area described under Contractor's Activities, Item No. 4 on Monday and shown on Figure 1. Field Representative confirmed that one lift of material was being placed approximately 8 to 10-in. thick (loose measure). Field Representative did not observe compaction of granular fill. In-situ density testing was not considered necessary due to the minimal amount of fill placed.

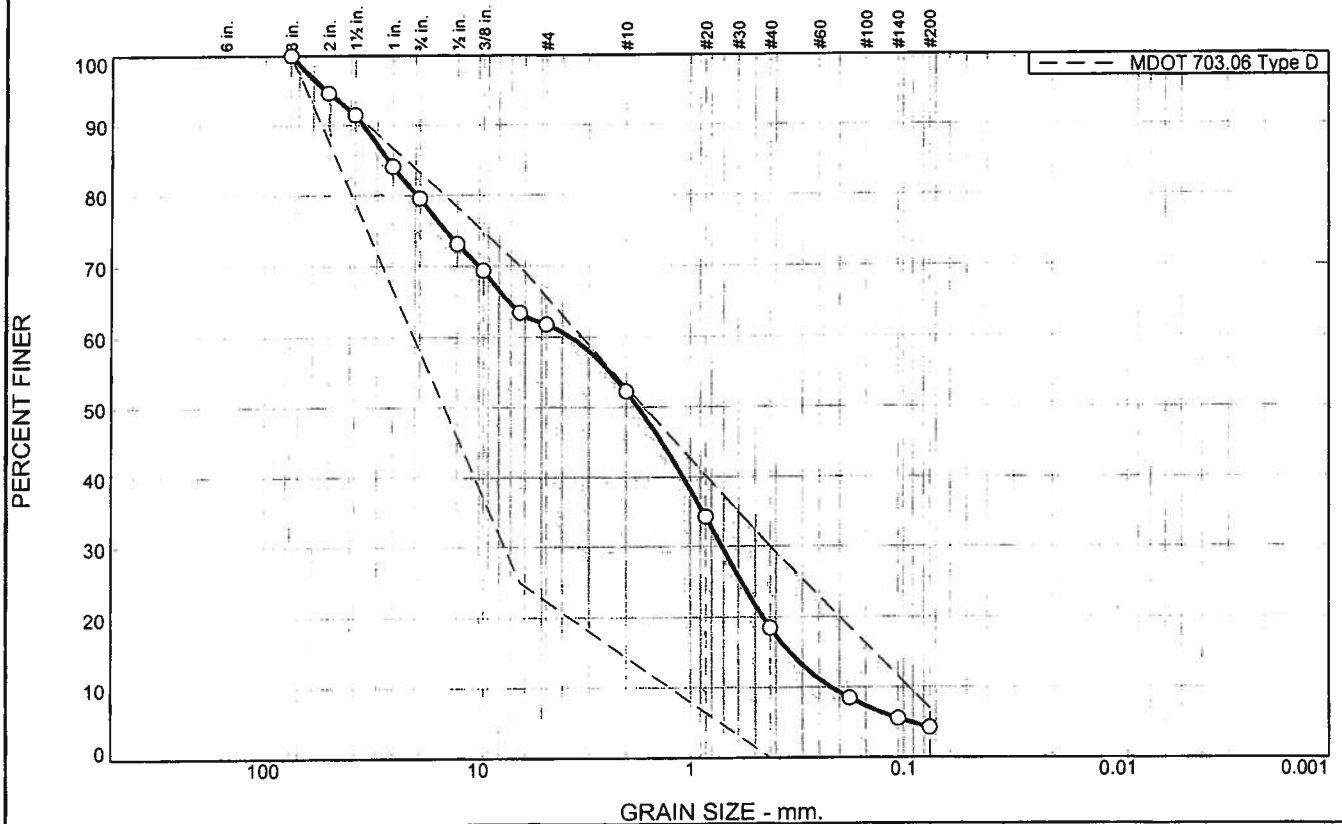
Particle Size Distribution Report

1. Field Representative collected one sample of granular material imported to the site from Shaw Bros. H-Pit for gradation and modified proctor compaction tests. The samples were transported to R.W. Gillespie Associates (RWG) in Saco, Maine for testing. Shaw Bros. proposed to use this material as Type D subbase gravel per the project specifications. Results of the laboratory tests are provided in the attachment. This information will be used to measure in-situ density of compacted lifts of subbase gravel.

Imported Subbase Gravel - poorly graded sand with gravel

USCS= SP AASHTO=

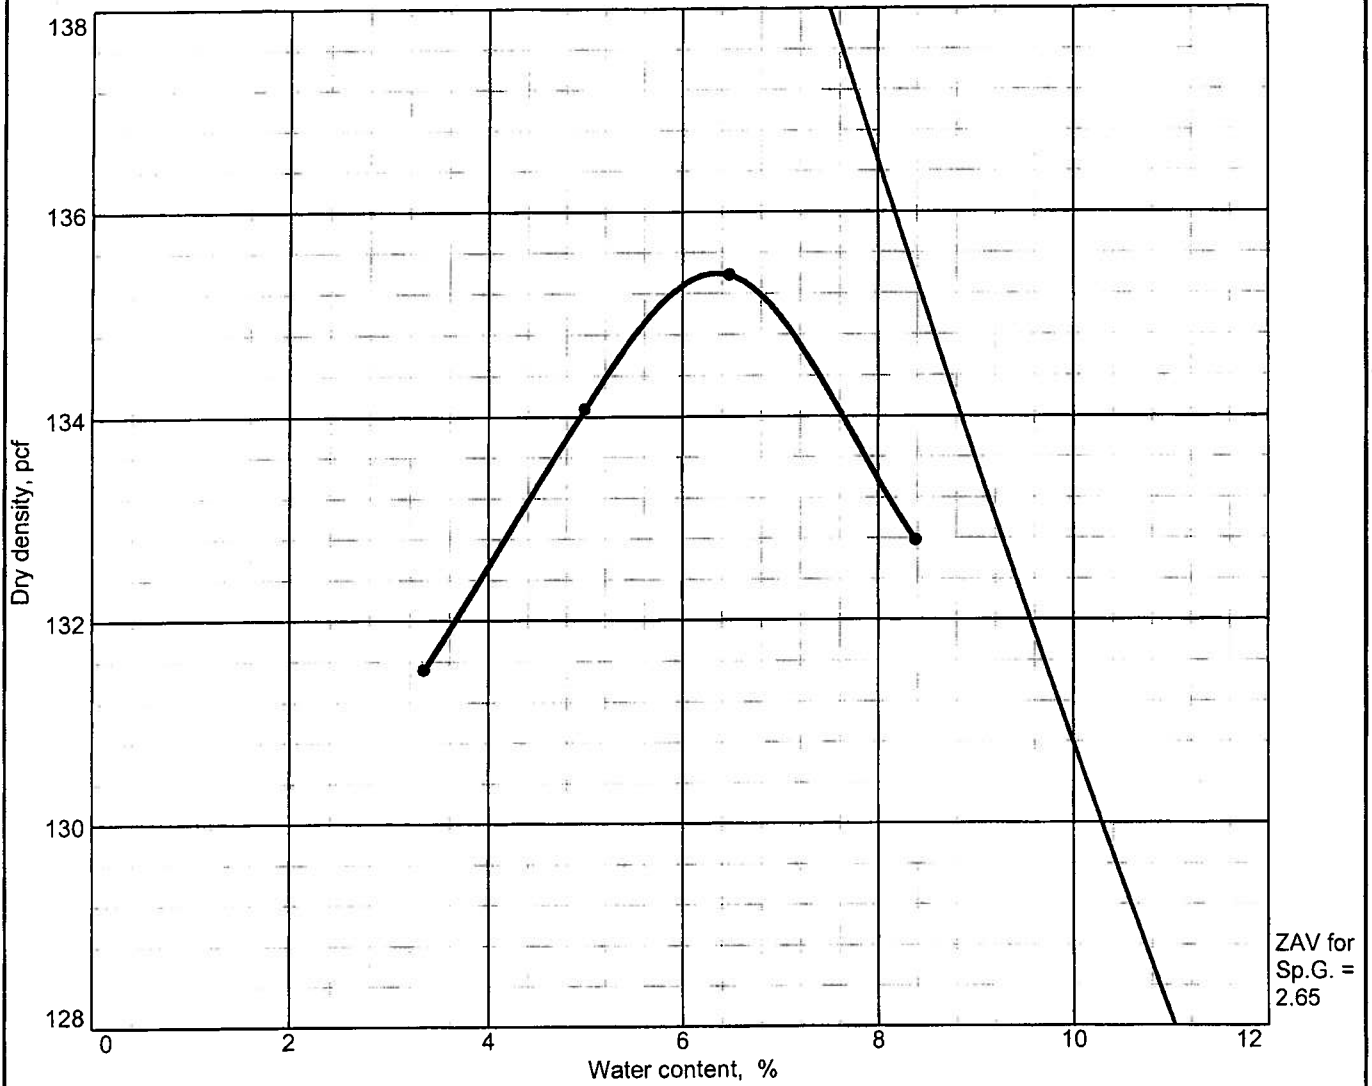
Moisture-Density Test Report

ROCK CORRECTED TEST RESULTS	MATERIAL DESCRIPTION
Maximum dry density = 135.4 pcf Optimum moisture = 6.4 %	Imported Subbase Gravel - poorly graded sand with gravel
Project No. 956-06 Client: Haley & Aldrich, Inc. Project: Ocean Gateway Parking Garage ● Location: Stockpile	Remarks: Teted by: TJB/DCH <div style="text-align: right;"><i>MAG</i></div>
R.W. Gillespie & Associates, Inc. Saco, Maine	
	Lab # 9815

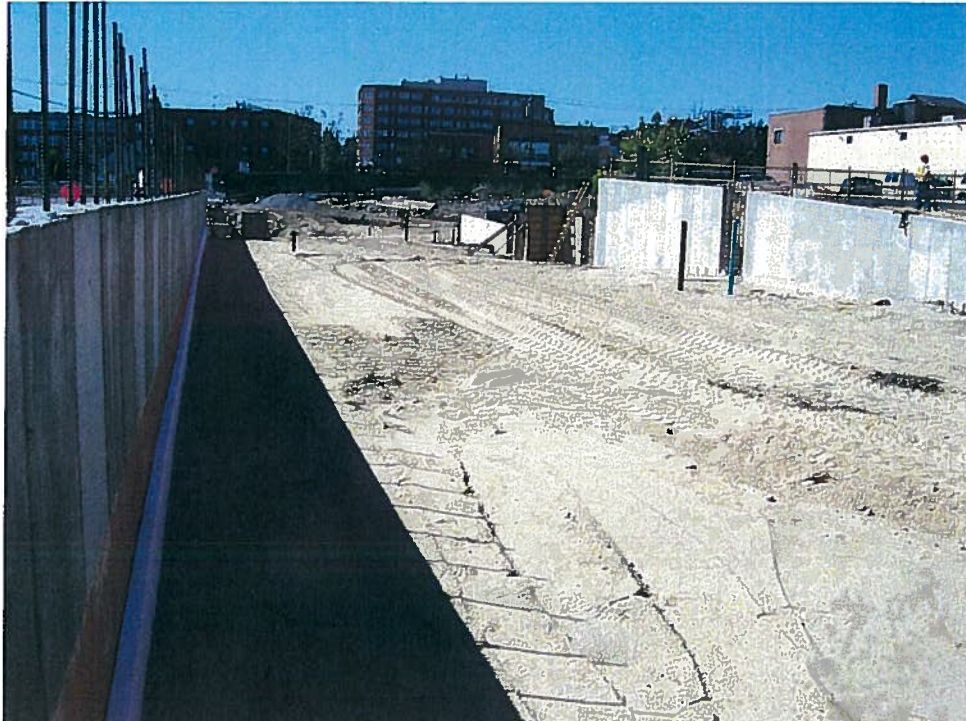
Photograph 1. Granular fill previously placed up to subgrade level between column line 1.9/2.1 and 2.8 with insulation board and waterproofing visible on the above grade wall along column line 2.8, looking south (9/17/07).

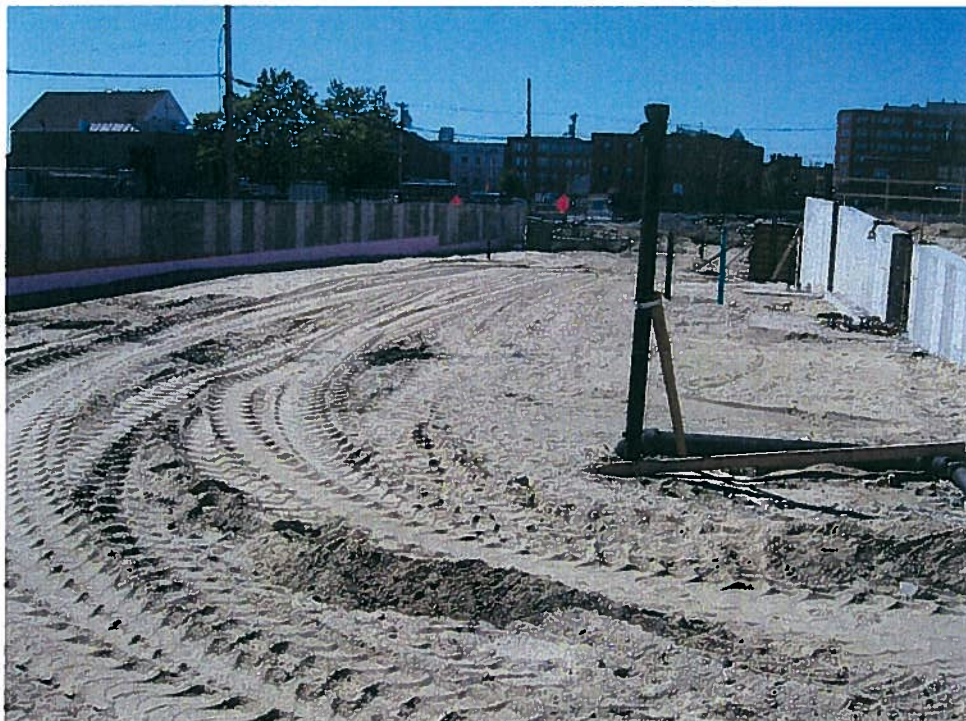
Photograph 2. Granular fill previously placed up to subgrade level between column line 1.9/2.1 and 2.8 with insulation board and waterproofing visible on the above grade wall along column line 2.8, looking south (9/17/07).

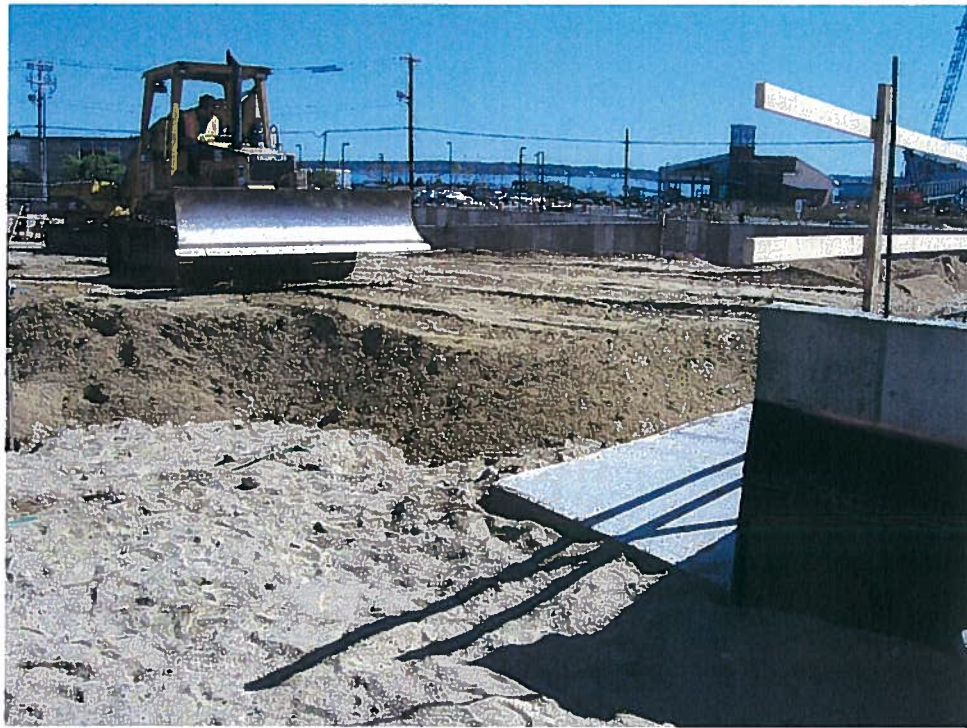
Photograph 3. Spreading a lift of granular fill up to subgrade elevation between column line 1 and column line 1.9/2.1 near column line D with a CAT D5C bulldozer, looking northeast (9/17/07).

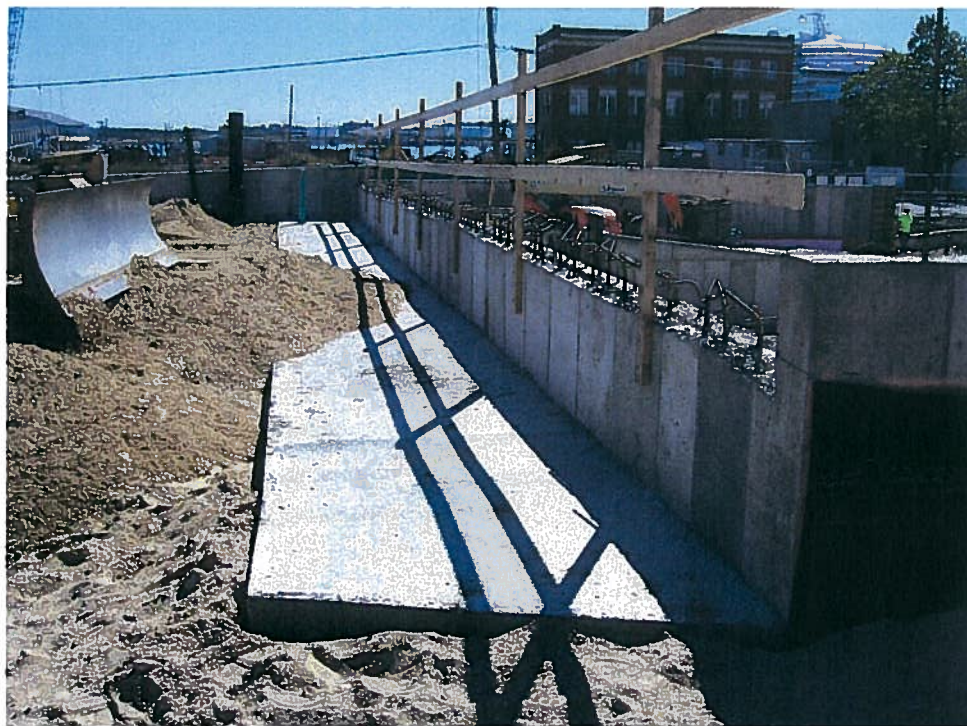
Photograph 4. Spreading a lift of granular fill up to subgrade elevation between column line 1 and column line 1.9/2.1 near column line D with a CAT D5C bulldozer, looking east (9/17/07).
