Re: 48 Hancock Street – Project Number 2015-00033

The Hawk Existing Foundation Wall

48 Hancock Street Portland, Maine

Project Number: 14-135

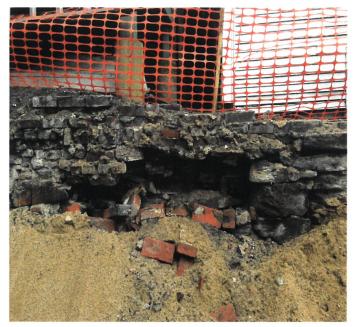
Casco Bay Engineering made a site visit to observe the existing foundation conditions at the property referenced above on May 4, 2016. The existing building has been demolished and only the uphill foundation wall/retaining wall remains. The existing foundation portion where the structure was located is a stone/brick wall that has a significant inward deflection. The condition of the mortar is poor and most stones can be easily removed from the wall by hand with little to no effort.

It is my professional opinion that the structural integrity of the entire uphill foundation and retaining walls are severely compromised and therefore should not be used for any superstructure support.

Picture 1: Crumbling Stone Foundation Wall

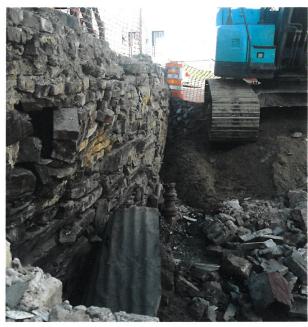
Picture 2: Deflection of Stone Foundation Wall

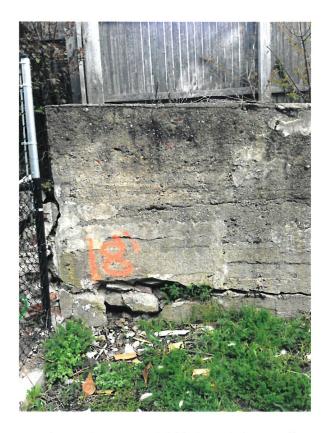
At the rear of the property, the wall transitions to a concrete retaining wall. This wall is also in very poor condition and several large cracks can be seen at various locations along the face. There also exists a significant void at the base of the wall at the rear end where large pieces of concrete are not present. It is more probable than not that no steel rebar exists in the retaining wall.

Picture 3: Large Void in Retaining Wall

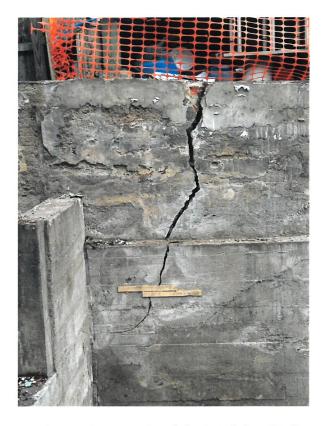
Picture 4: Large Crack in Retaining Wall

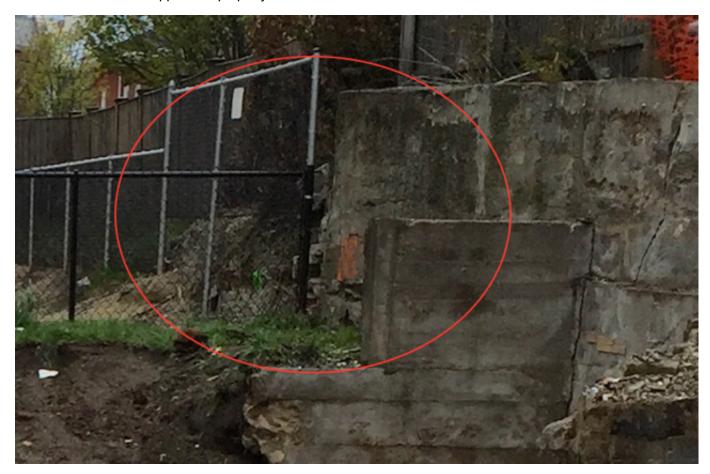
an old existing wall that continues to the south along the Filipos property line and then extends as an old "tabby" wall between the 113 Newbury and the Federal St. properties. (See circled area in accompanying photograph) This wall is in poor shape as pointed out in the letter submitted by Casco Bay Engineering and will likely suffer severe damage if cut to allow the SOE to intersect the rear property wall. Furthermore, once the SOE is removed, what will continue to support the property in this area?

The plans by HB Fleming show an intersection of the SOE wall with an existing retaining wall at the rear of the property. This would require cutting an old existing wall that continues to the south along the Filipos property line and then extends as an old "tabby" wall between the 113 Newbury and the Federal St. properties. (See circled area in accompanying photograph) This wall is in poor shape as pointed out in the letter submitted by Casco Bay Engineering and will likely suffer severe damage if cut to allow the SOE to intersect the rear property wall. Furthermore, once the SOE is removed, what will continue to support the property in this area?

As requested to me by the owners, we will be extending our pile system to address any safety concerns of the existing concrete wall. This wall will be below the 4' required height for permit review.
