DEVELOPMENT REVIEW COORDINATOR
POST APPROVAL PROJECT CHECKLIST

Project Name: Seaport Lofts (Bay House Phase II)

This report presents the results of our independent technical evaluation of excessive retaining wall movements and damage to adjacent properties potentially associated with the construction of the Seaport Lofts development project located on Newbury Street in Portland, Maine. This work was undertaken at your request, in accordance with our proposal dated 13 May 2015, as authorized by Joseph Cahoon, Jr. (attorney with Richardson, Whitman, Large and Badger who was authorized by Travelers to execute the agreement) on 14 May 2015.

Haley & Aldrich, Inc. (Haley Aldrich) was retained in mid-May to conduct an independent technical evaluation to assess the cause(s) of the excessive retaining wall movements and damage to adjacent structures and to determine possible measures to stabilize the site so that construction could continue.

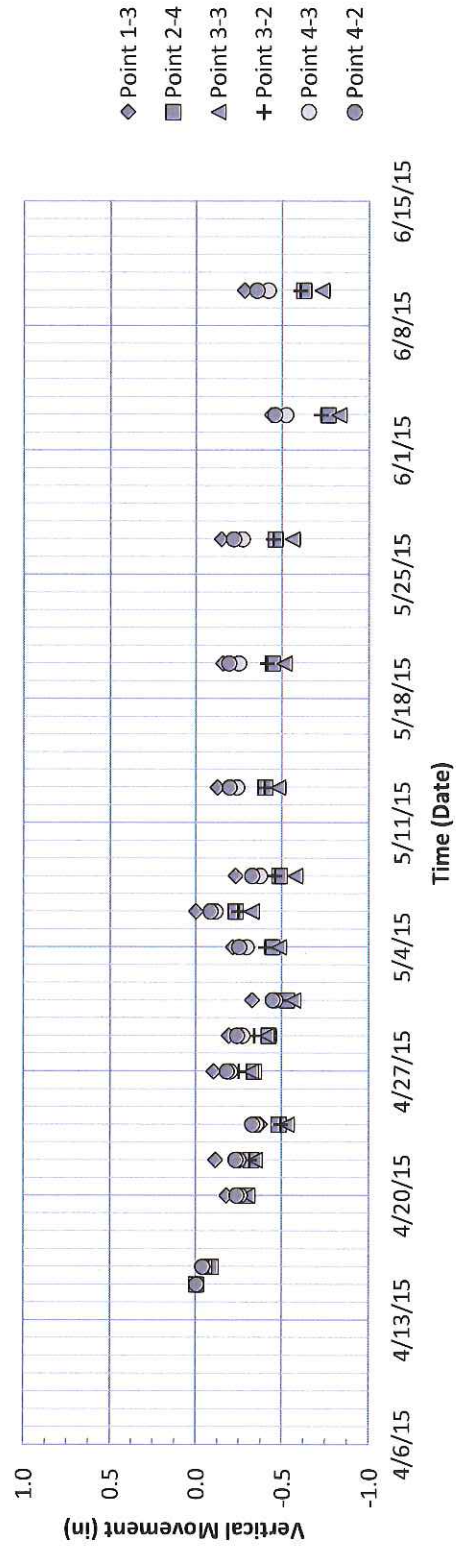
Nails in Top of New Retaining Wall

- Extraction of sheeting on 9 and 10 April (event No. 11) precipitated approximately 2 in. of settlement of the new retaining wall (see Figure 3, Appendix B). Based on discussions with the adjacent property owners, it appears that extraction of the sheeting also precipitated the foundation settlement and cracking of the foundation walls and floor slab at 48 Hancock Street (blue building), settlement of the backyard patio at 36 Federal Street (white house) and the surficial tension crack that was observed at ground surface behind the 38, 40, 42 and 44 Federal Street townhouses. Please note that the owner of 40 Federal Street stated that the tension crack was not present in the back of the townhouses on the morning of 9 April but was present around noontime on 9 April after the start of sheeting extraction had begun.

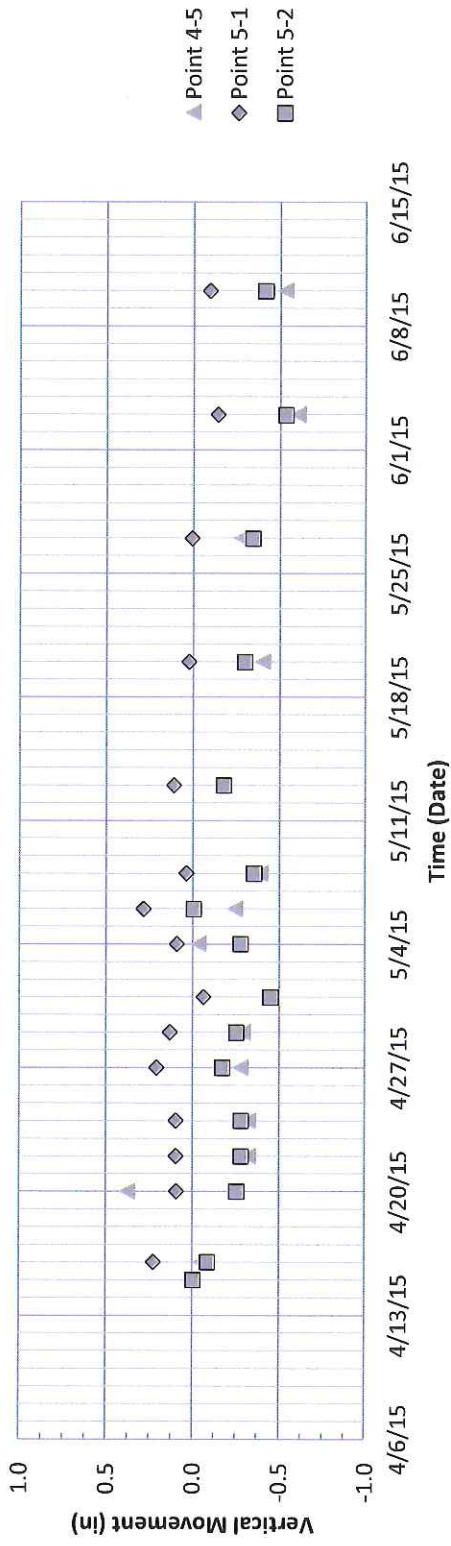
Foundation Movement, 48 Hancock Street (blue house)

- Movement of the 48 Hancock Street building did not result from a global slope instability but was caused by either the settlement of the retaining wall and the movement of the active

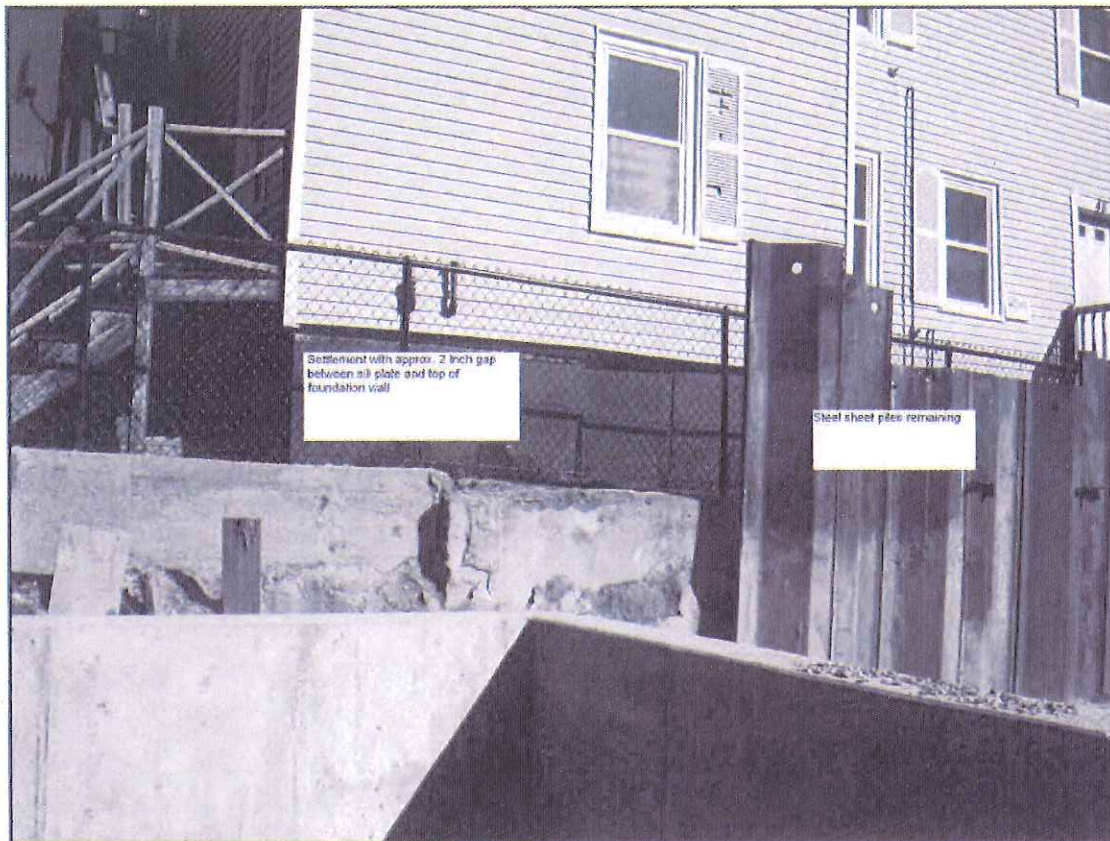
Figure 1

During and following and extraction of steel sheet piles, foundation settlement occurred at the corner of an adjacent structure on Hancock Street. This is depicted on Figure 1.

The foundation settlement is most apparent along the length of sheet pile removal. It is believed that the existing foundation occurs within the influence of the SOE. As such, the SOE design would have to be inherently stiff and the removal of SOE elements may pose risk of disturbance to existing structures.

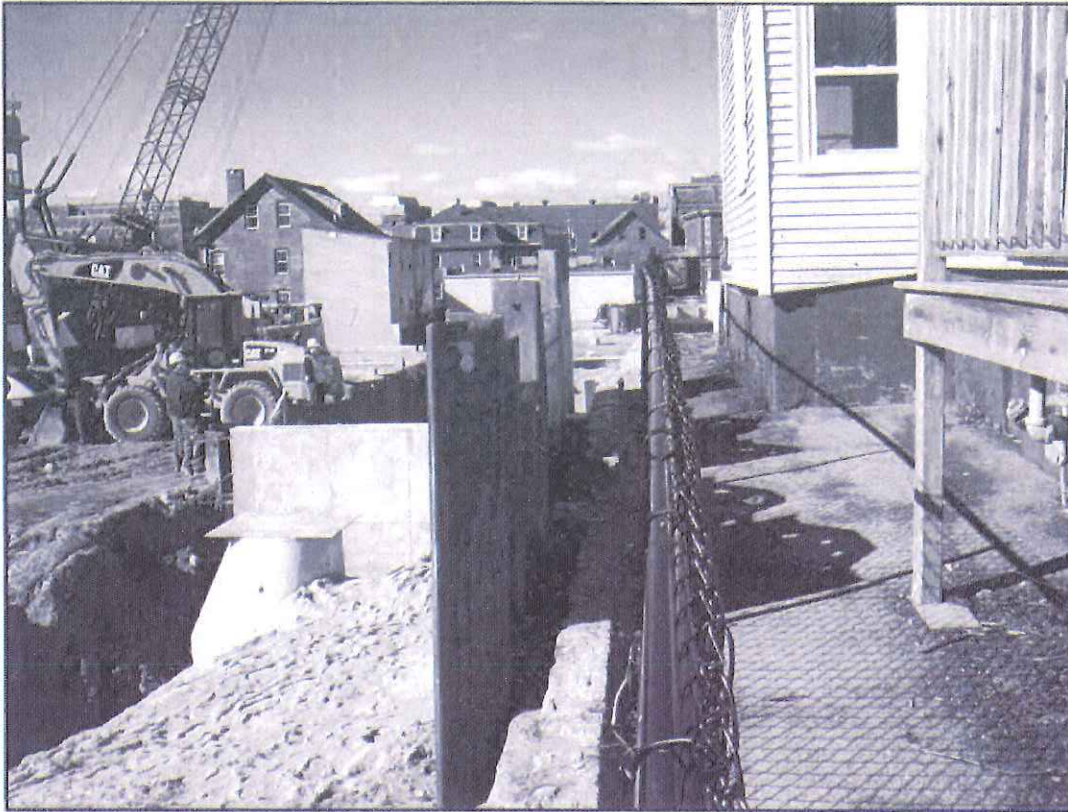
Figure 2 illustrates the proximity of the structure to the SOE system.

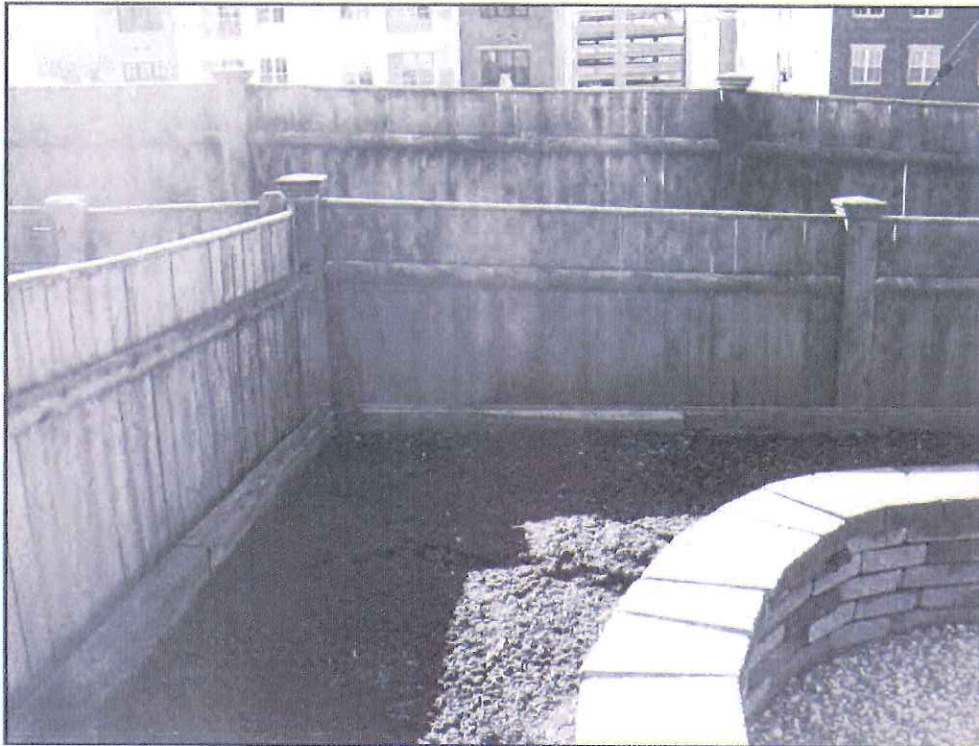
Figure 3

We also viewed ground disturbance at 40 Federal Street with shifting of the ground resulting in displacement of landscape features and patio blocks. This also coincided with the removal of steel sheet piles. A crack has formed in the rear yard which runs parallel to the SOE system and is shown in Figure 3. It is believed that this crack relates to the active state boundary. LF has engaged their surveyor to make elevation readings and prepare a cross-section at this location so that we may further evaluate the geometry and its relation to the SOE. The crack is approximately 10 feet from the residence, and given the depth of its foundation (at least 4 feet below exterior grade), our preliminary evaluation is that the ground movement does not extend to the structure.
