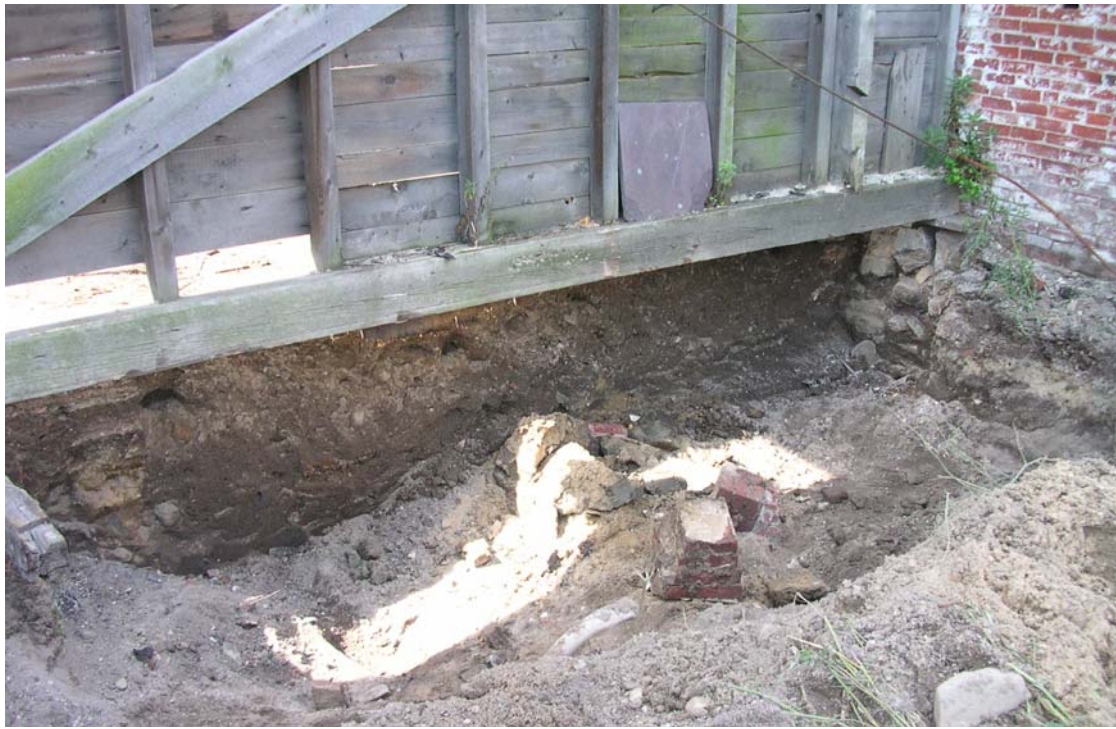
PHOTO
1002.1
1002 004.jpg

Carriage House Rear Wall: Subgrade preparation immediately after removing center pier from below timber girder.

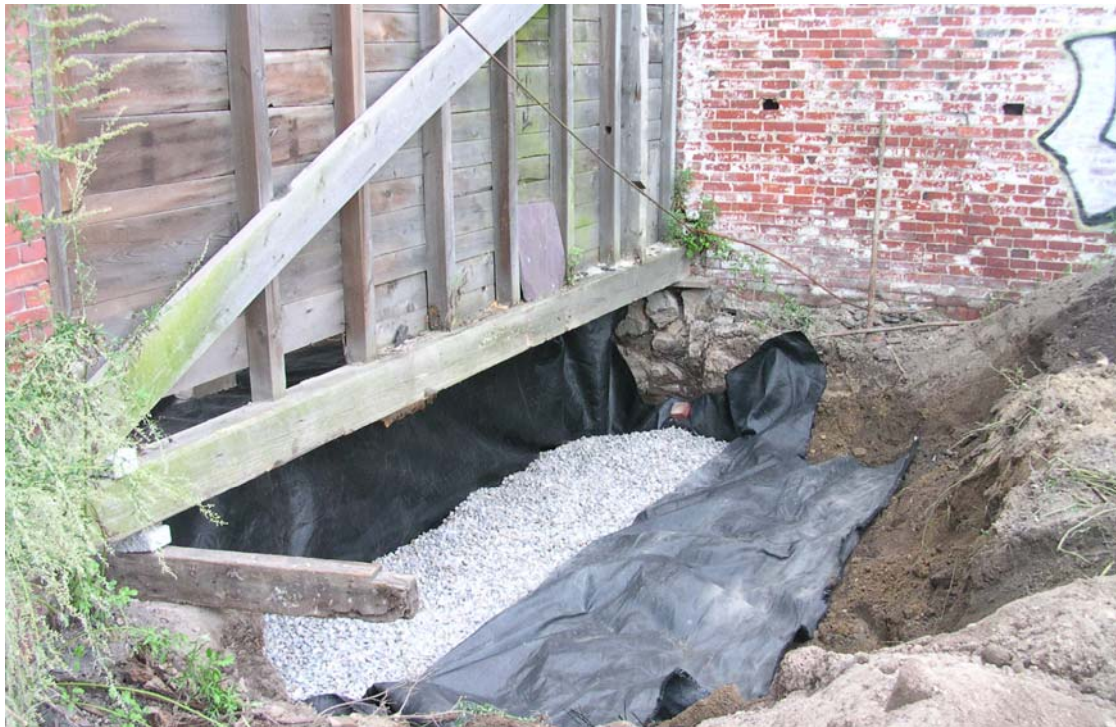
PHOTO
1002.2
1002 010.jpg

Carriage House Rear Wall: Filter fabric and crushed stone in place, prior to crushed stone compaction.

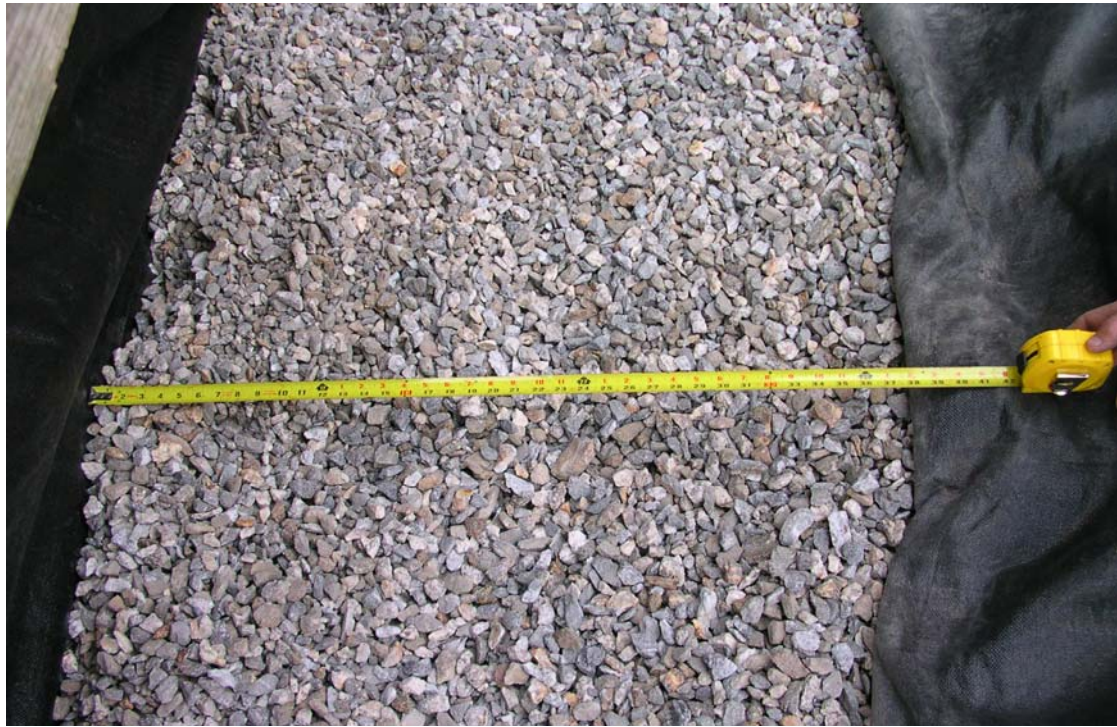
PHOTO
1002.3
1002 005.jpg

Carriage House Rear Wall: Crushed stone bed, prior to compaction and placing concrete.

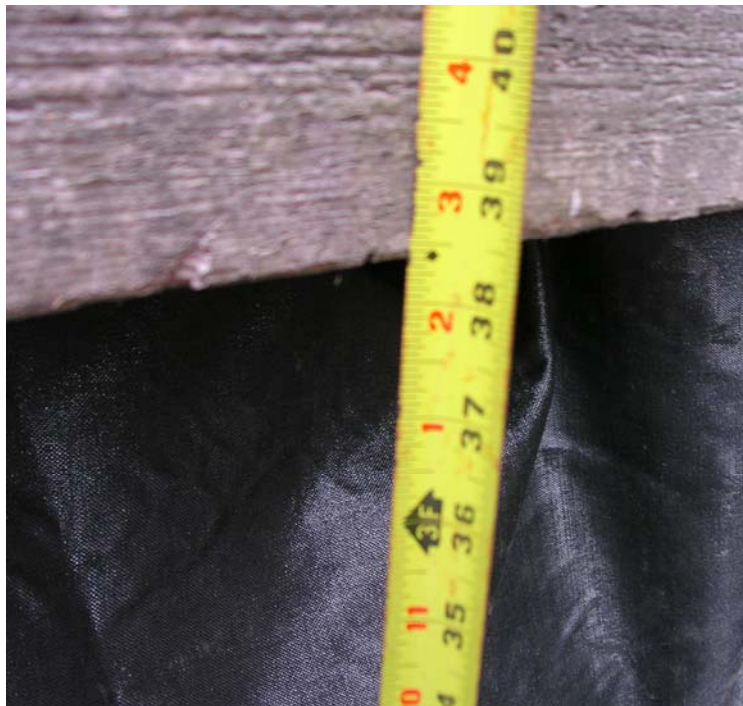
PHOTO
1002.4
1002 008.jpg

Carriage House Rear Wall: Photo showing 38 ½" depth from top of crushed stone to bottom of girder.
