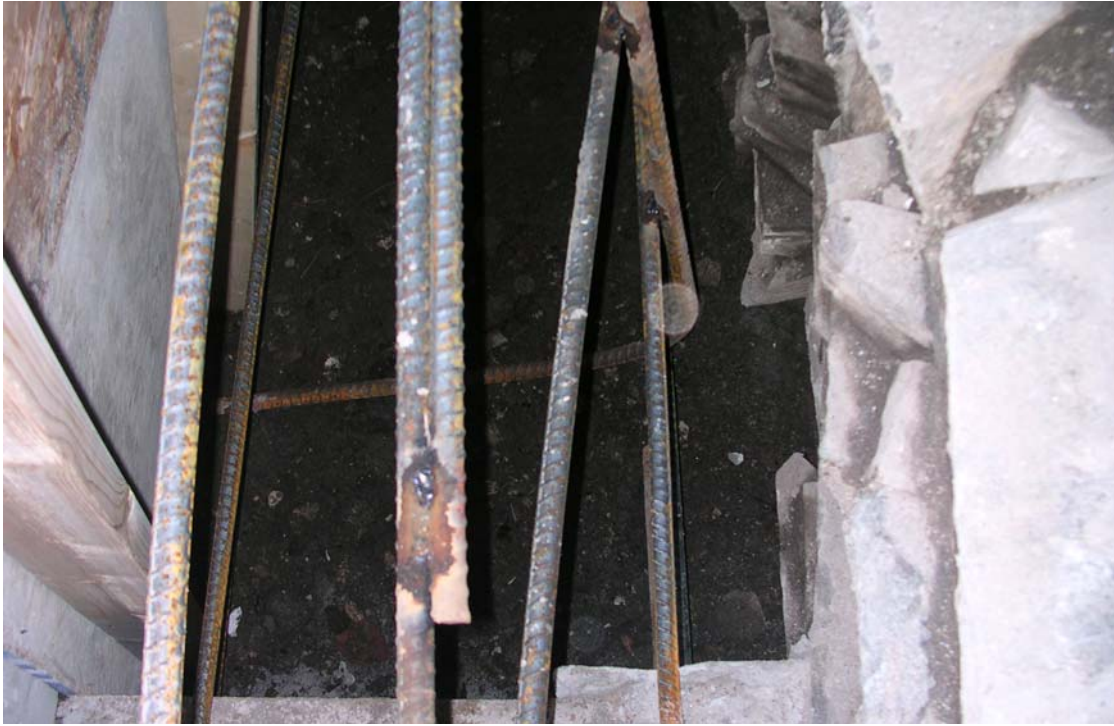
**PHOTO**  
**1031.1**  
1031 001.jpg

East Wall: Formwork and rebar cages in place against cleaned-off, existing rubble wall. Footing is approximately 32" wide at base, and will naturally key into existing rubble wall

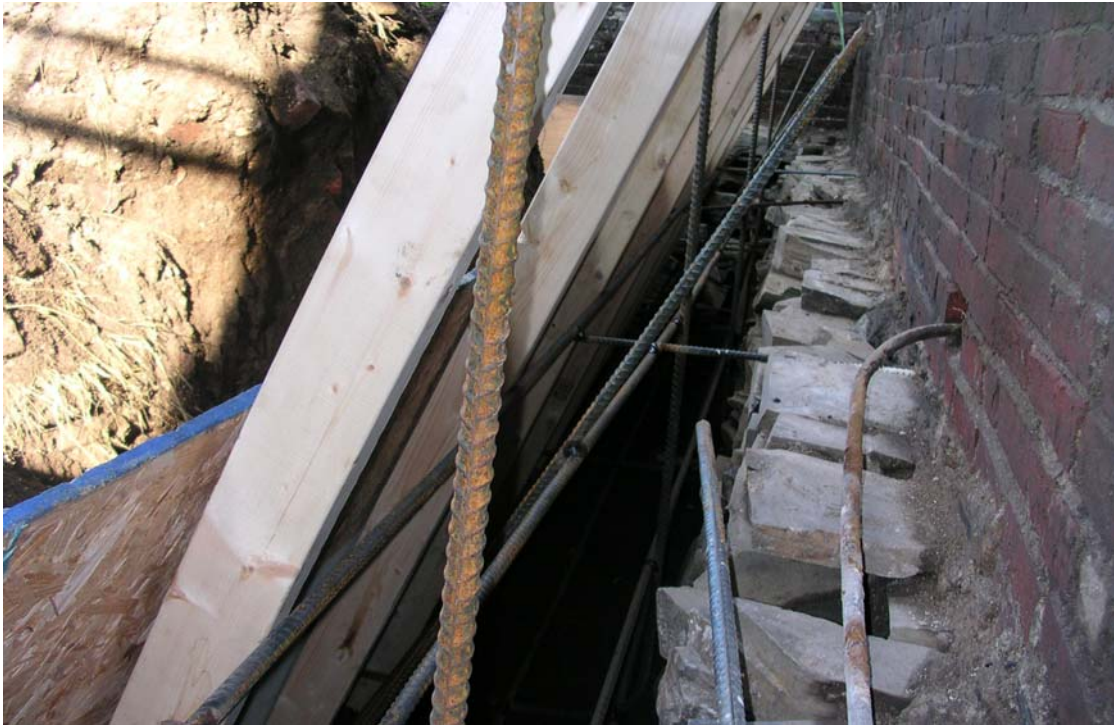
**PHOTO**  
**1031.2**  
1031 003.jpg

East Wall: View down length of wall showing reinforcement. Note that a similar footing was placed inside the garage on the opposite side of this rubble wall, considerably widening the bearing area for the footing.

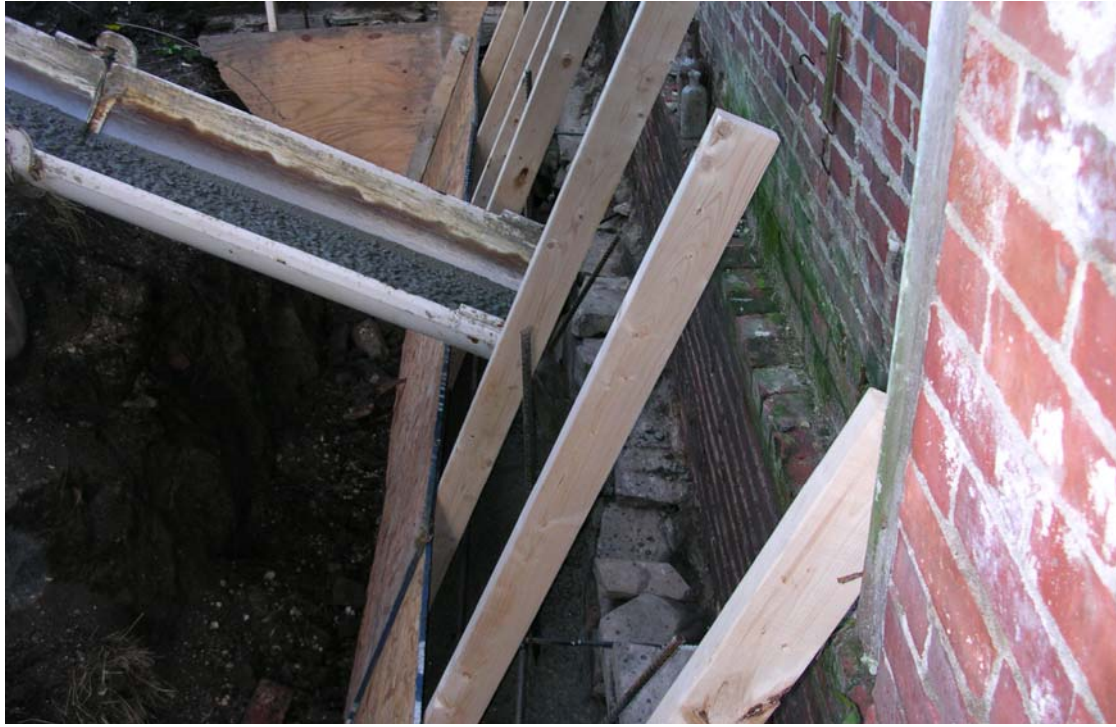
**PHOTO  
1031.3**  
1031 005.jpg

East Wall: Concrete Placement in progress. Note formwork extending around the corner at the top of the photo.

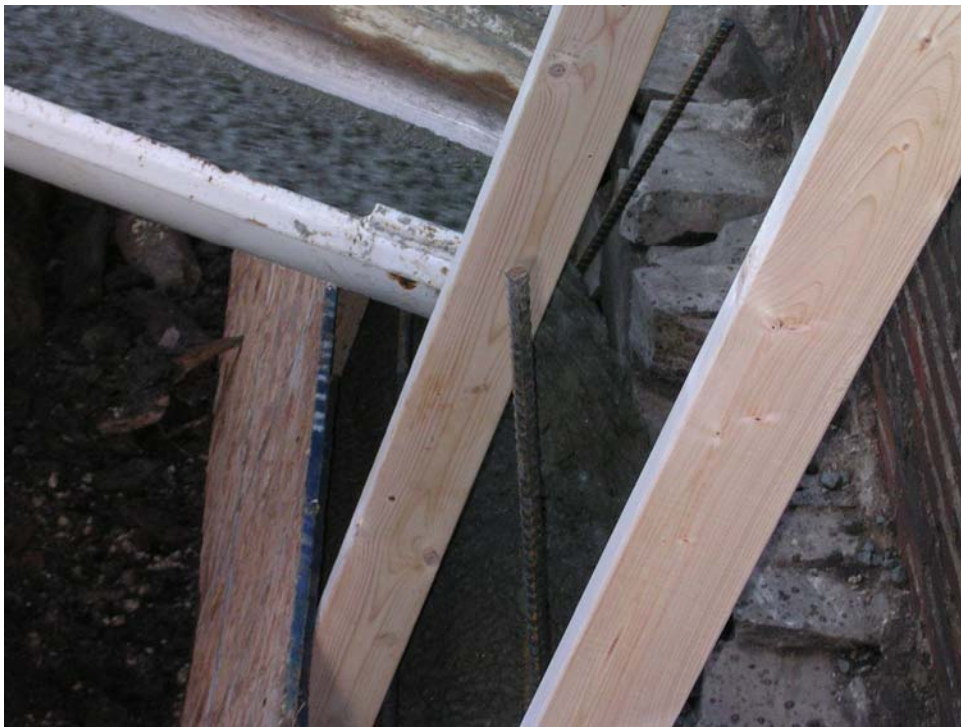
**PHOTO  
1031.4**  
1031 006.jpg

East Wall: Placement nearly complete.
