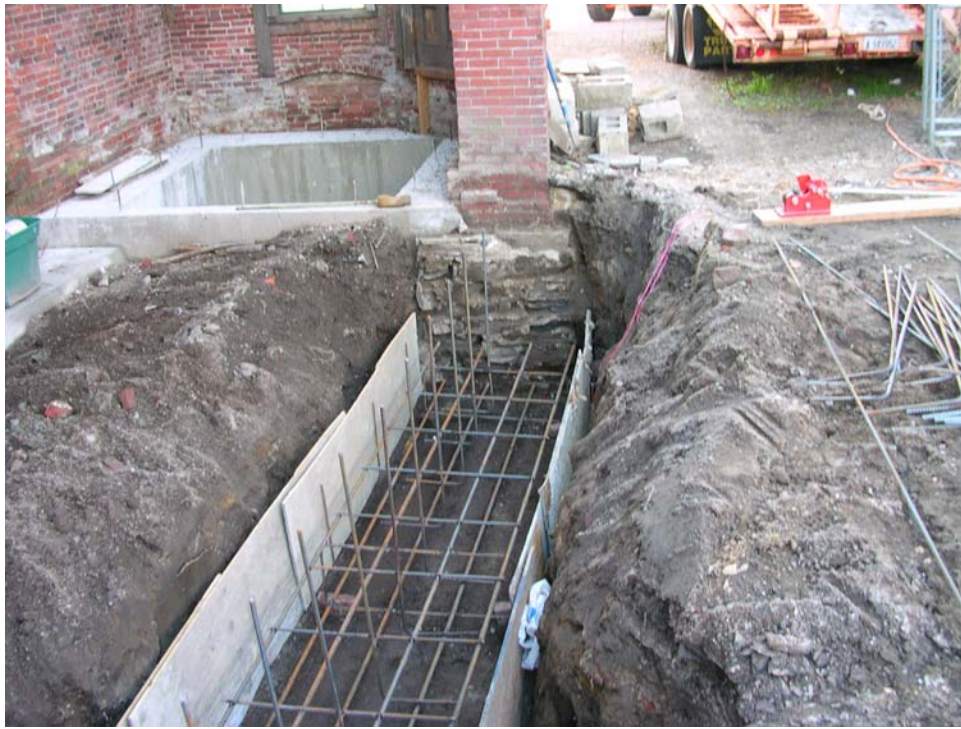
PHOTO
1114.1
1114 001.jpg

Center-East Wall: Formwork and rebar cages in place on compacted fill just over clay subgrade. Note tower in upper left background. Bottom of footing 4'-0 below grade.

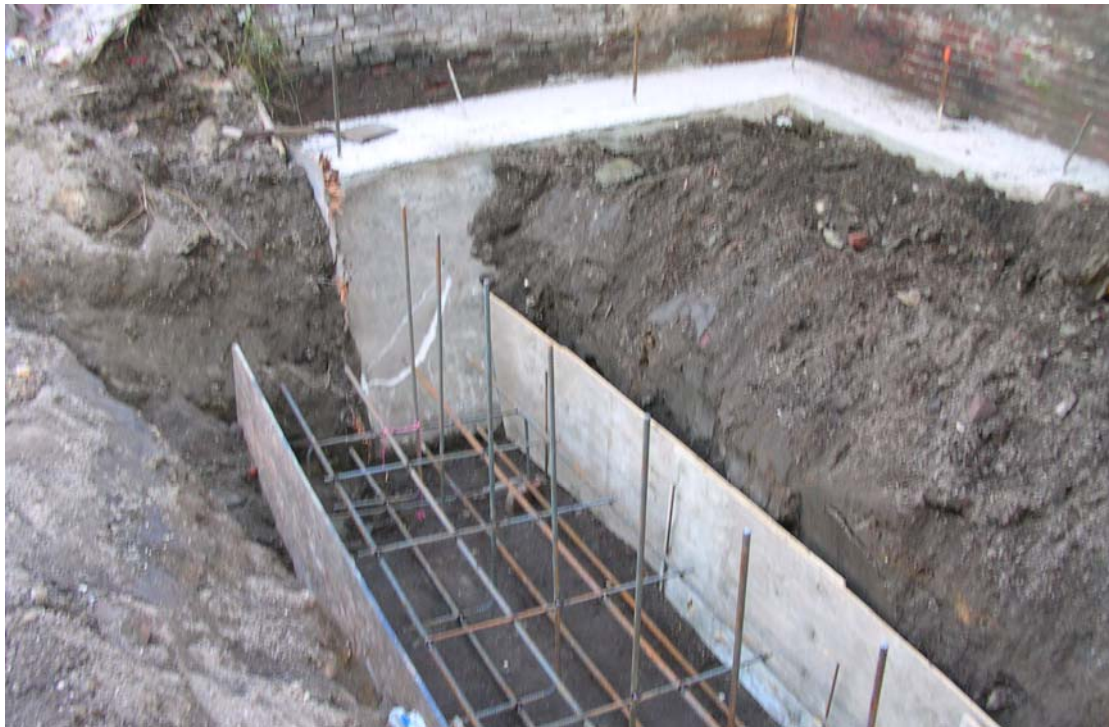
PHOTO
1114.2
1114 002.jpg

Center-East Wall: View looking north showing reinforcement and dowels.
