Project	OCEAN GATEWAY PARKING GARAGE	Report No.	15
Location	PORTLAND, MAINE	Period From	27 August 2007
		To	31 August 2007
Client	RIVERWALK, LLC.	Page	1 of 4
Contractor	LEDGEWOOD CONSTRUCTION (CM) SHAW BROTHERS CONSTRUCTION (EARTHWORK) G. DONALDSON CONSTRUCTION (PILE DRIVING)	File No.	30322-030

WEEKLY FIELD REPORT

FOUNDATION PLAN (SHEET NO. S1.00)
WEEKLY FIELD REPORT NO.: 15

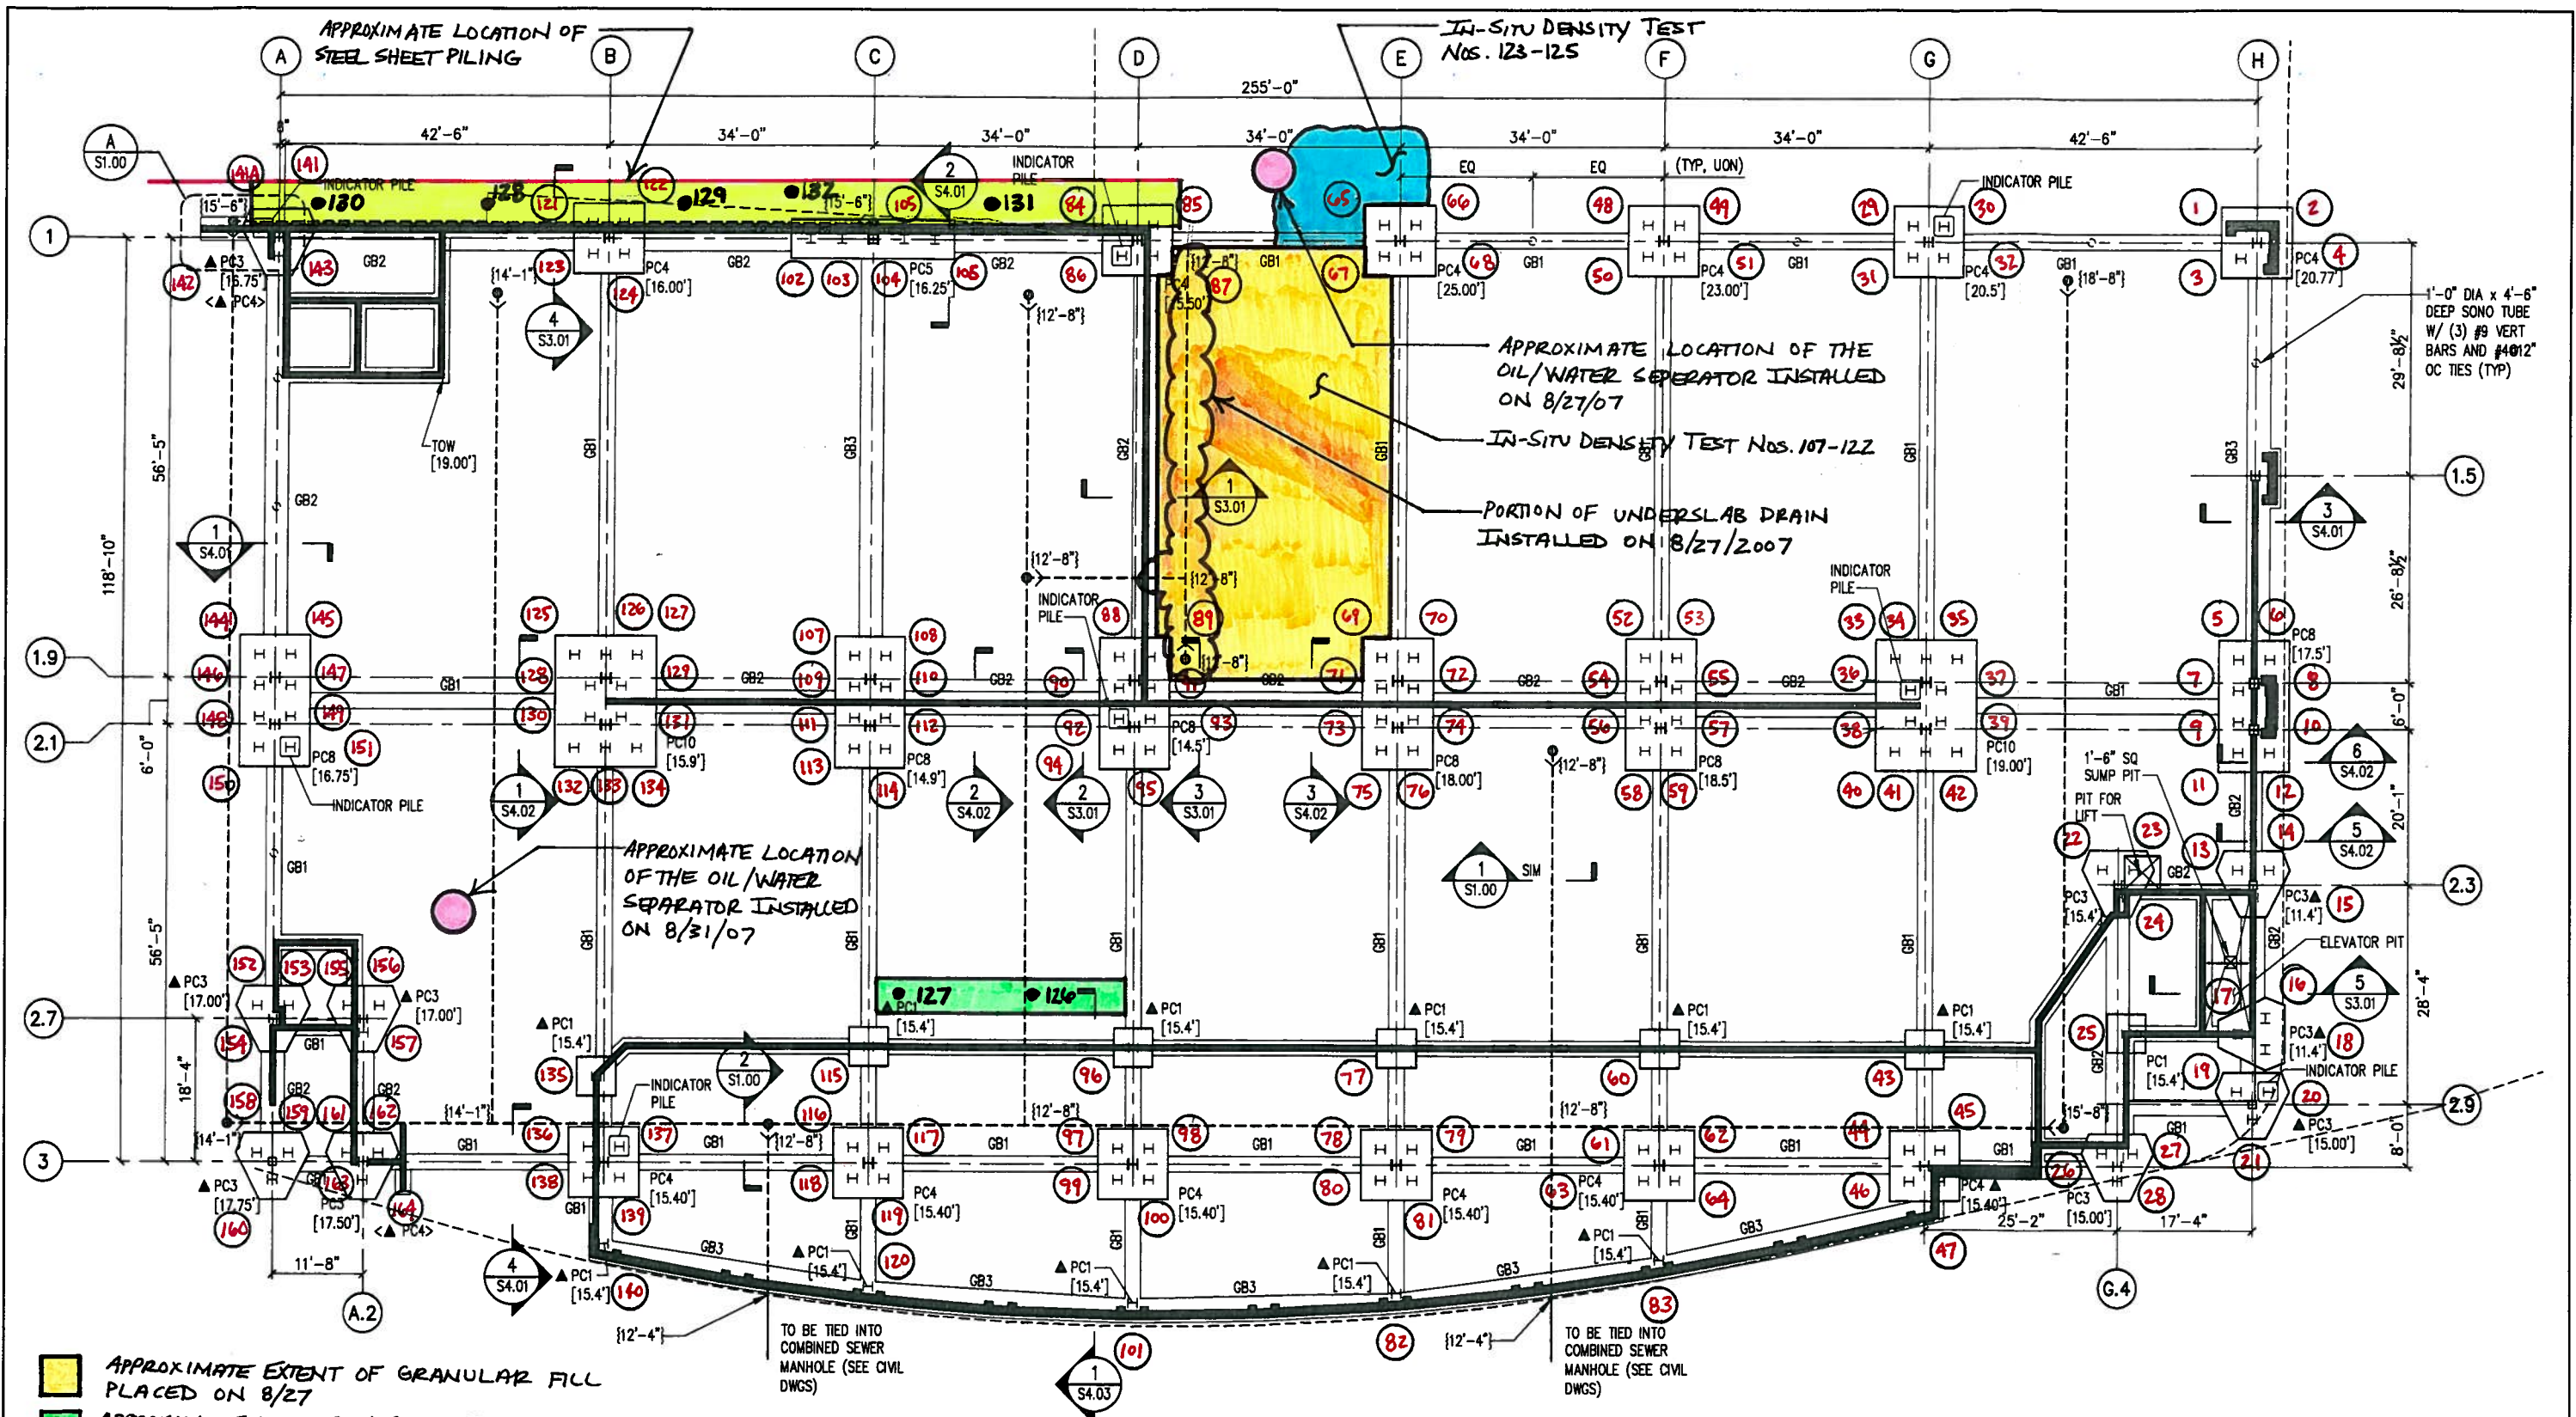
FIGURE 1

1. Shaw Bros. installed the oil/water separator located within the limits of the entrance roadway off of Middle Street, west of column line 1 (see Figure 1). The installation was completed prior to Field Representatives arrival at site.

3. Shaw Bros. installed a portion of the underslab drain north of column line D, between column line 1 and column line 1.9/2.1 (see Figure 1 and photographs). The perimeter drain consisted of a 4-in. diameter perforated HDPE plastic pipe and was installed with the perforations oriented down. The pipe was embedded in 4-in. of ¾-in. crushed stone and was entirely wrapped in geosynthetic separation fabric (Mirafi 140N). The pipe was installed at the invert elevation shown on the plans (El. 12.67). The pipe was backfilled with granular fill imported to the site from Shaw Bros. Dayton Pit.

4. Shaw Bros. began placing granular fill in the area bound by column lines D, E, 1 and 1.9/2 with a CAT 320C excavator and/or hand tools (see Figure 1). The fill consisted of granular soil imported to the site from Shaw Bros. Dayton Pit (see attached for laboratory test results). The material was spread in approximate 12-in. thick (loose measure) lifts. Water was added to the granular fill as necessary to meet the compaction requirements outlined in the project specifications. Each lift of soil was compacted with 4 to 5 passes of a self propelled vibratory plate compactor or 3 to 4 passes of a BOMAG BW172D-2 smooth drum vibratory roller. Fill was placed from approximately El. 13 to El. 21.5 in this area.

1. Shaw Bros. backfilled a section of plumbing utility trench running from north to south between column lines 1.9/2.1 and 3 (see Figure 1). An approximate 6-in. thick (loose measure) lift of screened sand was placed directly over the top of the pipe and was compacted with one pass of a self-propelled vibratory plate compactor. One approximate 12-in. thick (loose measure) lift of granular fill imported to the site from Shaw Bros. Dayton Pit was placed above the screened sand (see attached for laboratory test results). Water was added to the granular fill as necessary to meet the compaction requirements outlined in the project specifications. The granular fill was compacted with 4 to 5 passes of a self-propelled vibratory plate compactor. Fill was placed to approximately El. 16.5 in this area.

2. Shaw Bros. placed granular fill in the area immediately west of the pile cap located at column E-1, within the limits of the entrance roadway off of Middle Street (see Figure 1). The fill consisted of granular soil imported to the site from Shaw Bros. Dayton Pit (see attached for laboratory test results). The material was spread in approximate 12-in. thick (loose measure) lifts. Each lift of soil was compacted with 3 to 4 passes of a BOMAG BW172D-2 smooth drum vibratory roller. Fill was placed from approximately El. 21.0 to El. 24.0 in this area.

2. Shaw Bros. began backfilling west of column line 1 between the foundation wall and the steel sheet piles installed for the support of excavation system (see Figure 1). The fill consisted of granular soil imported to the site from Shaw Bros. Dayton Pit (see attached for laboratory test results). The material was spread in approximate 12-in. thick (loose measure) lifts up to approximately 1.5 ft below the continuous steel waler (El. 20) installed for the support of excavation system. Water was added to the granular fill as necessary to meet the compaction requirements outlined in the project specifications. Each lift of soil was compacted with 4 to 5 passes of a self propelled vibratory plate compactor.

1. Shaw Bros. began installing the oil/water separator between column lines A, B, 1.9/2.1 and 3 (see Figure 1 and photographs). The area was previously excavated down to El. 4.5 (approximate) with a CAT 320C excavator. The excavated material consisted of naturally deposited marine clay, which was loaded into dump trucks and hauled off site. An approximate 1 ft thick lift of 1½-in. crushed stone was placed on the subgrade up to the proposed bottom of structure elevation.

1. Field Representative observed and inspected the installation of the section of underslab drain described under Item No. 3, above, and shown on Figure 1. Field Representative judged that this section of the perimeter foundation drain was installed as shown on the construction drawings.
2. Field Representative observed placement of compacted granular fill in the area described under Contractors Activities, Item No. 4 on Monday and shown on Figure 1. Fill material consisted of imported granular soil from Shaw Bros. Dayton Pit. Field Representative used a Humboldt 5001EZ nuclear density gauge to monitor relative compaction during fill placement. The granular fill appeared stable under the compactive effort of a self propelled vibratory plate compactor or a BOMAG BW172D-2 smooth drum vibratory roller. In-situ density tests

indicated the fill material met the minimum compaction specifications (see Table 1, test nos. 107 to 122 for results and Figure 1 for density test locations).

1. Field Representative observed placement of compacted granular fill in the areas described under Contractors Activities, Item Nos. 1 and 2 on Tuesday and shown on Figure 1. Fill material consisted of imported granular soil from Shaw Bros. Dayton Pit. Field Representative used a Humboldt 5001EZ nuclear density gauge to monitor relative compaction during fill placement. The granular fill appeared stable under the compactive effort of a self propelled vibratory plate compactor or a BOMAG BW172D-2 smooth drum vibratory roller. In-situ density tests indicated the fill material met the minimum compaction specifications (see Table 1, test nos. 123 to 127 for results and Figure 1 for density test locations).

1. Field Representative observed placement of compacted granular fill in the area described under Contractors Activities, Item No. 2 on Thursday and shown on Figure 1. Fill material consisted of imported granular soil from Shaw Bros. Dayton Pit. Field Representative used a Humboldt 5001EZ nuclear density gauge to monitor relative compaction during fill placement. The granular fill appeared stable under the compactive effort of a self propelled vibratory plate compactor or a BOMAG BW172D-2 smooth drum vibratory roller. In-situ density tests indicated the fill material met the minimum compaction specifications (see Table 1, test nos. 128 to 132 for results and Figure 1 for density test locations).

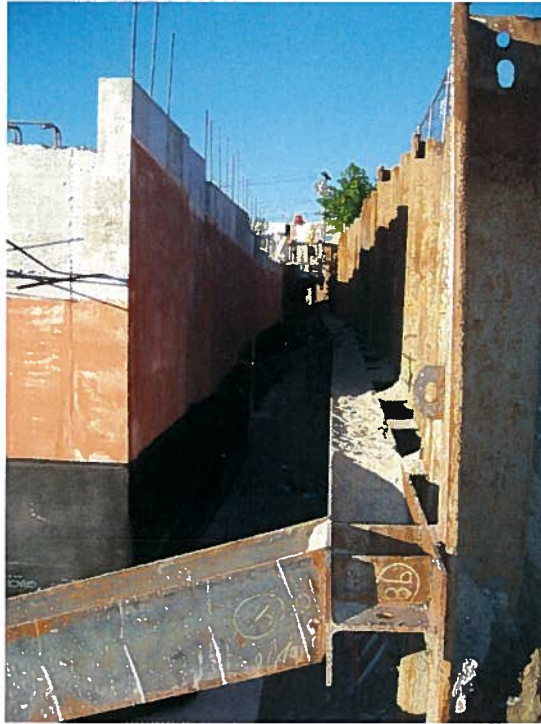
2. Shaw Bros. previously installed waterproofing (Procor® 75 Spray Grade) and drainage board (Grace Hydroduct® 220) on the exterior side of the foundation wall along column line 1 from column line A to column line D and on the interior side of the foundation wall along column line D from column line 1 to column 1.9/2.1 up to approximately El. 19-20 (see photographs).

Photograph 1. Dampproofing and drainage board installed on the exterior side of the foundation wall along column line 1, from column line A to column line D, looking south (8/27/07).

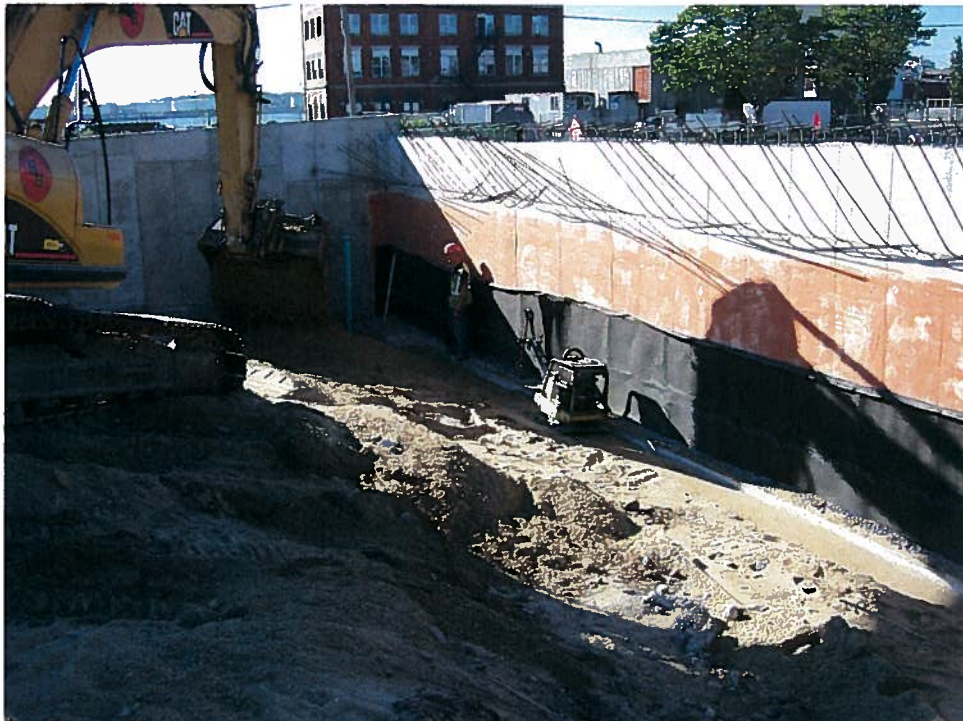
Photograph 2. Dampproofing and drainage board installed on the interior side of the foundation wall along column line D from column line 1 to column line 1.9/2.1, looking southeast (8/27/07).

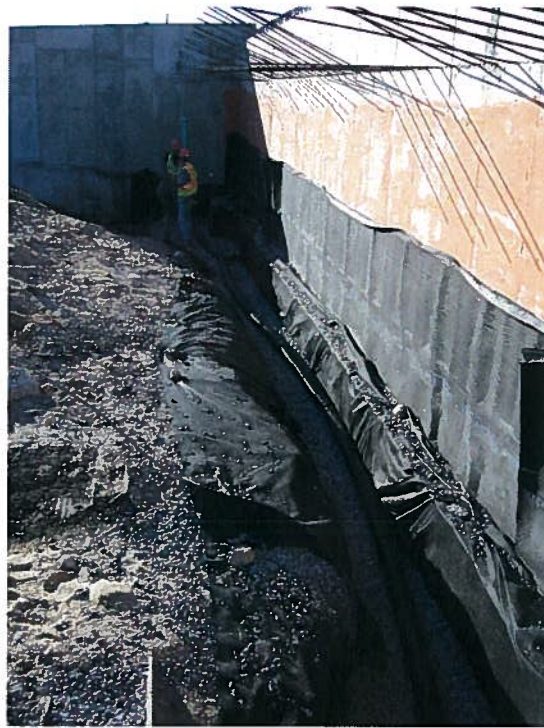
Photograph 3. Installation of underslab drain north of column line D, looking east (8/27/07).

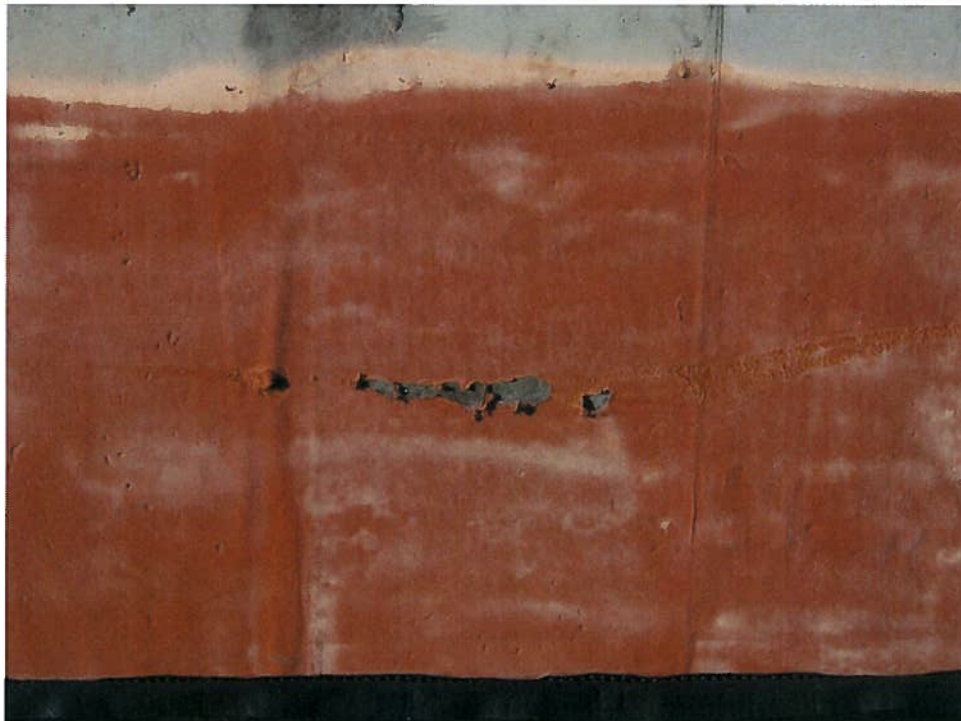
5. Shaw Bros. damaged a portion of the waterproofing along column line D while spreading/compacting granular fill (see Photographs). The waterproofing will require repair prior to placement of the drainage board and backfill.

Photograph 4. Damaged waterproofing along column line D, looking south (7/28/07).

1. Shaw Bros. repaired the portion of damaged waterproofing described under Contractors Activities, Item No. 5 on Monday and installed drainage board (Grace Hydroduct® 220) over this area prior to Field Representatives arrival at site.

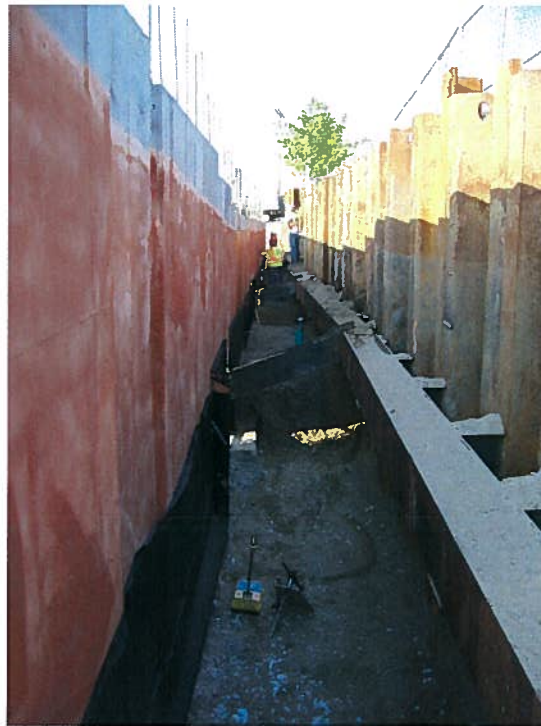
Photograph 5. Backfilling along column line 1 between the foundation wall and the steel sheet pile support of excavation system, looking south (8/30/07).

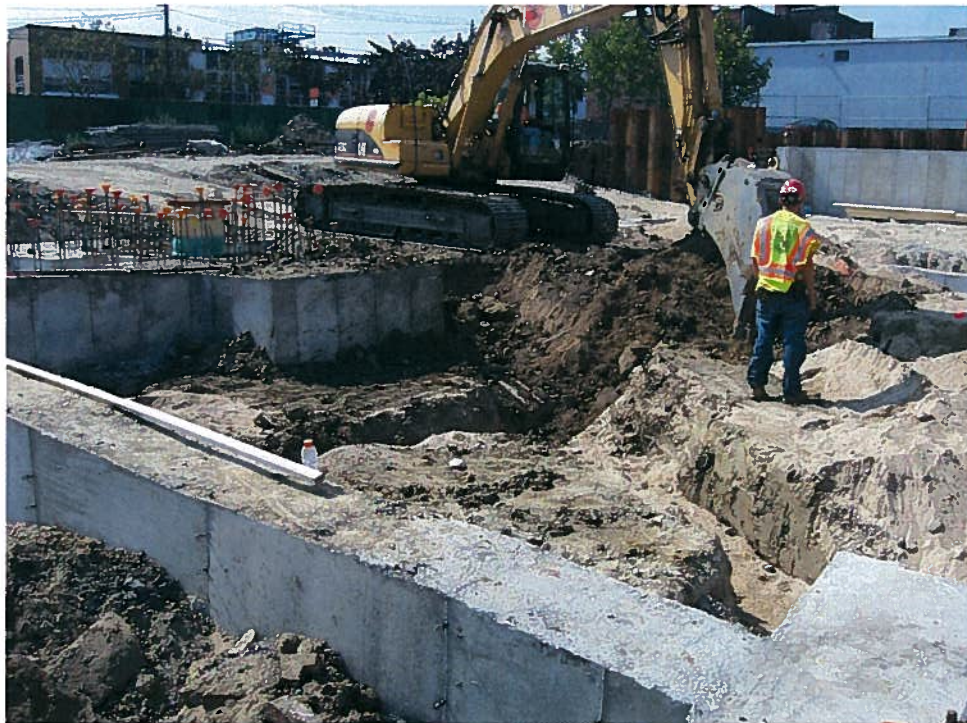
Photograph 6. Excavation for the oil/water separator in the southeast building corner, looking southwest (8/30/07).
