WEEKLY FIELD REPORT

Project Location OCEAN GATEWAY PARKING GARAGE

PORTLAND, MAINE

17

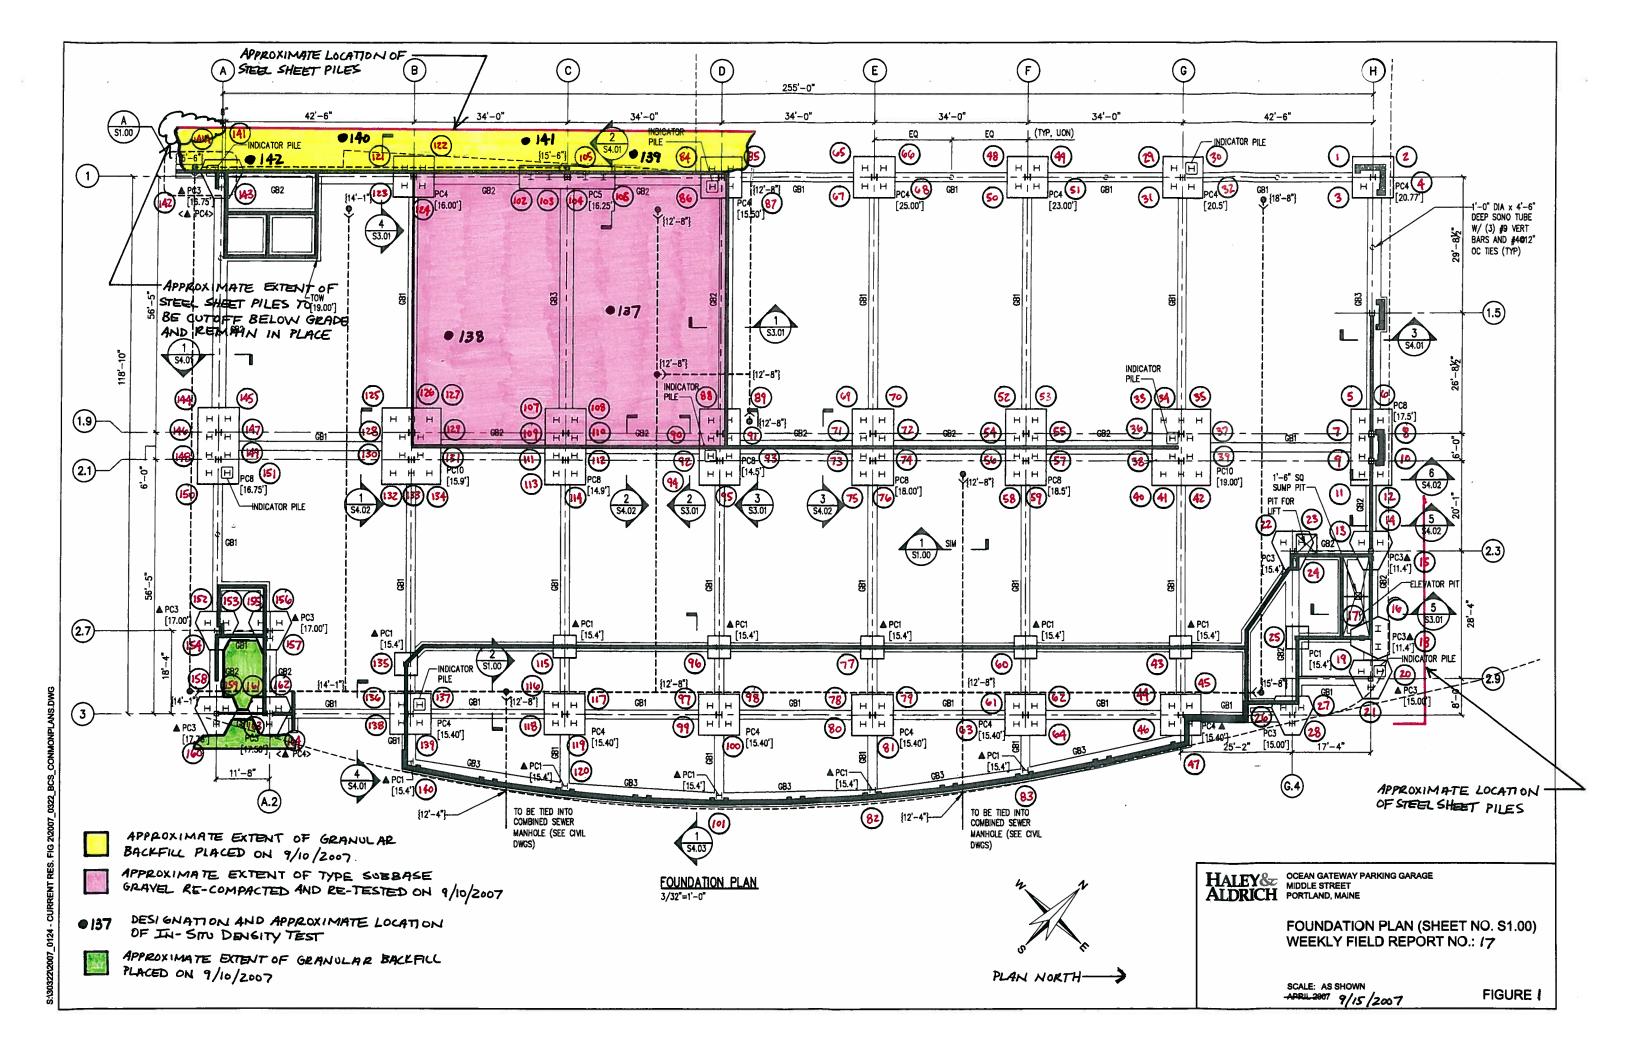
- Foundation Plan (Figure 1) 1.
- Weekly Summary of Field Unit Weight Test (1 page) 2.
- 3. Photograph Summary (2 pages)

- Shaw Bros. re-compacted Type D subbase gravel in the area bound by column lines B, D, 1 and 1.9/2.1 (see 1. Figure 1). The material was re-compacted with 3 passes of a BOMAG BW 172D-2 smooth drum vibratory roller. The area required re-compaction due to low moisture content during original compaction on Friday (9/7).

- 2. Shaw Bros. placed granular fill adjacent to pile caps/grade beams in the southeast corner of the garage with a CAT 320C excavator and/or hand tools (see Figure 1). The fill consisted of granular soil imported to the site from Shaw Bros. Dayton Pit. The material was spread in approximate 12-in. thick (loose measure) lifts. Each lift of soil was compacted with 5 to 6 passes of a self propelled vibratory plate compactor. Fill was placed from approximately El. 14 to El. 17 in this area.

- 1. Field Representative observed re-compaction of Type D subbase gravel in the area described under Contractors Activities, Item No. 1 on Monday and shown on Figure 1. Fill material consisted of imported granular soil from Shaw Bros. H-Pit. The subbase gravel appeared stable under the compactive effort of a BOMAG BW172D-2 smooth drum vibratory roller. Field Representative used a Humboldt 5001EZ nuclear density gauge to monitor relative compaction after the lift of material was re-compacted. In-situ density tests indicated the subbase material met the minimum compaction requirements outlined in the project specifications (see Table 1, test nos. 137 and 138 for results and Figure 1 for in-situ density test locations).

- 2. Field Representative observed placement of granular fill in the area described under Contractors Activities, Item No. 4 on Monday and shown on Figure 1. Fill material consisted of imported granular soil from Shaw Bros. Dayton Pit. The granular fill appeared stable under the compactive effort of a self-propelled vibratory plate compactor. Field Representative used a Humboldt 5001EZ nuclear density gauge to monitor relative compaction

after each lift of material was compacted. In-situ density tests indicated the material met the minimum compaction requirements outlined in the project specifications (see Table 1, test nos. 139-142 for results and Figure 1 for in-situ density test locations).

- 5. Field Representative spoke with Mr. Plourde regarding the schedule for completion of the support of excavation removal. Mr. Plourde indicated that G. Donaldson would complete the support of excavation removal by Wednesday (9/12). Mr. Plourde also indicated that a portion of the steel sheet piles south of the pile cap located at column A-1 would be cutoff below grade and remain in place (see Figure 1).

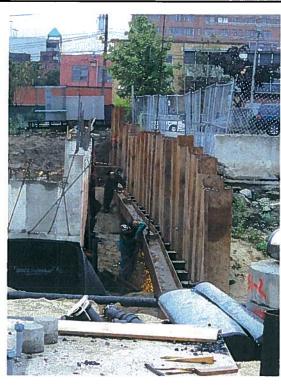
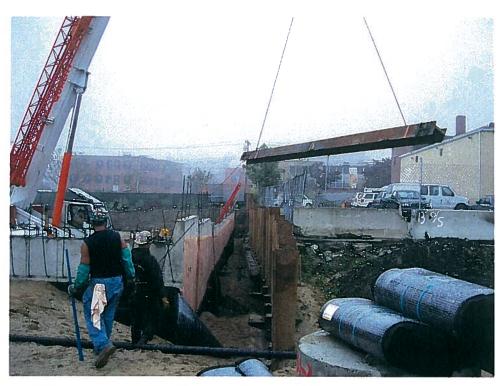
- G. Donaldson removed the continuous steel waler from the support of excavation system west of column line 1 3. (see Figure 1 and photographs).
- Shaw Bros. continued backfilling west of column line 1 between the foundation wall and the steel sheet piles 4. installed for the support of excavation system (see Figure 1). The fill consisted of granular soil imported to the site from Shaw Bros. Dayton Pit. The material was spread in approximate 12-in. thick (loose measure) lifts from approximately El. 18 to El. 20. Each lift of soil was compacted with 4 to 5 passes of a self propelled vibratory plate compactor.

Photograph 1. Removal of the continuous steel waler for the support of excavation system west of column line 1, looking south (9/10/07).

Photograph 2. Removal of the continuous steel waler for the support of excavation system west of column line 1, looking south (9/10/07).

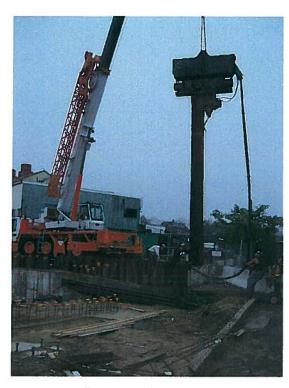
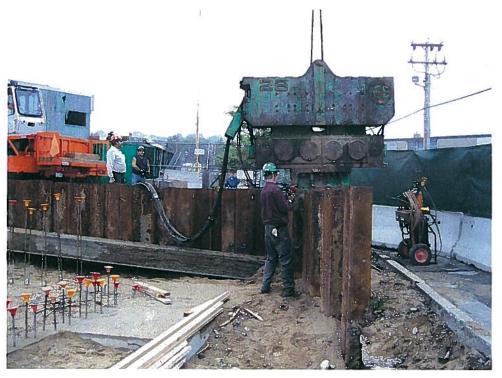
- 5. G. Donaldson began removing the steel sheet piles from the support of excavation system in the northeast corner of the garage (see Figure 1 and photographs). The steel sheet piles were removed using a service crane outfitted with an ICE 22 hydraulic vibratory driver/extractor.

Photograph 3. Removal of steel sheet piles from the support of excavation system in the northeast corner of the garage, looking north (9/10/07).

Photograph 4. Removal of steel sheet piles from the support of excavation system in the northeast corner of the garage, looking north (9/10/07).
