Project	OCEAN GATEWAY PARKING GARAGE	Report No.	7
Location	PORTLAND, MAINE	Period From	02 July 2007
		To	06 July 2007
Client	RIVERWALK, LLC.	Page	1 of 3
Contractor	LEDGEWOOD CONSTRUCTION (CM) SHAW BROTHERS CONSTRUCTION (EARTHWORK) G. DONALDSON CONSTRUCTION (PILE DRIVING)	File No.	30322-030

WEEKLY FIELD REPORT

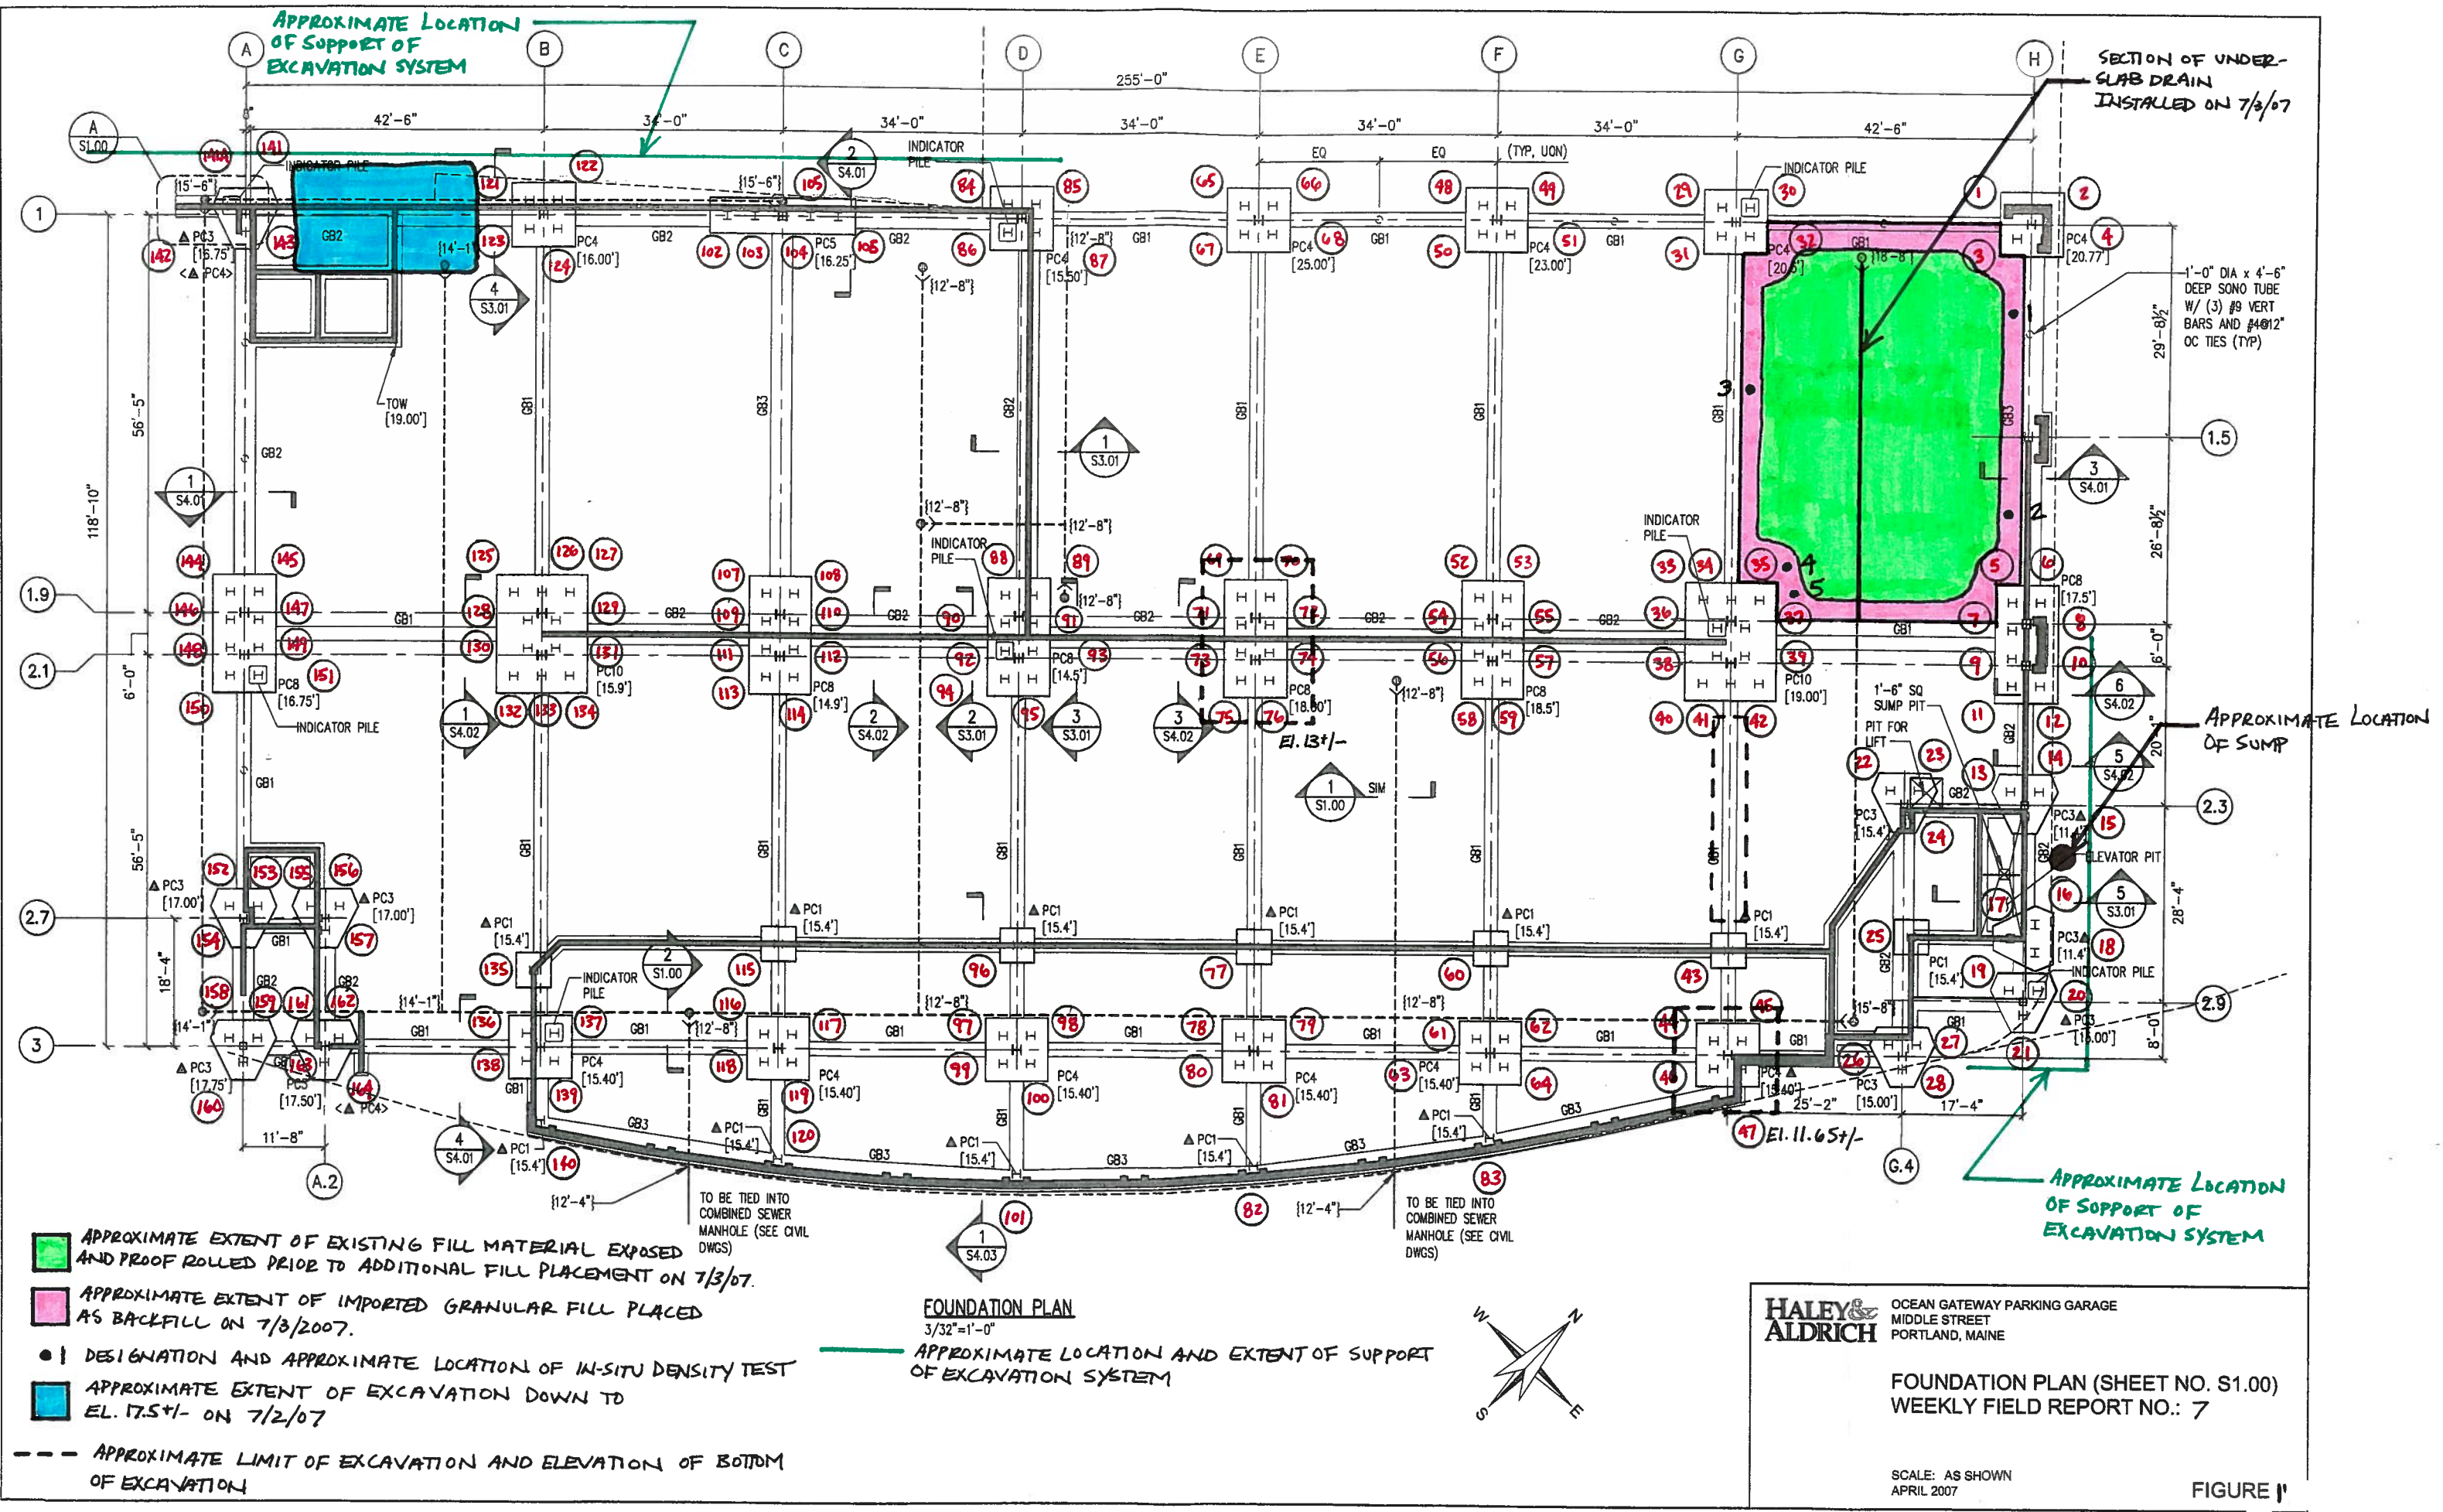
1. Field Representative observed placement of lifts of compacted granular fill in the northwest corner of the garage as shown on Figure 1. Fill material consisted of imported granular soil from Shaw Bros. Dayton Pit. Field Representative used a Humboldt 5001EZ nuclear density gauge to monitor relative compaction during fill placement. The granular fill appeared stable under the compactive effort of a self propelled vibratory plate compactor and/or an Ingersoll Rand SD-77DX smooth drum vibratory roller. In-situ density tests indicated the fill material met the minimum compaction specifications (see Table 1, test nos. 1-5 for results and Figure 1 for density test locations).

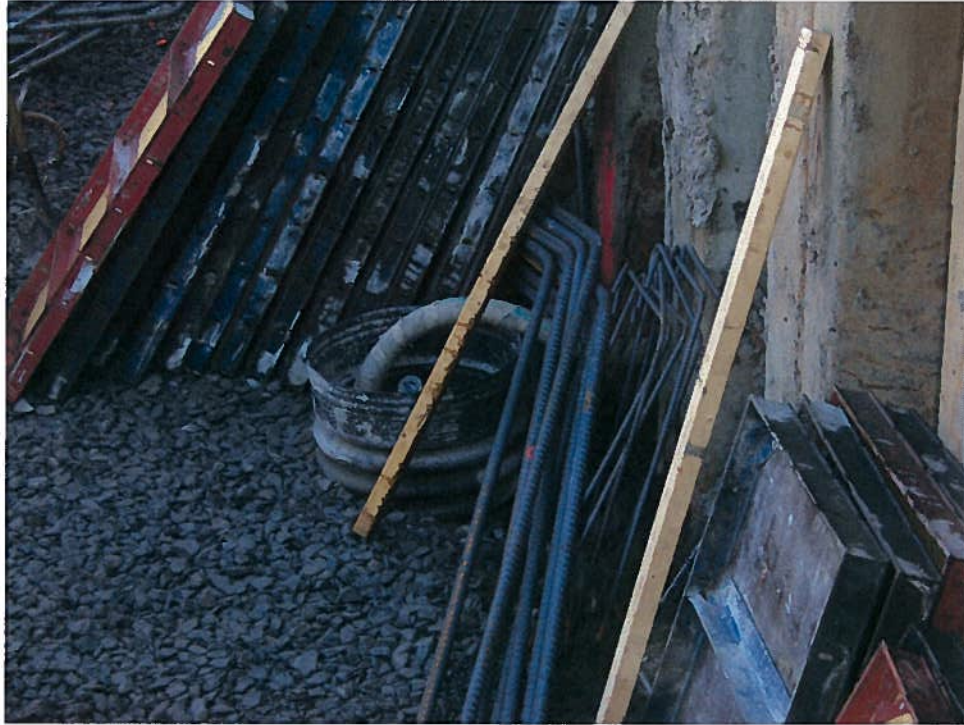
1. G. Donaldson did not work today.
2. Shaw Bros. previously installed a sump north of the proposed elevator pit (see Figure 1 and photographs). The sump consisted of an 18-in. diameter corrugated plastic pipe extending approximately 3 ft below the bottom of the excavation. A pump was installed in the sump and water was pumped into a FRAC tank located north of the support of excavation system.

Photograph 1. Sump consisting of an 18-in. diameter corrugated plastic pipe installed north of the elevator pit in the northeast building corner, looking west (7/2/07).

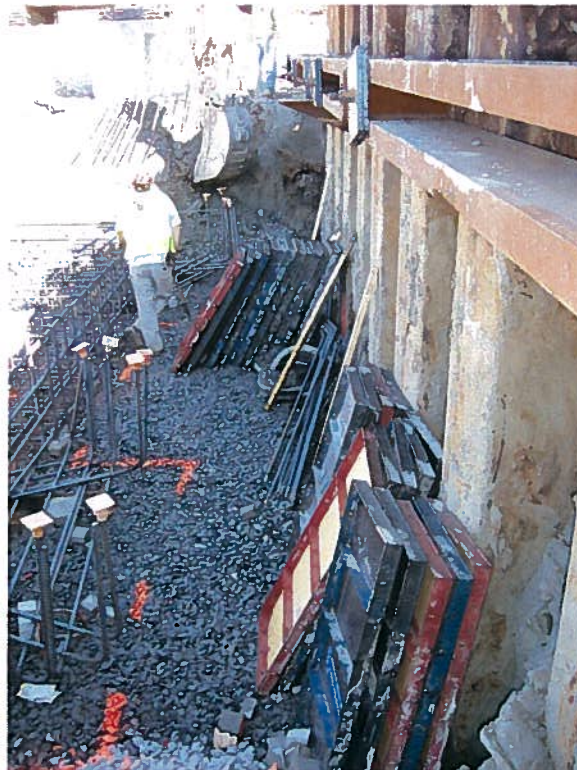
Photograph 2. Sump consisting of an 18-in. diameter corrugated plastic pipe installed north of the elevator pit in the northeast building corner, looking west (7/2/07).

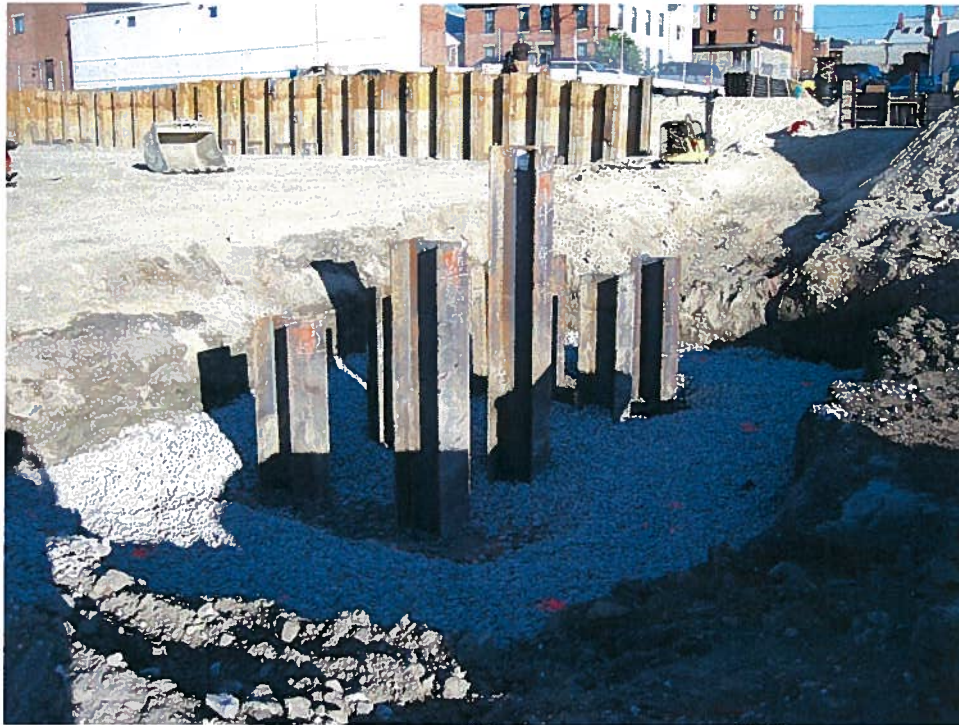
4. Shaw Bros. excavated pile cap located at column E-1.9/2.1 with a CAT 320C excavator (see Figure 1 and photographs). The area was excavated down to El. 13, approximately 6-in. below the proposed bottom of pile cap level. The subgrade was not proofrolled. A 6-in. thick lift of 1½-in. crushed stone was placed on the exposed marine clay subgrade in order to minimize disturbance to subgrade soils during placement of concrete forms and reinforcing steel. The excavated soils consisted of fill and naturally deposited marine clay. The soil was loaded into dump trucks and hauled off site.

Photograph 3. Completed excavation for pile cap located at column E-1.9/2.1, looking west (7/2/07).

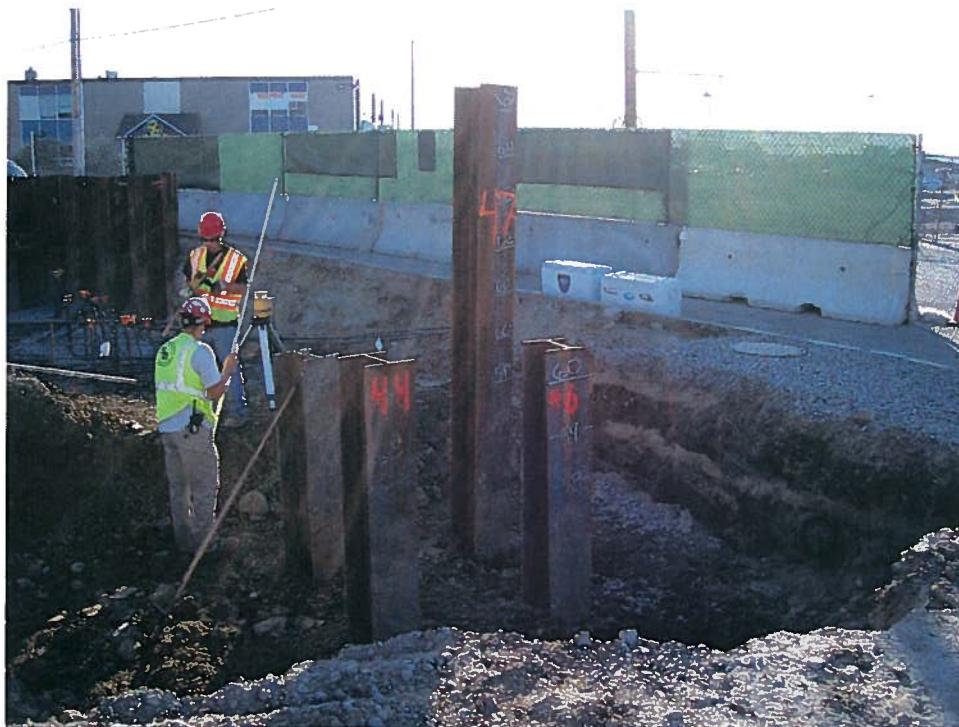
5. Shaw Bros. began excavating pile cap located at column G-3 with a CAT 320C excavator (see Figure 1 and photographs). An existing drainage structure located immediately southeast of pile no. 46 was removed during excavation. The excavated soils consisted of in-situ fill that was loaded into dump trucks and hauled off site.

Photograph 4. Partially completed excavation for pile cap located at column G-3, looking east (7/2/07).

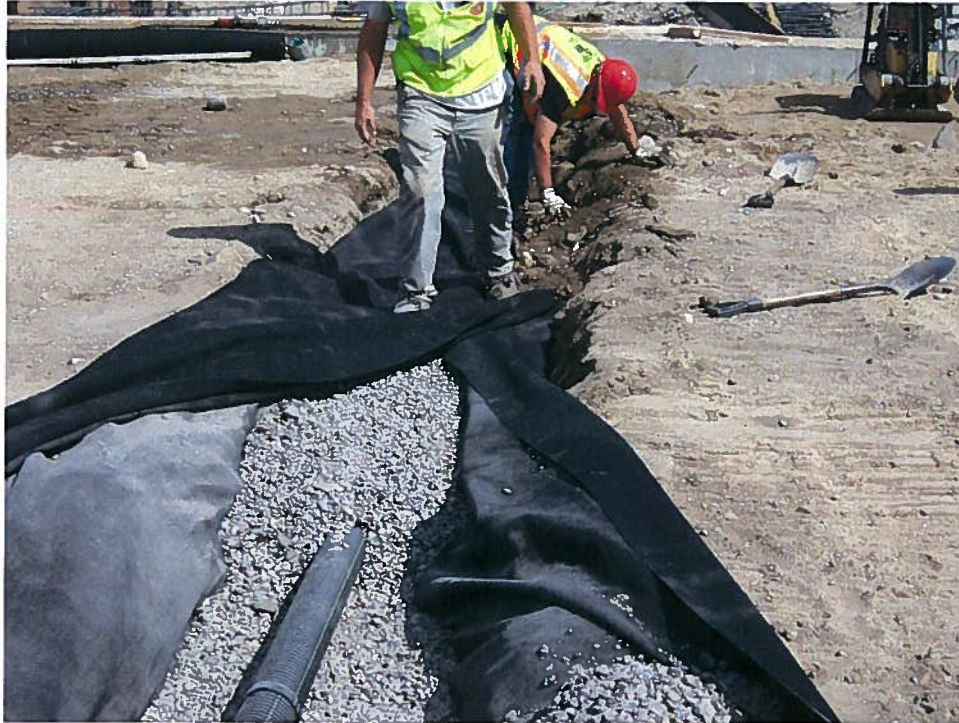
4. Shaw Bros. installed the section of underslab drain between column lines 1, 1.9/2.1, G and H (see Figure 1 and photographs). The underslab drain consisted of a 4-in. diameter slotted/corrugated plastic pipe embedded in 4-in. (all around) of ¾-in. crushed stone. The crushed stone and pipe was encapsulated in Mirafi 140N filter fabric

2. Field Representative observed the installation of the underslab drain between column lines 1, 1.9/2.1, G and H. Field Representative confirmed the materials, plan location and invert elevations were consistent with those provided in the specifications and contract drawings.

Photograph 5. Installation of the underslab drain in the northwest building corner, looking east (7/3/07).

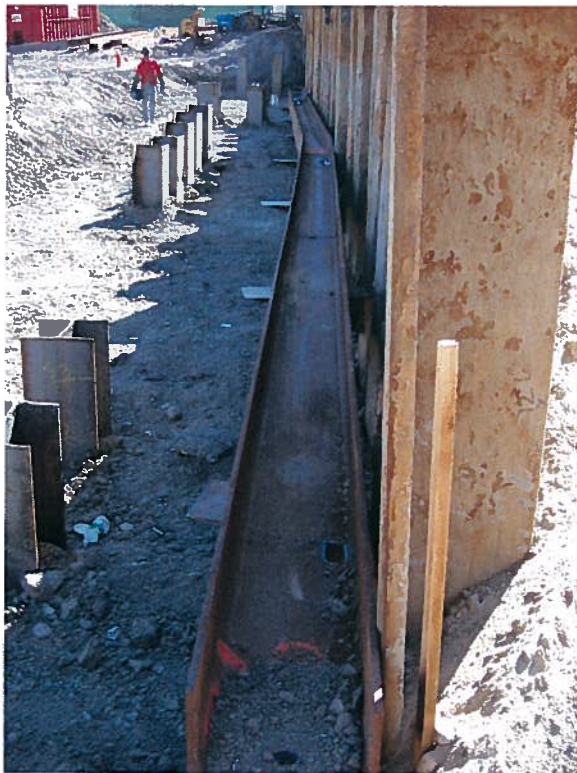
- and backfilled with imported granular fill from Shaw Bros. Dayton Pit. The invert elevation of the cleanout east of column line 1 was El. 18.67 and sloped down to an invert elevation of El. 15.89 at column line 1.9/2.1.
5. G. Donaldson cutoff piles at design elevations (surveyed by Ledgewood) at column E-1.9/2.1, column G-3.0 and column G-2.8. Additional piles were cutoff at ground surface at columns B-3 and B-3.1 in order to allow construction vehicle traffic into and out of the site. These piles will require additional cutoff in order to reach the design cutoff elevation.
 6. G. Donaldson began installing the continuous steel whaler for the support of excavation system west of column line 1 (see Figure 1 and photographs).

Photograph 6. Installation of the whaler on the support of excavation system west of column line 1, looking south (7/6/07).
