# WEEKLY FIELD REPORT

Project OCEAN GATEWAY PARKING GARAGE

Location PORTLAND, MAINE

9 Report No.

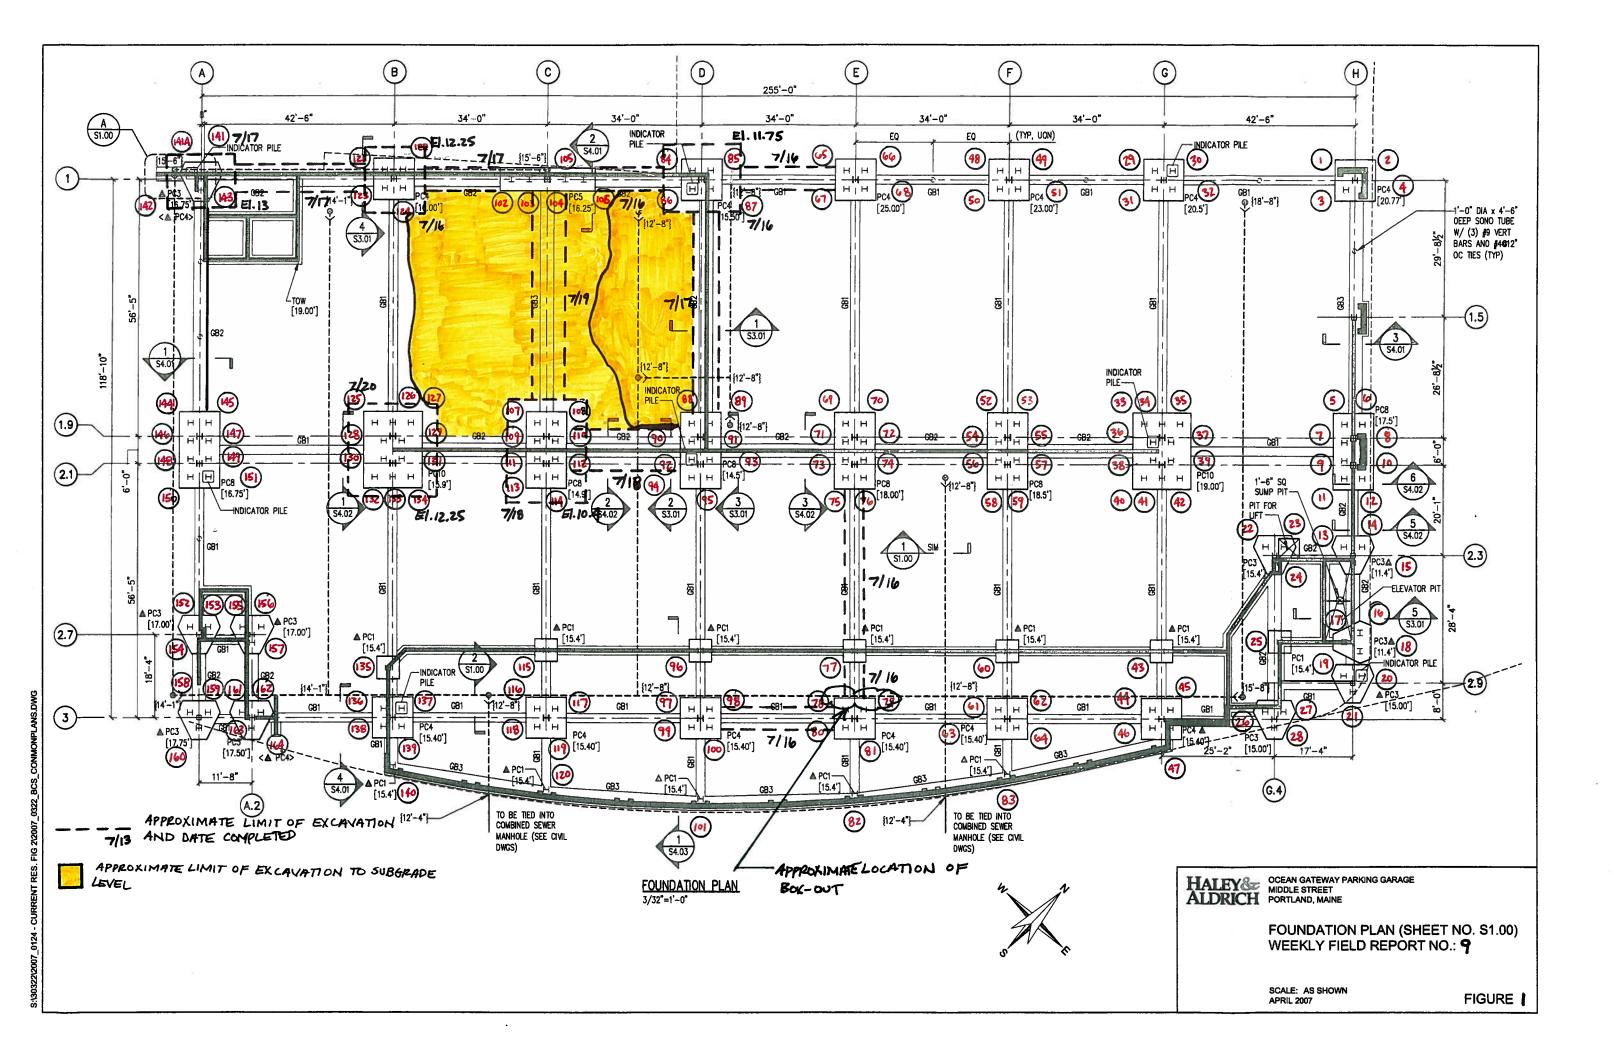
**ATTACHMENTS:** 1. Foundation Plan (Figure 1)

- 2. Shaw Bros. provided a "box-out" for the underslab drain running west of column E-3 (see Figure 1) with invert elevation at El. 12.67.
- Shaw Bros. conducted excavations for pile caps located at columns B-1 and D-1 with a CAT 320C excavator (see 3. Figure 1). The areas were excavated approximately 3-in, below the proposed bottom of pile cap level, El. 12.25 and El. 11.75, respectively. The excavated soils consisted of fill and naturally deposited marine clay. The soil was loaded into dump trucks and hauled off site. A 3-in. thick lift of 1½-in. crushed stone was placed on the exposed marine clay subgrade in order to minimize disturbance to subgrade soils during placement of concrete forms and reinforcing steel.

- 2. Shaw Bros. conducted excavation for pile cap located at column A-1 with a CAT 320C excavator (see Figure 1). The area was excavated down to El. 13, approximately 4-in. below the proposed bottom of pile cap level. A 4-in. thick lift of 11/2-in. crushed stone was placed on the exposed marine clay subgrade in order to minimize disturbance to subgrade soils during placement of concrete forms and reinforcing steel. The excavated soils consisted of fill and naturally deposited marine clay. The soil was loaded into dump trucks and hauled off site.

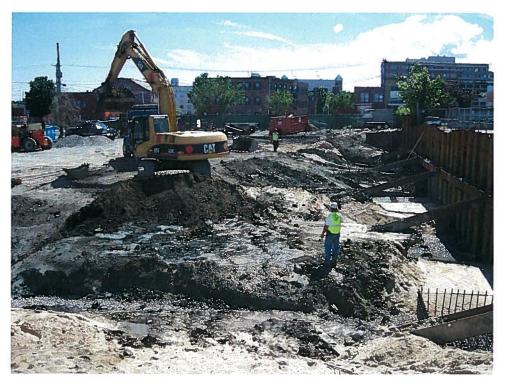
1. Field Representative inspected excavation to subgrade level in the area described under Item No. 1 on Thursday. The subgrade consisted of naturally deposited, olive gray marine clay. The subgrade appeared firm/stable prior to the placement of the granular fill protective layer. Field Representative judged that the subgrade was acceptable for additional fill placement.

Photograph 1. Excavation to subgrade level south of column line D with exposed marine clay subgrade, looking south (7/19/07).

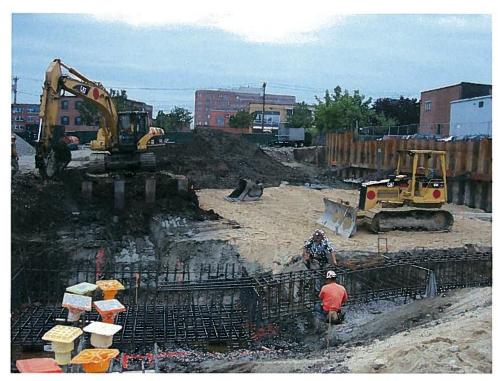
- 3. Shaw Bros. excavated for the pile cap located at column C-1.9/2.1 with a CAT 320C excavator (see Figure 1). The area was excavated down to El. 10.4, approximately 3-in. below the proposed bottom of pile cap level. A 3-in. thick lift of 1½-in. crushed stone was placed on the exposed marine clay subgrade in order to minimize disturbance to subgrade soils during placement of concrete forms and reinforcing steel. The excavated soils consisted of fill and naturally deposited marine clay. The soil was loaded into dump trucks and hauled off site. Five truck loads of excavated material were taken to Commercial Paving & Recycling in Scarborough, Maine for disposal.

Photograph 2. Excavation of pile cap located at column line C-1.9/2.1 with granular fill subgrade protective layer visible to the right, looking south (7/18/07).
