REPORT OF STRUCTURAL STEEL INSPECTION

PROJECT: Ocean Gateway Garage
Portland, ME

DATE: February 20, 2008

REPORT #: 07-SIS-117-050

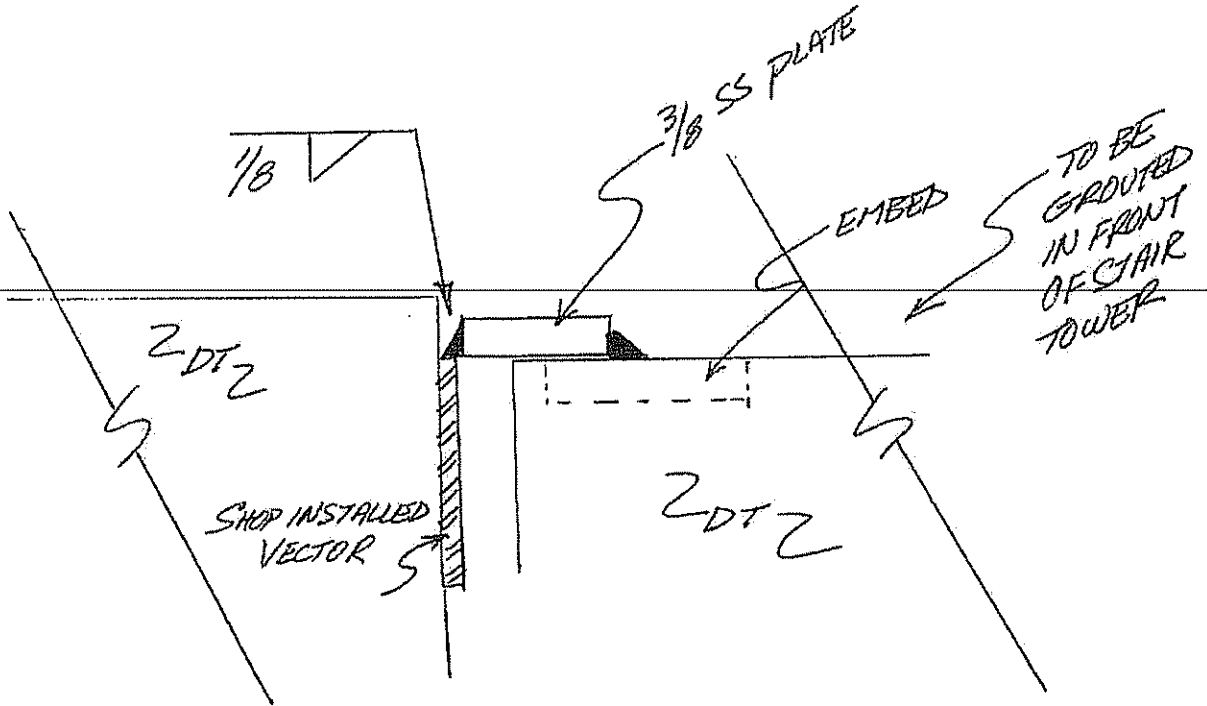
- Vector not welded near D1.9
- At recessed area near stair line A.2 vectors were shop installed at wrong elevation. I don't know if the corrective work is acceptable. I will submit a sketch with my report for the engineer to review. This occurs at all levels.
- Cut out and repair moment connection as marked at E2.1 bottom flange.
- Add 5/16 reinf. fillet at F2.1
- Misaligned vectors near A.5/2.1

TYPICAL DETAIL DT TO DT CONNECTION NEAR LINE A-2
OCCURS TWO LOCATIONS EACH LEVEL

- This is for structural work on the garage only. Miscellaneous work, retail shop and stair have not been inspected.
- Third and Fourth levels have not had a final inspection of corrective work, DT to beam welds and bolted connections. I began the inspection but noted discrepancies had not been corrected.
- All vectors have been inspected.
- Waiting for engineers approval of repaired DT to DT connection (sketch enclosed in previous report)
