Structural Special Inspections Report

Maine Eye Retina & Surgery Center

Portland, Maine
December 22, 2016

Structural Engineer of Record
Becker Structural Engineers, Inc.
75 York Street
Portland, ME 04101
207. 879. 1838

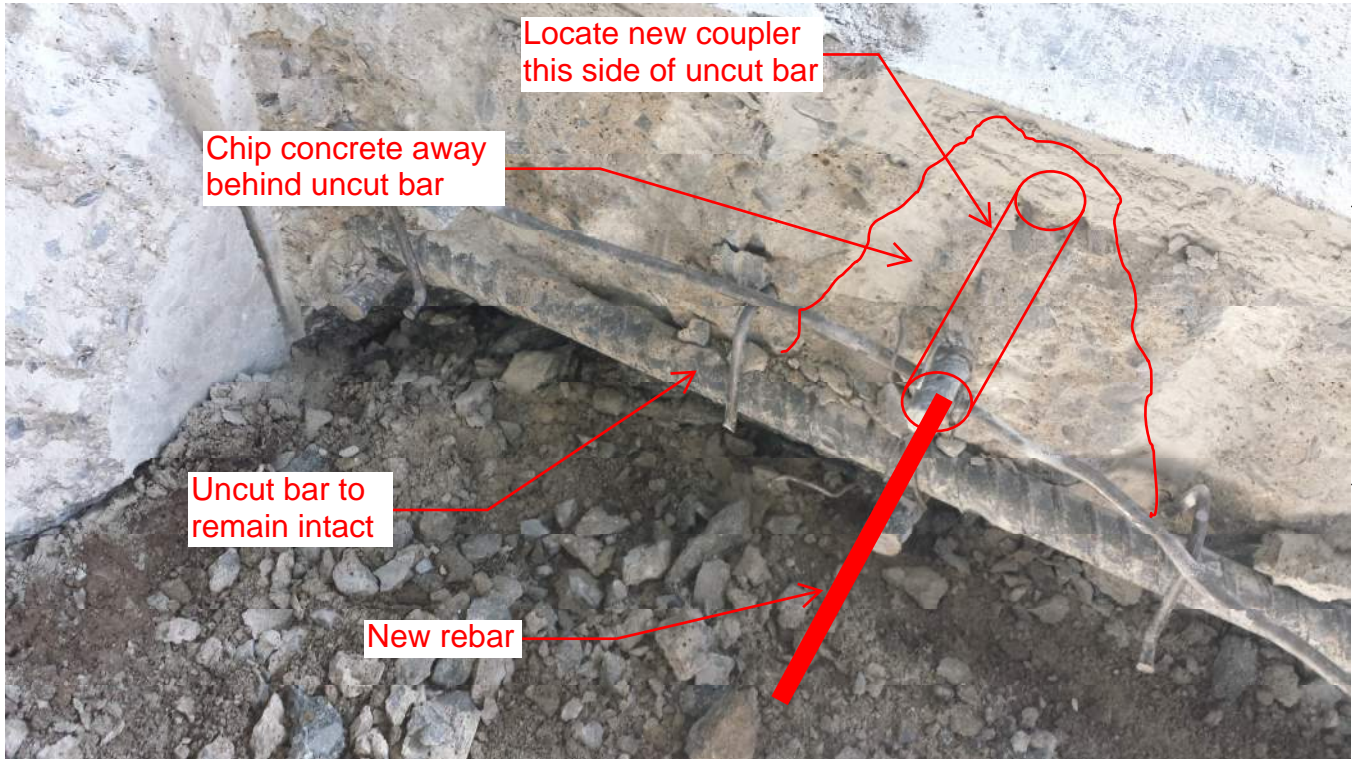
Concrete and reinforcement had been fully removed at the (5) locations that were previously marked for slab demolition. Bar sizes in the slab ranged from #4 to #8. Sample rebar couplers were made available by the GC to observe fitup. In most locations, chipping with a hammer will be required in order to expose the ends of the existing rebar so that the new couplers can be slid on. There are some isolated locations where the layout of the bars in each direction will interfere with the coupler (see attached photo 1). At these conditions, the GC was instructed to chip behind the uncut piece of rebar, leaving the uncut bar intact. The couplers shall then be spliced between

Photo 1: Exposed, Field-Cut Reinf in Structural Slab

the uncut bar and the edge of the slab. Work on exposing the existing bars for the new couplers was ongoing. We will visit the site in the near future to observe the couplers prior to slab placement.

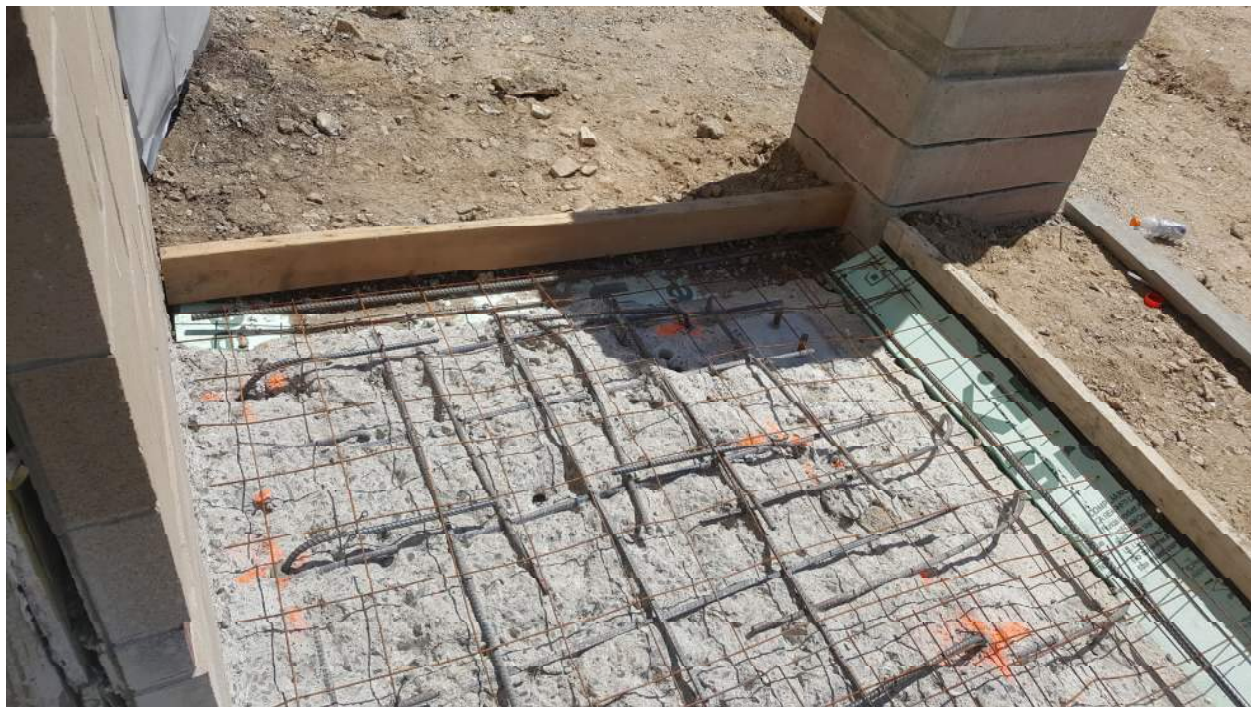
I visited the site to observe the entry slab concrete placement. A portion of this slab was accidentally demo'd by the contractor. My inspection was based on the repair sketches CSKS-2 and CSKS-3 issued to the GC. The following items were noted not to be in conformance with these sketches:

1. Standing water was observed ponding in several areas throughout the repair. The GC was requested to remove this water with a vacuum.
2. The welded wire fabric reinforcement (WWF) was not tied down to the existing slab. CSKS-2 indicated the WWF to be tied to bent rebar dowels that are drilled and epoxied into the slab. The GC was made aware that these dowels were not installed.

3. The WWF was set directly on the existing slab. Per CSKS-3, it must be chaired up to 1 1/2" below the top of the finished concrete.
4. CSKS-3 required a #4 bar around the perimeter of the repair. These bars were not installed. The concrete subcontractor had #5 on site, and that is what was placed.

This work took some time to correct, and thus we did not remain on the site while it was completed. The GC provided us with a field photo of this work prior to the placement (see below). We reviewed the work in this photo and determined that it is acceptable. Perimeter bars and dowels have been installed. The WWF is now chaired up to the correct elevation. All standing water has been removed.

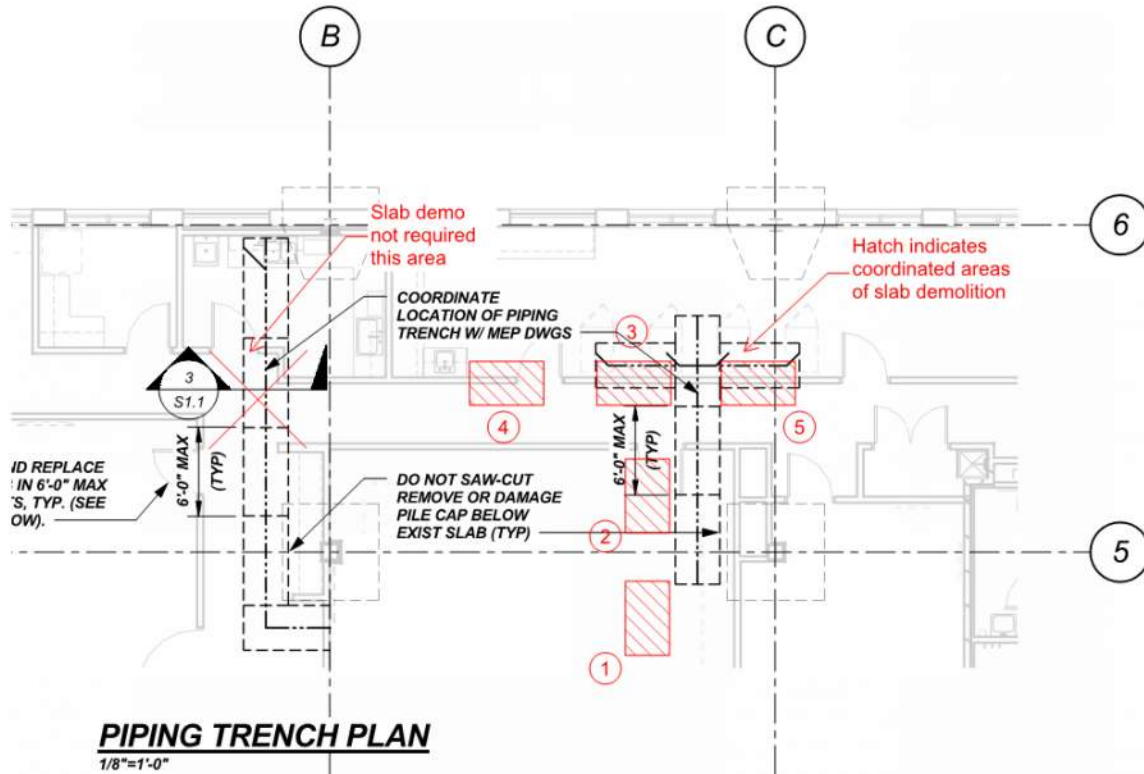
Figure 1: Slab Cut Locations for New MEP Installation

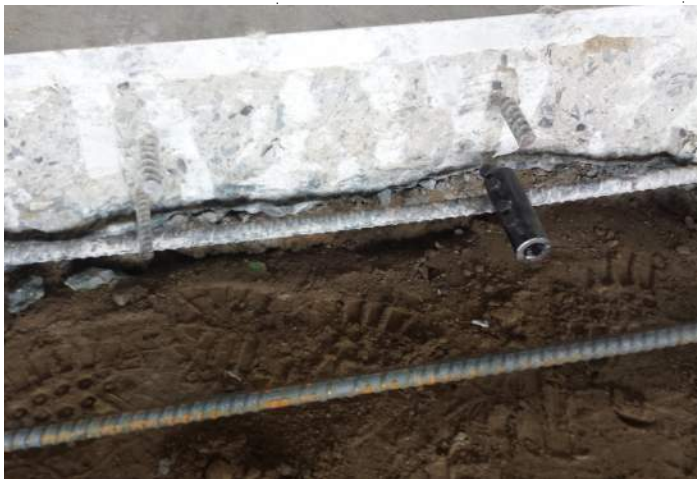
Photo 1: Bars Bent Down to Fit New Coupler

Opening 4 had no interferences, except that some of the bottom bars need to be bent upward to fit the new couplers. This is similar to the condition described for openings 1 and 2. We will inspect this work during a future visit.

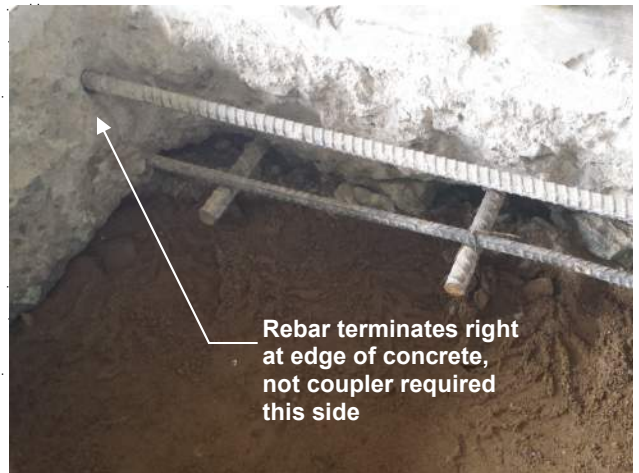
In opening 2, I observed that the top bars that run parallel to the B-line do not continue through the entire opening. They instead terminate right at the edge of the opening (see photo 2). Therefore, the couplers are not needed at this specific location. The GC was made aware of this, and we will inspect the final work during a future visit.

Photo 2: Top Bars Terminate at Edge of Opening
Rebar terminates right at edge of concrete, not coupler required this side

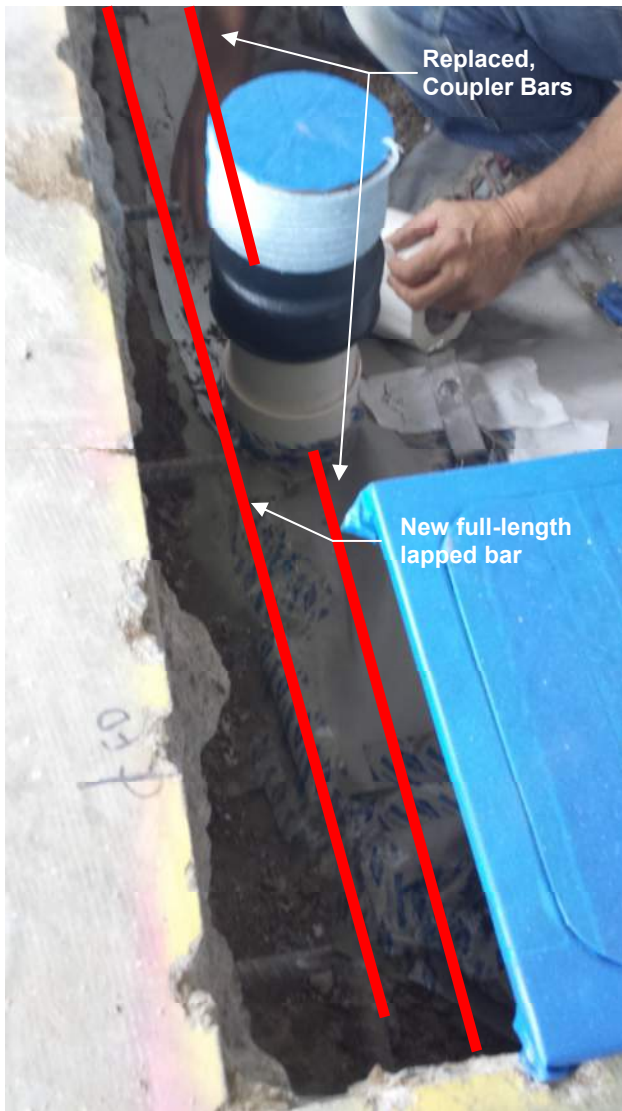
In opening 5, one the new drains interfered with a coupler and prevented it from being installed. The MEP installer looked at this condition and determined the drain pipe could be moved to avoid the interference. This work began while I was on site. Also in opening 5, at the end closest to C-line, I observed double the amount of bottom reinforcement as the opposite end. It was then realized that the opening was cut through a series of rebar lap splices. Since it's the bottom reinforcement in an area of negative bending, the rebar is not in tension. Therefore, the additional bars do not need to be lapped through the length of the opening. The GC was made aware of this. Couplers will be provided at one end of the opening only, and we will observe this work during a future visit to the site.

Photo 3: Lapped bars at interfering drain

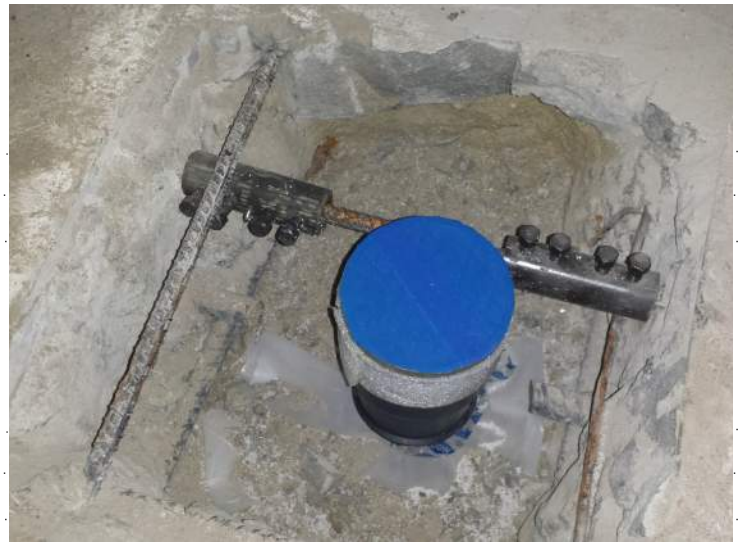
At the other openings throughout the building, two issues were noted. Bottom reinforcement in one of the openings was cut around a new drain and cannot be replaced (see photo 4). We analyzed the slab with this one rebar omitted, and determined that the overall slab capacity was not compromised, and no further corrective action is required. The other issue was the that several slab cuts where done to create re-entrant corners, which can cause future cracking in the new slab repair (see photo 5). The GC was instructed to make additional cuts in the slab to avoid the re-entrant corners. This work will be inspected during future visits to the site.

Photo 4: Cut Bottom Bar Cannot Be Lapped w/ New Couplers

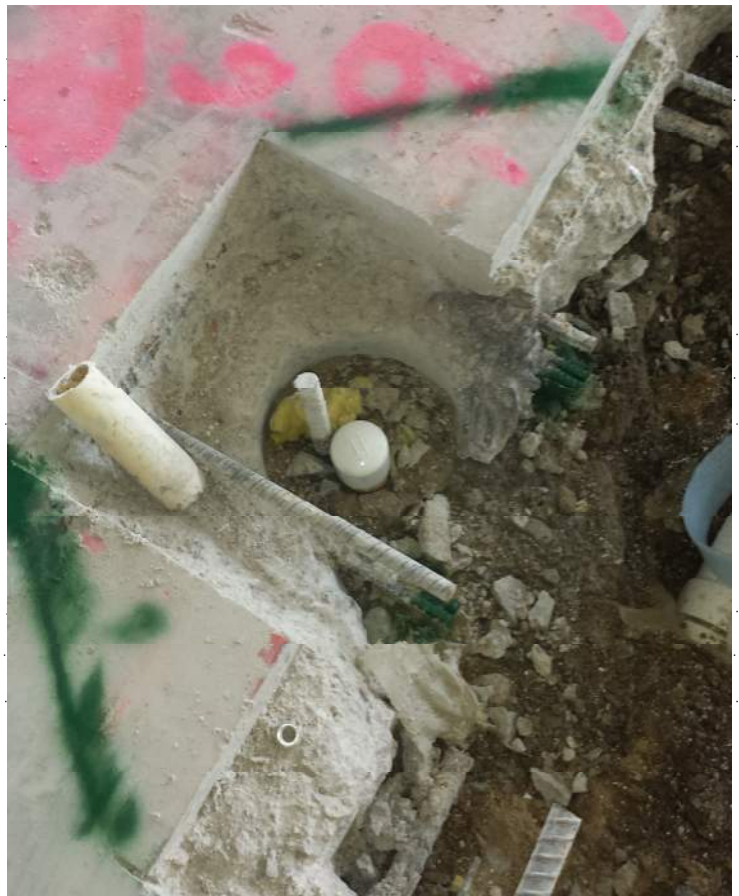
Photo 5: Existing slab cuts create re-entrant corners (green spray paint shows correct areas to be removed in the future)

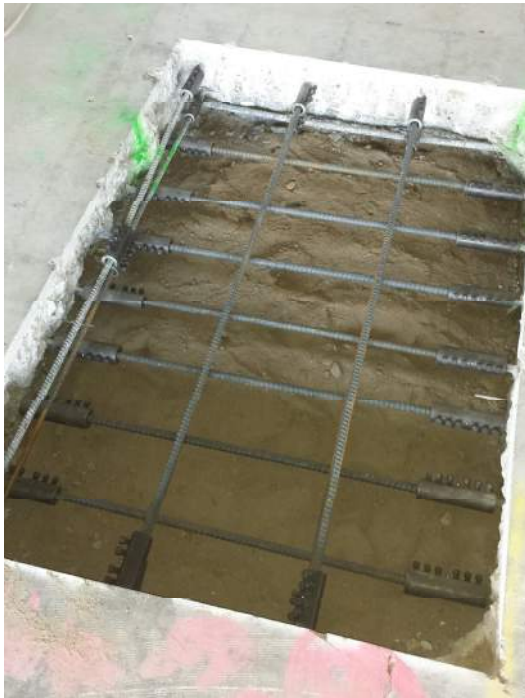
The reinforcement in the exterior pad was observed to be in conformance with the structural drawings. During my visit, I also observed the coupler and reinforcement installation in openings 1 and 2 in the ground floor slab (see figure 1, and photos 1 and 2). The reinforcement and couplers were installed per the structural drawings and per the requirements identified in the Concrete Report on 8/15. The GC was instructed to place concrete in these two openings only. Reinforcement work within openings 3,4 and 5 is ongoing, and we will inspect this during future visits to the site.

Photo 1: Complete work in opening 1

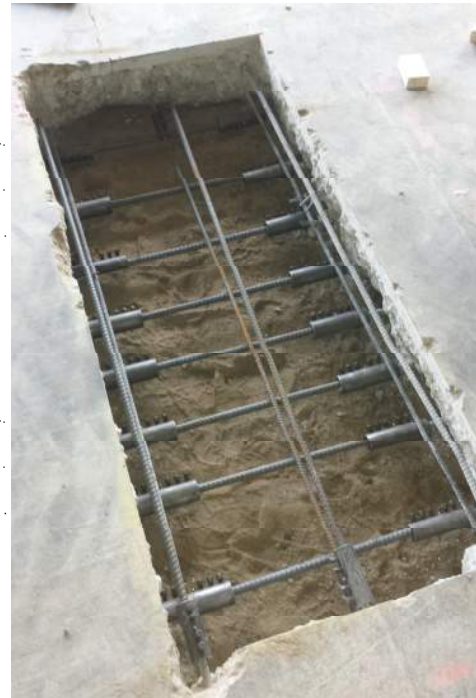
Photo 2: Complete work in opening 2

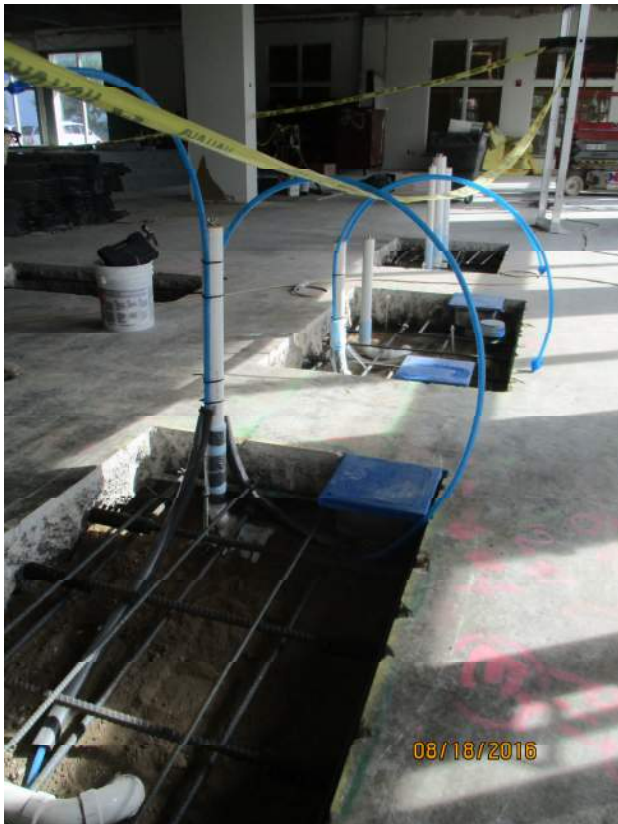
During my visit, I observed the coupler and reinforcement installation in openings 3, 4 and 5 in the ground floor slab (see figure 1). Reinforcement in openings 1 and 2 were inspected on 8/16 (refer to 8/16 report for additional information). The reinforcement and couplers were installed per the structural drawings and per the requirements identified in the Concrete Report on 8/15. In openings 3 and 5, the GC was asked to provide corner dowels around the drains to avoid cracking at reentrant corners. The corner bars were installed and are shown in photos 1 and 2. No additional work is required at this time, and the GC was allowed to place concrete in openings 3, 4 and 5.

Photo 1: Slab Reinf in Openings 3, 4 and 5

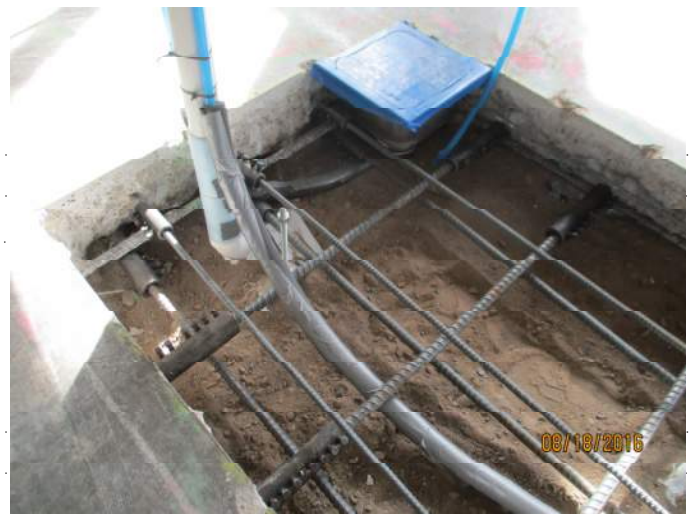
Photo 1: Slab Reinf and Couplers in Opening 5

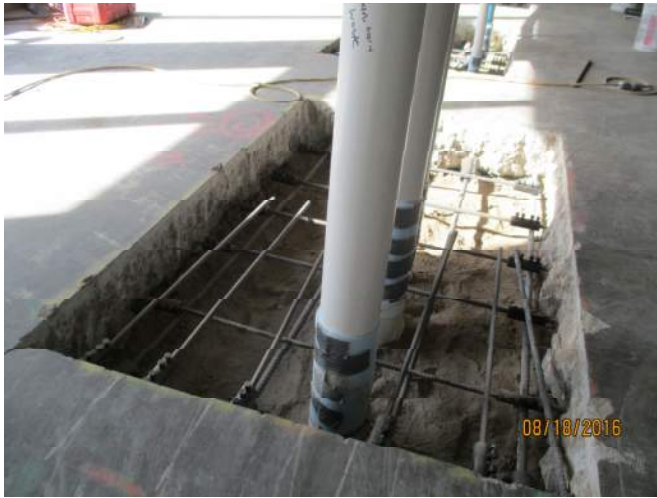
Photo 3: Slab Reinf and Couplers in Opening 4

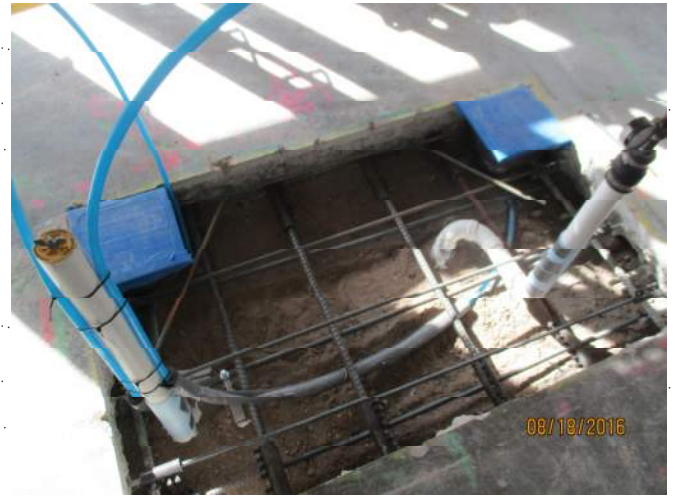
Photo 4: Slab Reinf and Couplers in Opening 5 with Diagonal Dowels Installed

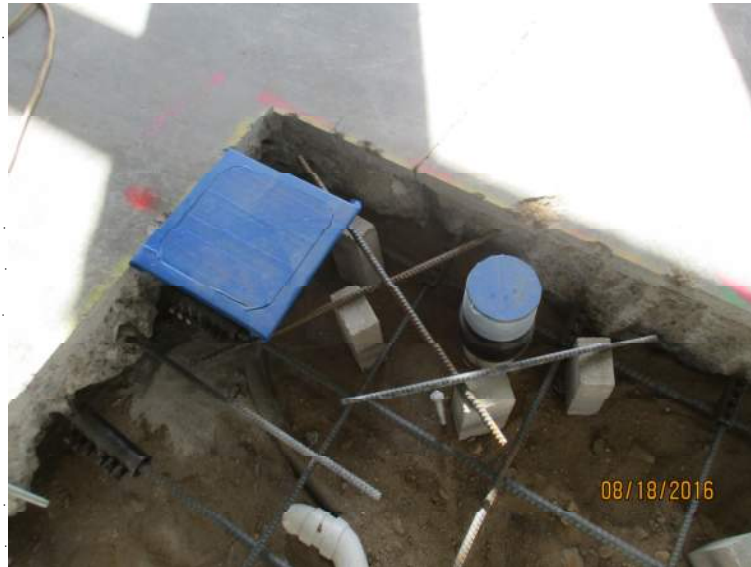
Photo 5: Slab Reinf and Couplers in Opening 3 with Diagonal Dowels Installed

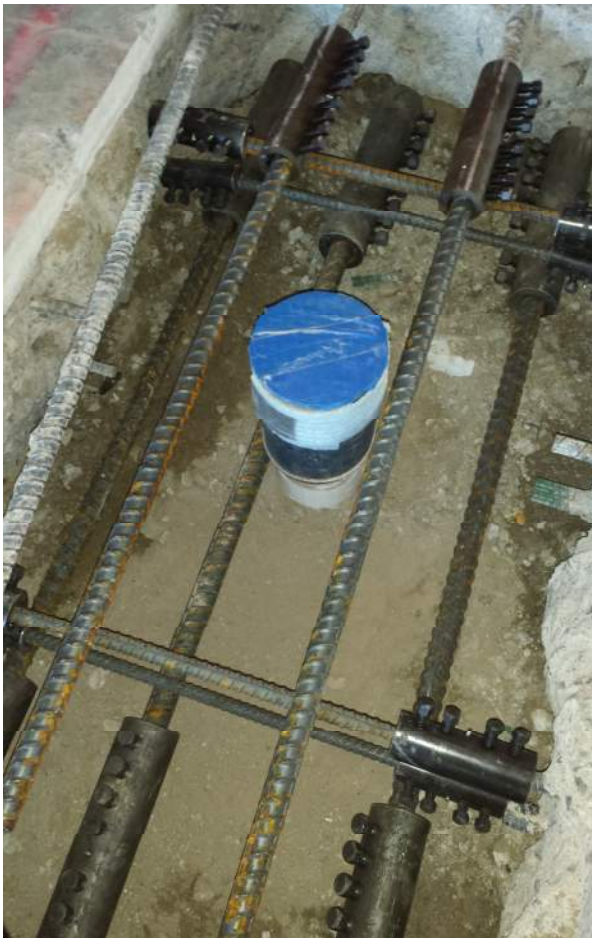
Photo 1: Cut Top/Bottom Bars Can't be coupled

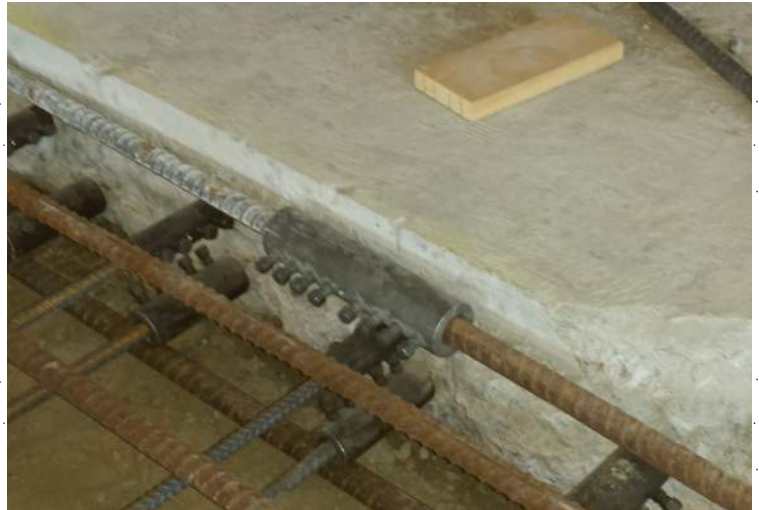
For the other opening, one coupler was observed with less than 1/2" of cover to the top of the slab (see photo 2). The GC was made aware of this. The surrounding bars were bent down slightly to increase the cover at the coupler. A straight-edge was laid down after, and it was shown that about 7/8" of cover was now provided, which is acceptable

Photo 2: Coupler w/ Inadequate Cover

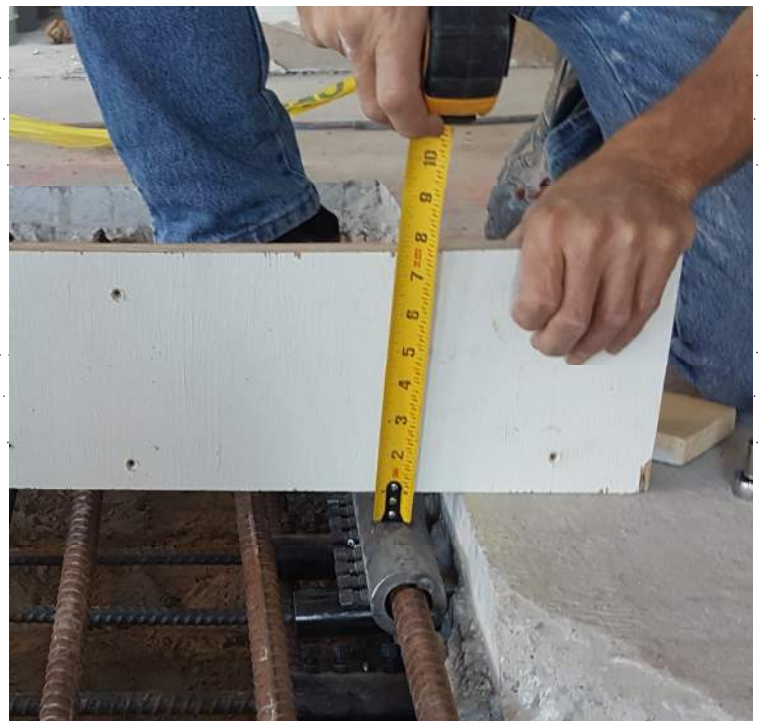
Photo 3: Corrected Coupler w/ Adequate Cover

(see photo 3). No further corrective action will be required, and the GC was given the go-ahead to place concrete.

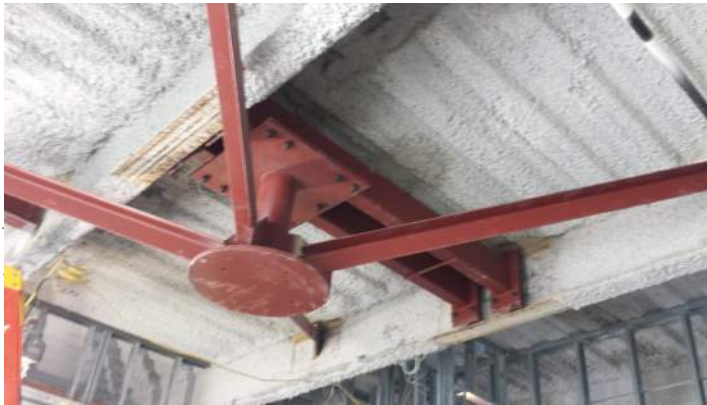
At two of the OR mounting structures, a kicker brace was found to interfere with an existing drain pipe. At both conditions, the GC was instructed to slightly shift the kicker location by approximately 3"-6" laterally in order to miss the pipe.

Photo 1: OR Mounting Structure

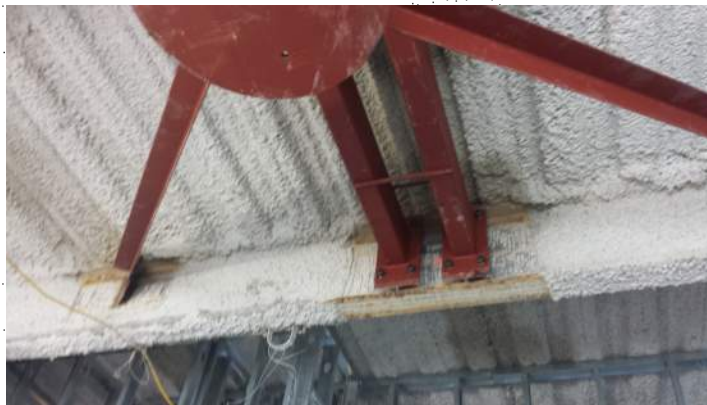
Photo 2: OR Mounting Structure

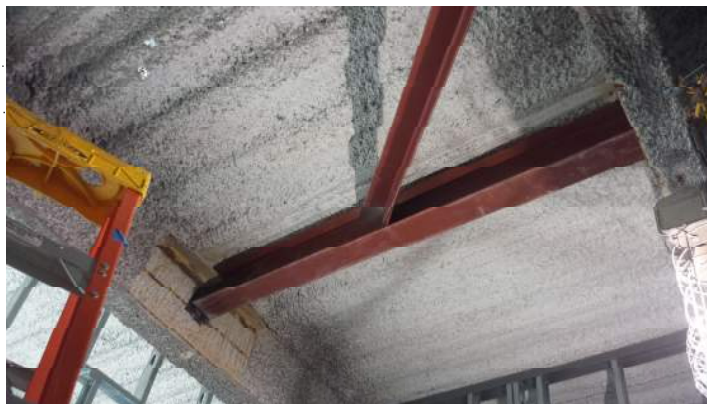
Photo 3: OR Mounting Structure
