**Field Report**

**sv\_2007/02/06**

**Project:** Pearl Place  
**Project #:** 1605  
**Date/Time:** 2/6/07-2:40 PM to 3:30 PM  
**Observers** Michael Cyr

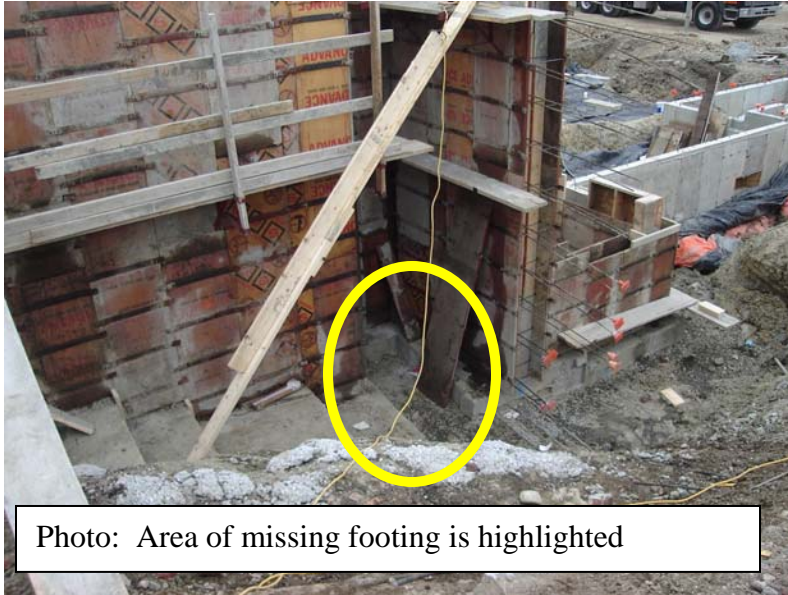
A small section of spread footing was excluded from previous concrete placements (See photo). As previously discussed on site yesterday with members of S.W. Cole, Ledgewood and Jim Fortin from our office, this small void is to be filled in during the concrete placement of the adjacent spread footing for the interior retaining wall. This area should have reinforcement as per SSK-12 from addendum #2. This includes #5 bars placed near the top of the footing and spaced at 9" O.C. These bars should extend up to the exterior edge of the existing stepped footing. I told the general contractor to also drill and dowel 8 #5 dowels into the existing footing and extend them into the footing of the interior retaining wall. The embedment of the #5 bars should be 6" minimum and Hilti HIT HY 150/HIT-ICE epoxy should be used.
