Structural Special Inspections Report

PEARL PLACE BUILDING 1& 2

Portland, Maine
December 5, 2007

Structural Engineer of Record
Becker Structural Engineers, Inc.
75 York Street
Portland, Maine 04101

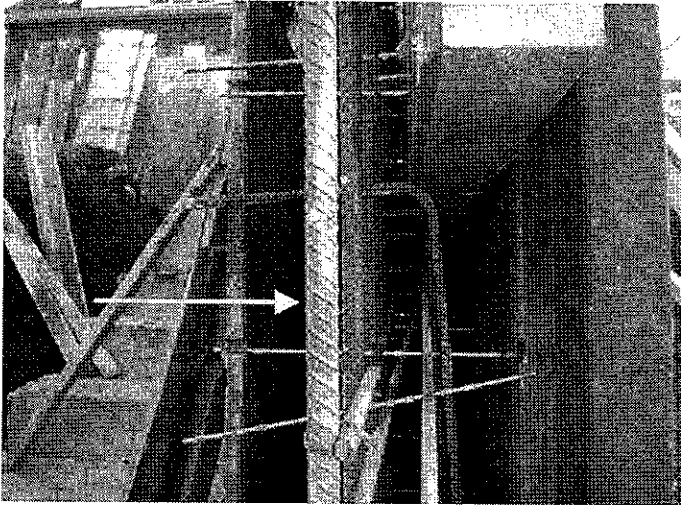
Photo 1: #7 bars should be closer to the inside face of the wall (more to the left)

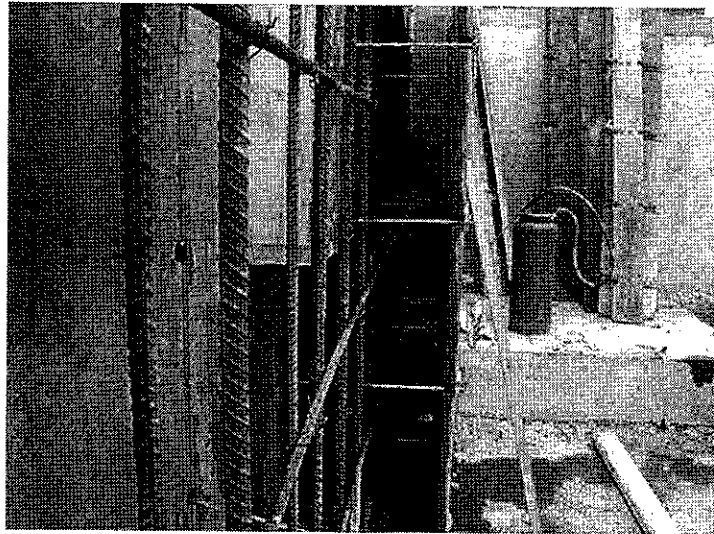
Photo 1: #7 dowels should be 2" from the inside face. The #7 dowels are adjacent to the brick shelf which is the outside face. The subcontractor should use SSK-25 to repair this discrepancy.

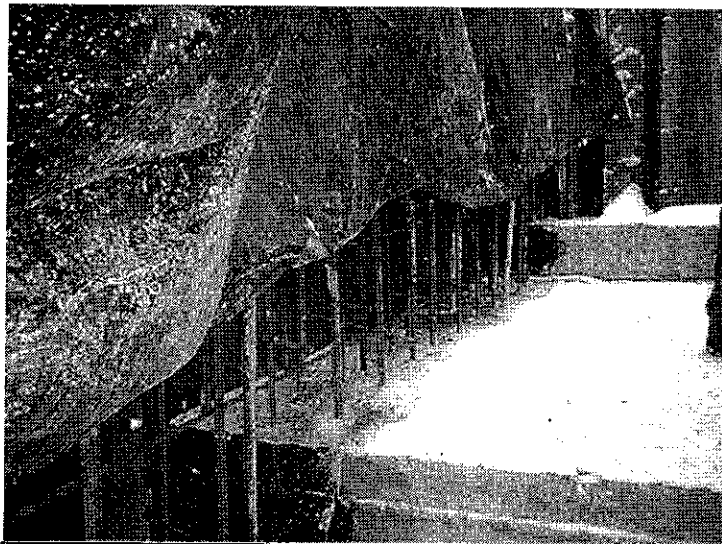
Photo 2: #7 dowels have been added as per the structural sketch SSK-25.

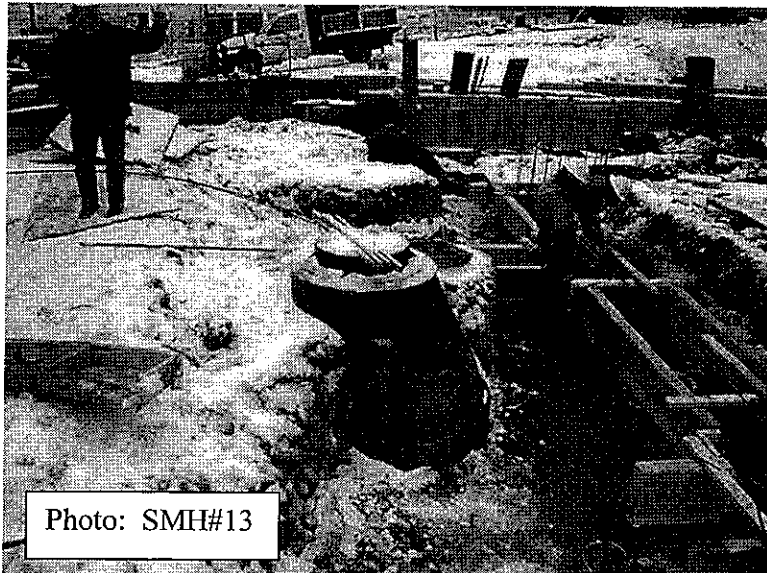
Photo: SMH#13

The general contractor informed me of a possible conflict with a sewer manhole and structural foundation wall at the community room 1-B01 entrance (Ref: A/1.1). After reviewing the civil site plan C-2, and a discussion with the architect, it appears that the sewer manhole SMH#13 may be in the wrong location. Please have the civil engineer verify the location of this unit.

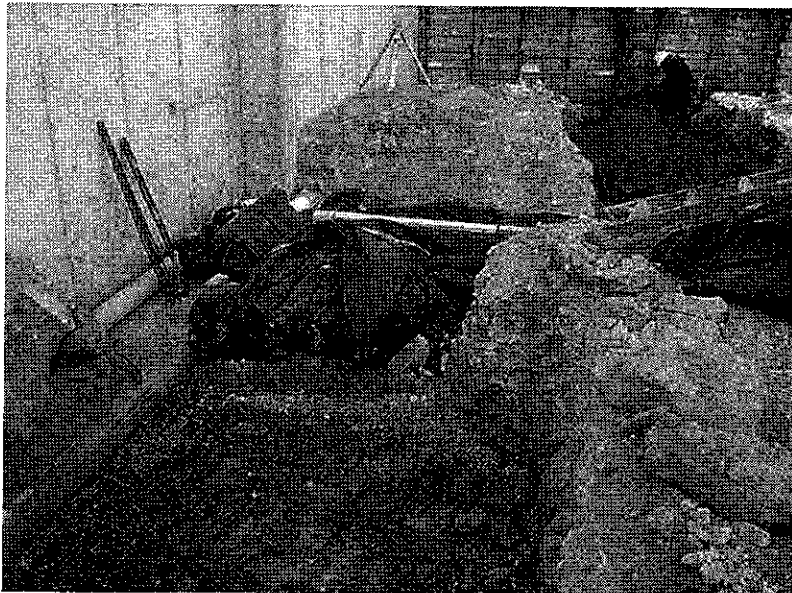
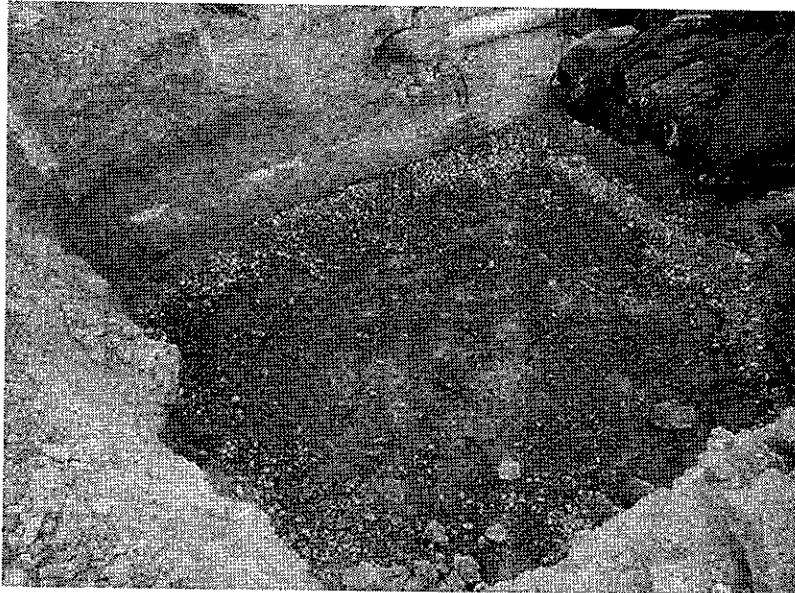
The site subcontractor has excavated for the interior footings adjacent to the retaining wall. During my morning site visit, frozen water was observed at the A-4 footing subgrade (See attached photos). During my return visit in the afternoon, the ground water had infiltrated all footings excavated earlier in the day. Our notes state that "concrete shall not be placed in water or on frozen ground." (Ref: Concrete Note # 7 on drawing S1.0). The next concrete placement is scheduled for this Thursday morning.

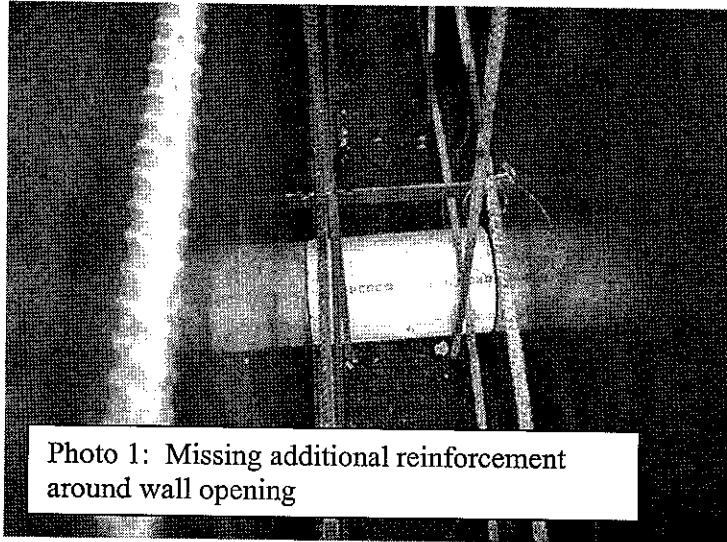
Photo 1: Missing additional reinforcement around wall opening

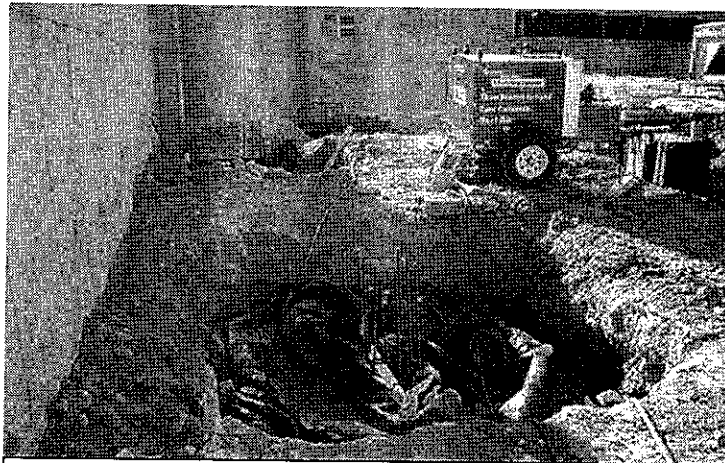
Photo 2: ground heater tendons draped inside forms for spread footing and covered with thermal blankets

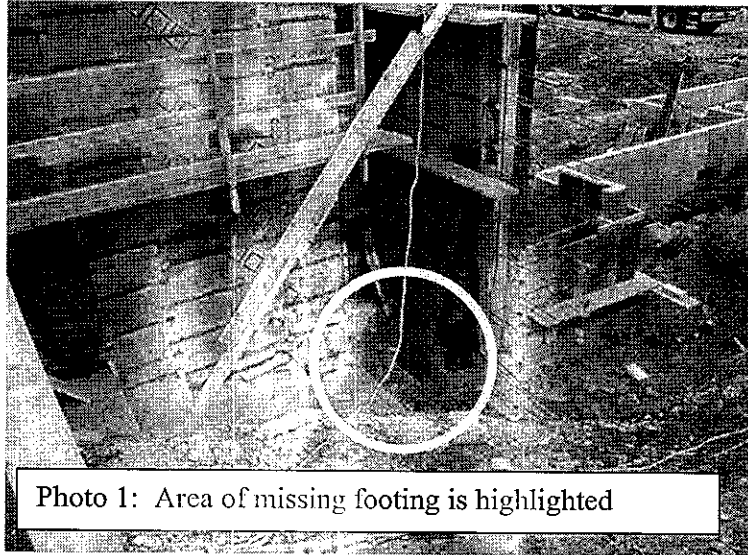
Photo 1: Area of missing footing is highlighted

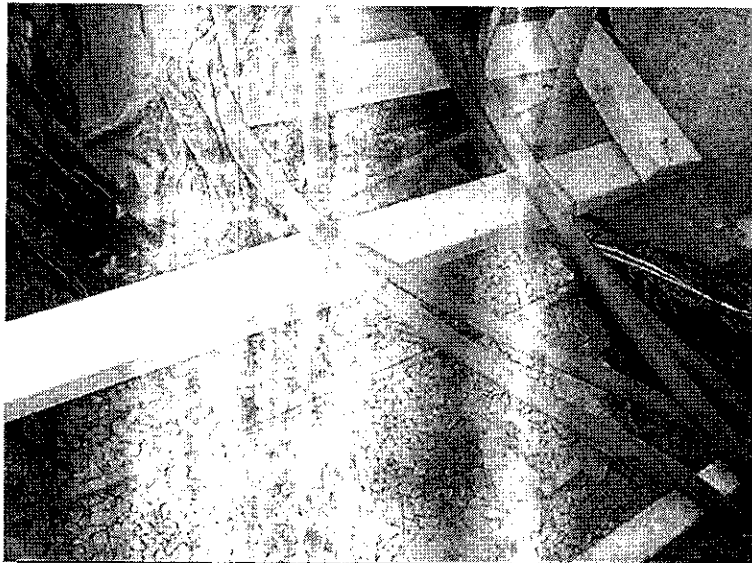
Photo 2: Ice within the formwork of today's proposed concrete placement

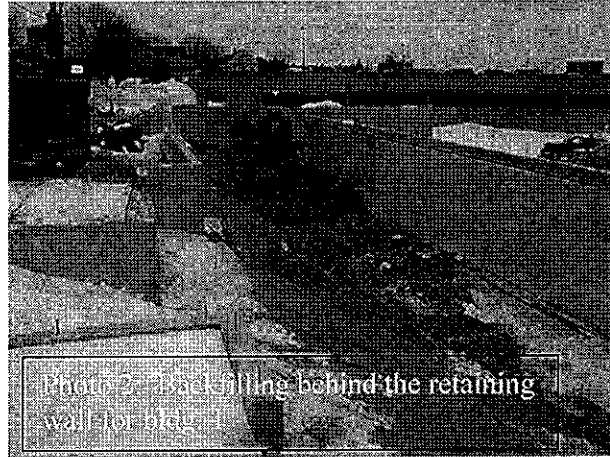
General contractor was backfilling behind the retaining wall. (See photo 2)
