PPL - CAR IMPACT REPAIR
PORTLAND, ME
EXIST CONDITIONS AND REPAIR

S1

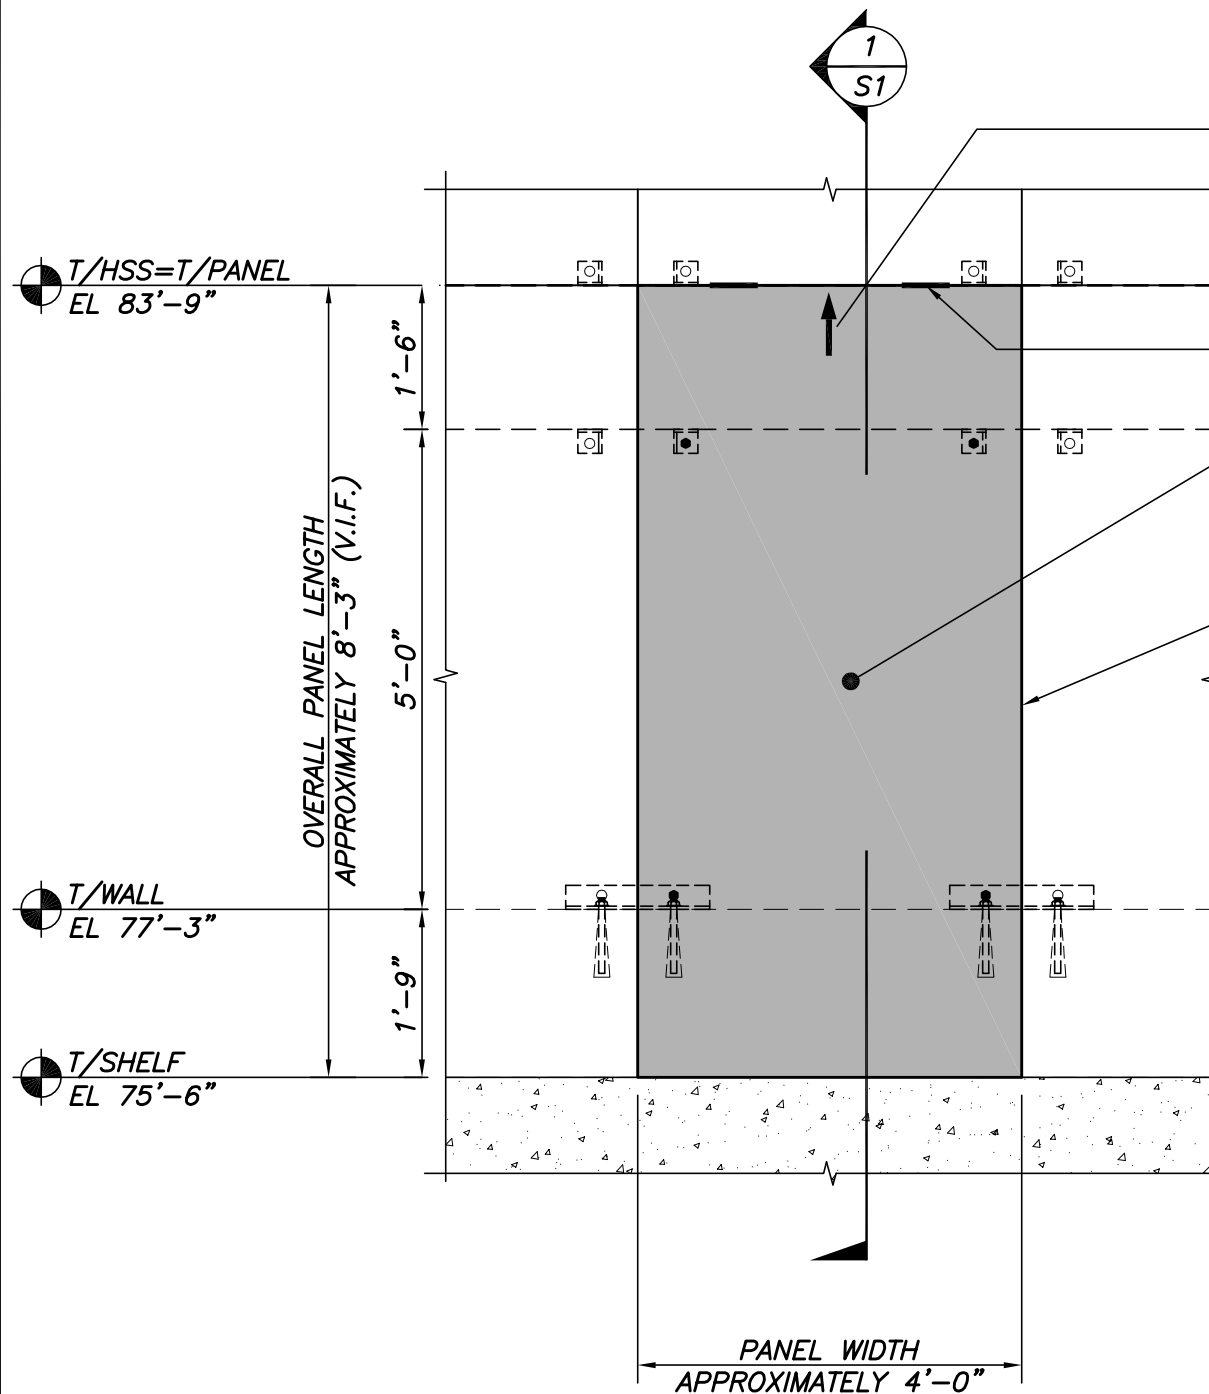
PANEL ELEVATION
1/2"=1'-0"

- EXISTING PANELS ABOVE TO REMAIN— SHORE PANEL ABOVE REPLACEMENT PANEL FOR 10 KIP AXIAL GRAVITY LOAD
- PLASTIC SHIM STACK, 3"x6" MIN. x 2 LOCATIONS
- REPLACE EXISTING CRACKED GRANITE PANEL WITH NEW GRANITE PANEL OF SAME DIMENSIONS
- PROVIDE BACKER ROD AND SEALANT AT SIDES AND TOP, COLOR TO MATCH EXISTING, INSTALL PER MANUF. INSTRUCTIONS

NOTE: REUSE EXISTING CLIP ANGLES AND PROVIDE NEW ADHESIVE ANCHOR CONNECTIONS TO NEW GRANITE PANEL. FIELD VERIFY EXISTING CONDITIONS AND DIMENSIONS. NOTIFY STRUCTURAL ENGINEER OF ANY UNDOCUMENTED DAMAGE OR DISCREPANCIES

- EXISTING GRATING AND STEEL SUPPORT STRUCTURE (V.I.F.)
- EXISTING CONCRETE INFILL (V.I.F.) REMOVE AS REQUIRED TO REPLACE GRANITE, REPLACE CONCRETE AFTER INSTALLATION
