Luckse Design, LLC

RE: Port City Glass Permit Application; 50 India Street, Portland, ME (28-P-15)
DSC Project No. 2012-141

At your request, Downeast Structural Consultants, LLC performed a Limited Structural review of the Dormer Roof Framing at the Port City Glass Building located at 50 India Street in Portland, Maine on December 3, 2012. This report has been prepared based on that review.

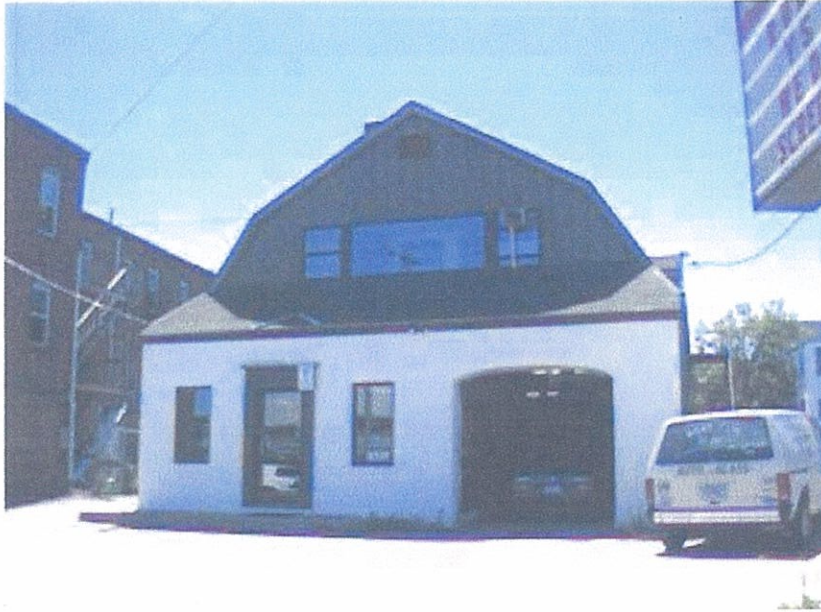
Number 1.

Exterior Front
Elevation.

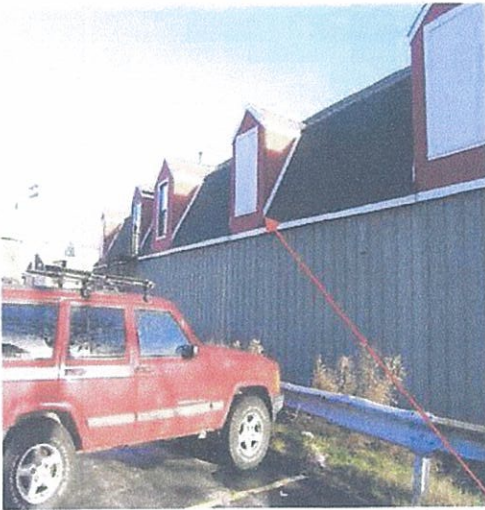
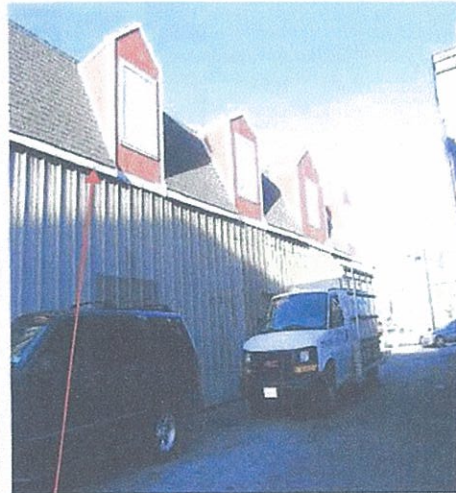
Number 2.

1. At the time of our site visit ten small roof dormers were previously constructed into the existing roof system of the Port City Glass Building. The dormers are approximately 8-feet by 5-feet and are equally spaced along each side of the building (Refer to Photo 2).
2. The dormers are constructed of 2x dimensional lumber and supported on interior and exterior load bearing walls (Refer to construction documents provided by Luckse Design, LLC dated December 20, 2012 with sheets S-1 through S-4).
3. An unfinished balcony is located along the rear of the building.
4. While on the first floor at the rear of the building we observed a steel beam spanning between the Workshop/Garage Bay and the Storage Area. The steel beam spans approximately 42-feet and supports the second floor joist framing. The beam is only supported at each end.

Based on our review, the dormers appear adequately constructed and do not adversely affect the roof framing or adversely affect the overall structural integrity of the building.

Dormer Roof
Framing

Exterior Elevation.

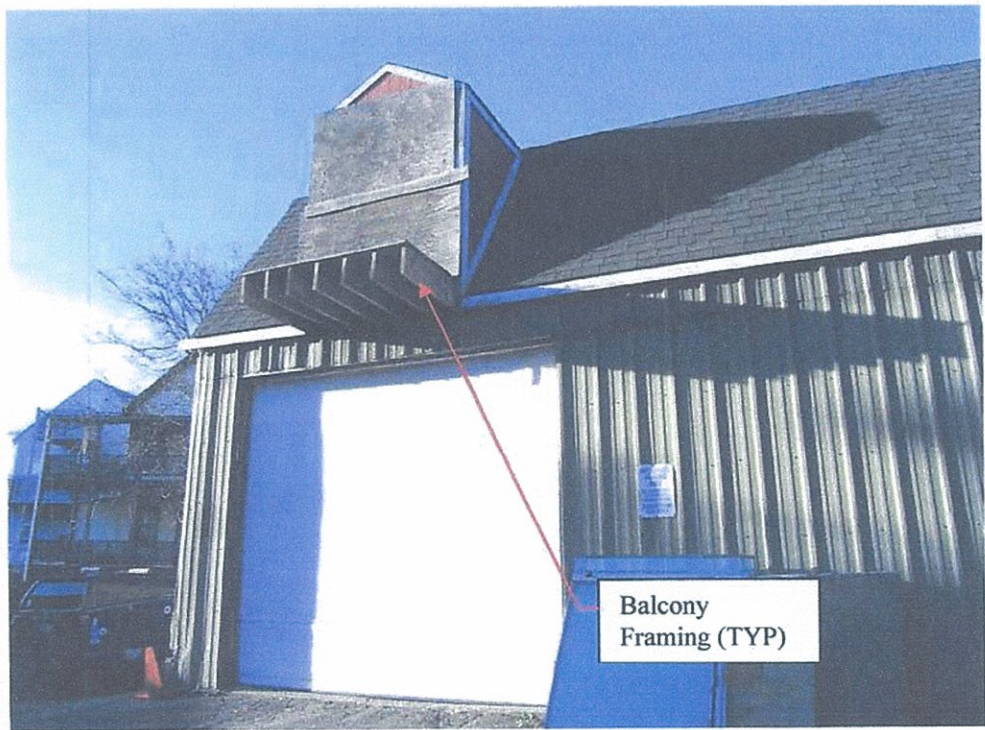
<p data-bbox="786 1682 1003 1766">Balcony Framing (TYP)</p>	<p><u>Building Location:</u> Port City Glass 50 India St, Portland, ME</p> <p><u>Photo Taken By:</u> Christopher Ray, P.E.</p> <p><u>Date:</u> December 3, 2012</p> <p><u>Description:</u> Balcony Framing.</p>	
		<p>Number 4.</p>

The unfinished balcony appears dilapidated and in poor condition. We recommend dismantling this structure immediately.

1. *We recommend removal of the wood balcony at the rear of the building (Refer to Photo 4).*
2. *Provide (2) 8x8 Composite Wood or Steel Columns at Garage Bay/Workshop Area at Third-Points along existing steel beam length. Provide column cap connection to existing steel beam above and column base connection to 1/2-inch steel plate below.*
