May 29, 2007

Re: Custom House Square, 300 Fore Street
Portland, ME
Structural Observations

PROJECT: CUSTOM HOUSE

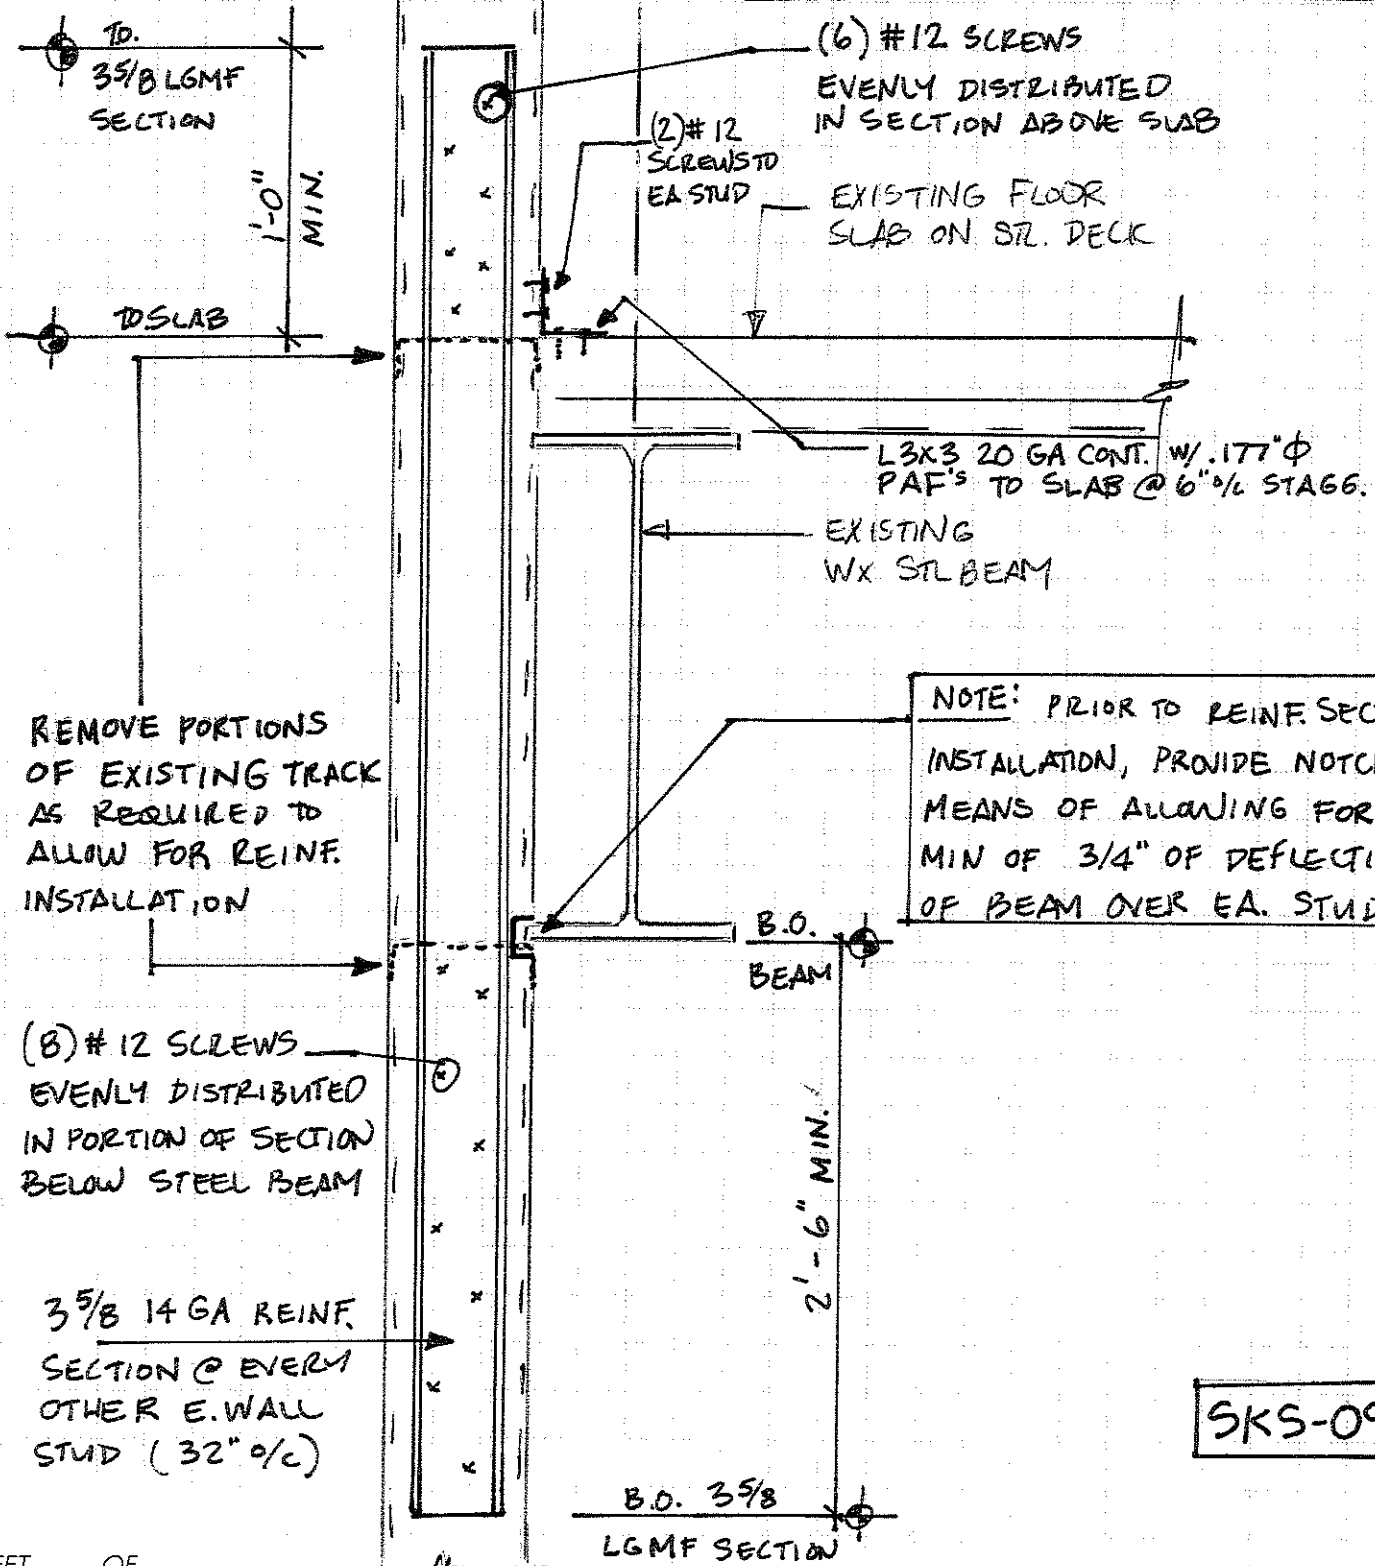
SKS-09

Along the "1" line of the structure, in bays at various levels, there were locations in which the 6" LGMF exterior wall did not bypass the floor framing as shown in the design. The LGMF at the exterior wall must resist out of plane wind loading (both pressure and suction). Said loading must be transferred directly to the floor diaphragm as indicated on the structural details. As viewed the LGMF terminated at the bottom flange of the steel beams, thus creating the potential for lateral loading (kicking in) at the bottom flange of the beam. Due to the exposed finish ceiling, it is not feasible to add wind bracing from the bottom flange of the beam to the floor diaphragm. Please refer to the attached sketch, SKS-09, which indicates the LGMF reinforcing required to transfer the support of the stud framing from the bottom flange of the beam to the design location near the top of the beam.

NOTE: APPLICATIONS OF THIS SECTION MUST APPLY AT EACH LEVEL ALONG "1" LINE WHERE LGMF WALL INTERRUPTED BY BEAM

NOTE: PRIOR TO REINF. SECTION INSTALLATION, PROVIDE NOTCH OR MEANS OF ALLOWING FOR A MIN OF 3/4" OF DEFLECTION OF BEAM OVER EA. STUD
