Development Review Application
Planning Division Transmittal Form

Application Number: 2013-097 **Application Date:** 04/17/2013
CBL: 156 F006001 **Application Type:** Level I Site Alteration
Project Name: Slope Re-Construction - Back Cove Estates
Address: 1 BACK COVE ESTATES
Project Description: Reconstruction of a failed embankment. Original embankment slid down the hill and came to rest in and adjacent to Fallbrook.
Zoning: R3

Activity Description

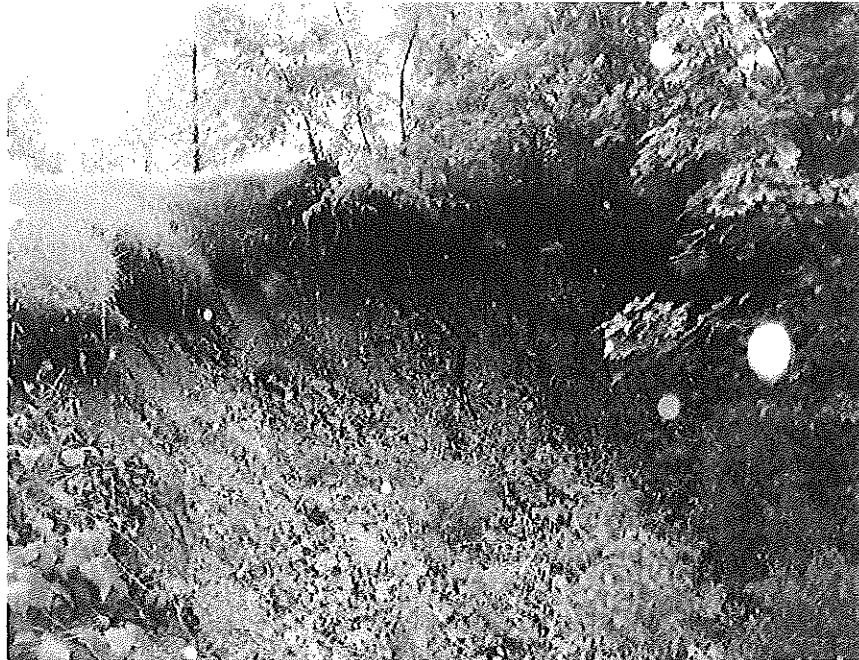
Back Cove Estates Road forms a loop through the property. Along the eastern side of the loop road - nearest to Unit #61- part of the embankment has washed down the slope, leaving a deposit of soft clay and top soil along the edge of Fall Brook. The slope failure is located approximately 15' east of the access road. A 6'-8' tall nearly vertical face marks the beginning of the slide plane. The slide area is approximately 20' wide nearest to the access road and widens as it nears the brook. Another slide appears likely in the area directly to the south. A crack has formed that emanates out of the southern edge of the exposed vertical face. The crack runs away from the failure line at about a 30 degree angle and leads down the embankment toward the brook. We have labeled this crack on the attached plans as the location of potential secondary failure.

S.W.Cole performed a geotechnical reconnaissance to determine the likely cause of the embankment failure. They examined the embankment and performed a series of hand borings. They determined that the original embankment had a small layer of organics on top of a 5' deep layer of soft clay that was resting on top of a layer of hard clay. They concluded that the slope failure was likely due to toe erosion that undermined the stream bank and caused a shallow surface failure.

A 6'-8' high vertical face is located along the upper rim of the slide.

The slide plane formed at the interface of the soft & hard clay. They recommended that the area be repaired by armoring the stream bank with a boulder wall, removing the slide debris to expose undisturbed native clay and keying in a compacted granular borrow fill to re-establish the slope. A copy of their report is attached to this section.

We propose to reconstruct the slope to its approximate original grade. The soft clay and organic slide material will be removed. The underlying stiff clay will be terraced to allow for the stable installation of granular fill material. The granular fill will allow for proper compaction of the reconstructed slope.

Riprap will be placed along the edge of Fall Brook and will extend up to the 100 year flood elevation. The riprap directly adjacent to the brook will have a large diameter, typically 2'-3'. We propose large boulders in this area for two reasons. First, the large stones will help to support the newly constructed embankment. Secondly, the shore of Fall Brook has an approximately 2' high vertical face in the area adjacent to the project area. The large rocks -being the same height as the existing vertical face- will allow for an easy transition back into the natural stream bed at the edge of the riprap.
