**INDOOR ENVIRONMENTAL QUALITY ASSESSMENT
208 FORE STREET
CITY OF PORTLAND, CUMBERLAND COUNTY, MAINE**

Project 066065
October 20, 2006

RE: Indoor Environmental Quality Assessment
208 Fore Street, Portland, Maine

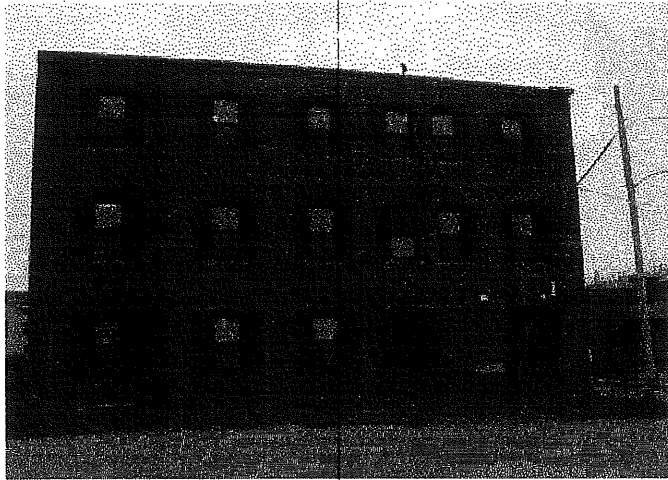
The building is currently leased and occupied by Parco as a business office, located at 208 Fore Street, intersecting with India Street. The building is an old, brick structure that appears to have some structural issues particularly related to the north exterior wall. Abrasive blasting of the brick surface on the north wall was reported to have occurred a few years ago.

The north wall on the basement level of 208 Fore Street has been impacted by water and visible mold growth on the surfaces of drywall, wood, concrete, brick, linoleum, carpeting, and cardboard materials. It's likely that the cause of the water intrusion may be from the abrasive blasting of the north wall which could have removed the hard, outer protective surface, making the brick more susceptible to weathering and degradation. In addition, use of abrasive materials to clean or remove paint may increase water permeability of the brick wall. The impact of the abrasive material has a tendency to erode the mortar and brick bond, leaving cracks or enlarging existing cracks creating a pathway for water to enter the interior space.

Exterior of north wall, 208 Fore Street.

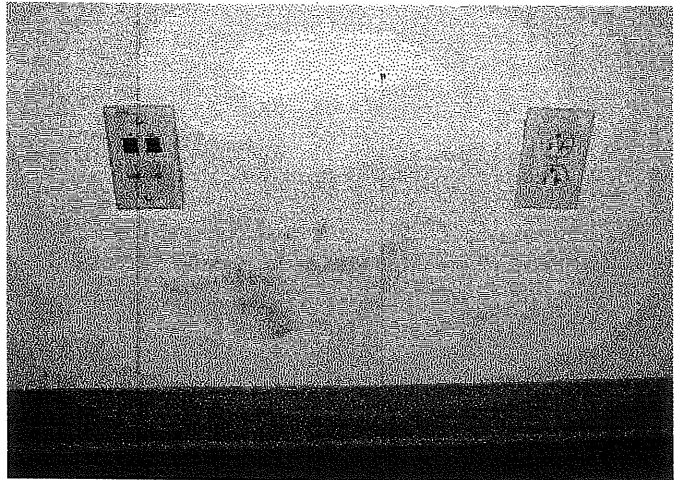
Mold growth on drywall in basement office.

Considering the IEQ assessment findings and reported employee health issues, the basement office space at 208 Fore Street should not be occupied by office staff until the moisture issue is corrected and impacted building materials are properly cleaned and abated. Furthermore, mold spores can travel passively through the air or mechanically through the HVAC system to areas beyond the basement. Occupancy of other work areas such as the first floor office space should also be avoided until water intrusion issues are addressed and repaired and mold-contaminated building materials are cleaned and/or remediated.

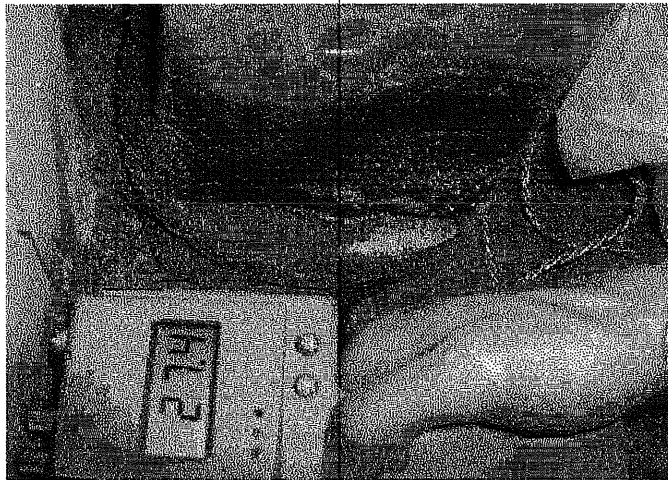
Moisture meter reading of wood support in electrical panel room and wet moldy cardboard box.

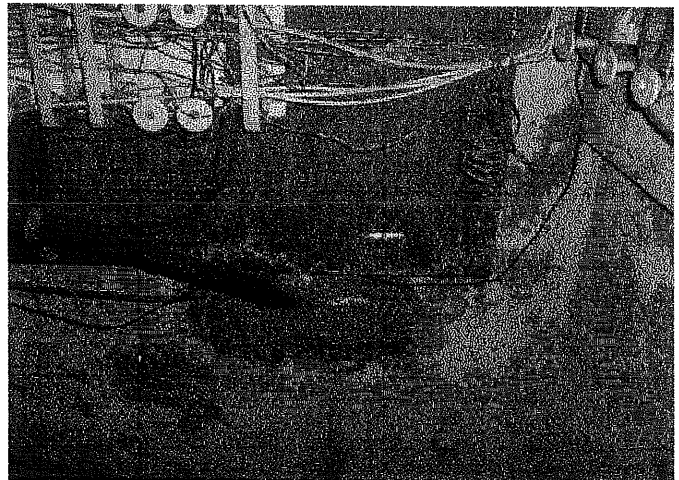
The species identified in sample TL-1 is *Aspergillus* sp. Sample results are summarized on Table 1 and laboratory results are attached at Appendix B.

Mold growth and water staining on telephone network mount.

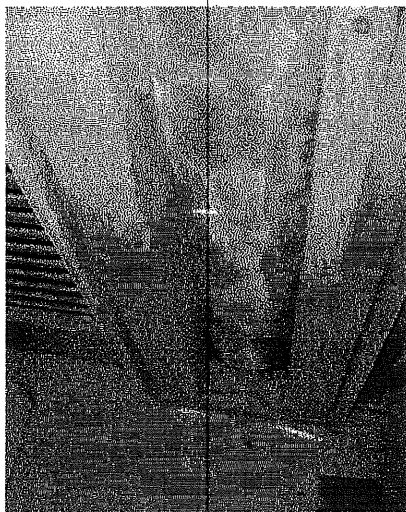
Mold growth on drywall in kitchenette closet

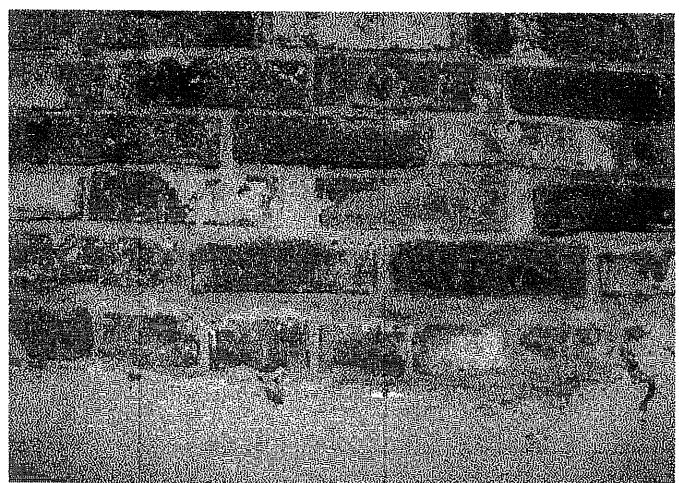
Mineral deposits on brick interior wall from water intrusion.
