RE: Re: 39 Portland Pier: Structural Analysis – Plan of Action

Substructure Survey  
**39 Portland Pier**  
Portland, Maine

EXECUTIVE SUMMARY .....	2	
STRUCTURAL ANALYSIS .....	4	
RECOMMENDED REHABILITATION PROGRAM .....	6	
APPENDICIES .....	8	
APPENDIX A	REFERENCE DOCUMENTS .....	A
APPENDIX B	TABULATED SUMMARY .....	B
APPENDIX C	CONDITION PHOTOGRAPHS .....	C
APPENDIX D	PLANS .....	D

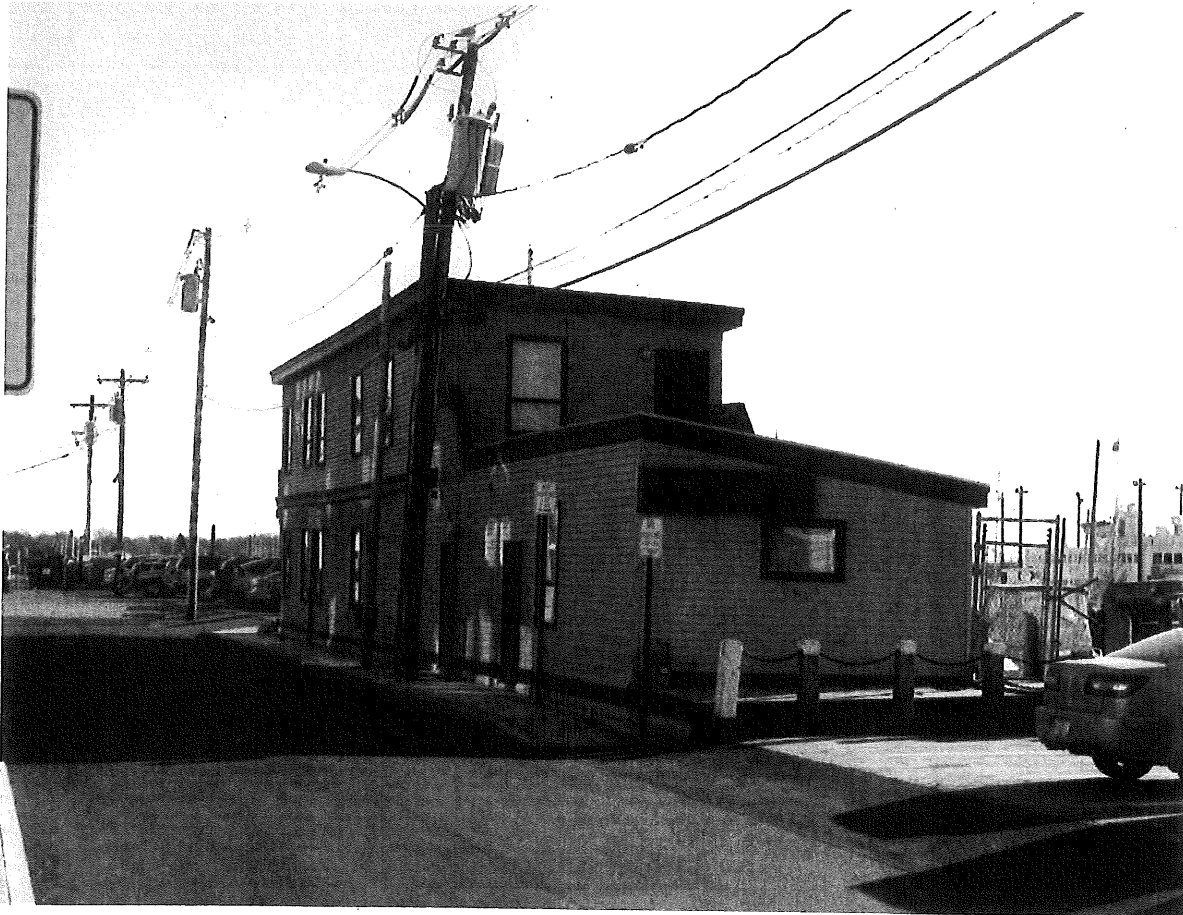
The 39 Portland Pier building is located on a pile supported timber pier. Note new road/sidewalk construction.

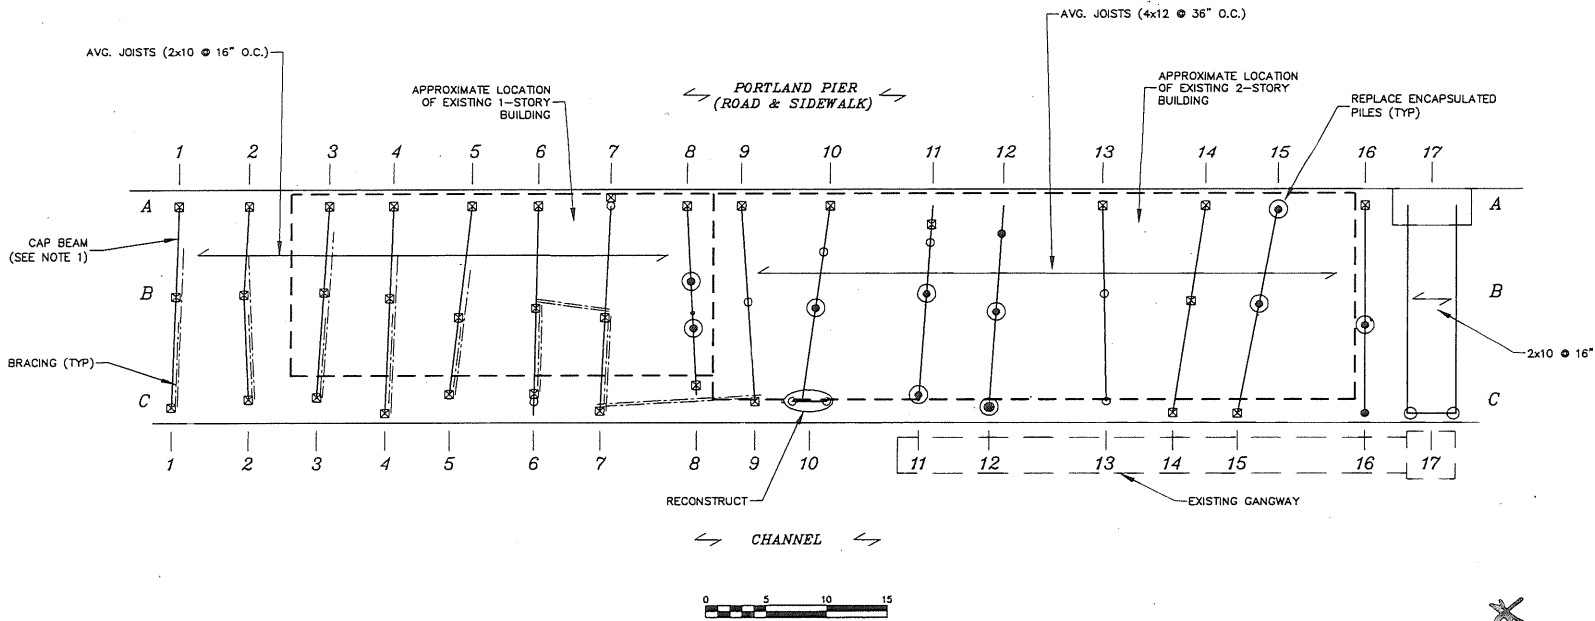
1. SEE TYPICAL SECTION ON SHEET 2.
2. RECOMMENDATIONS FOR REHABILITATION AND ANNUAL MAINTENANCE BASED ON NOV 2008 SITE INSPECTION AND CONDITION ASSESSMENT REPORT DATED 1/21/09..

**RECOMMENDATIONS FOR 2009 REHABILITATION:**

- ⊙ - REMOVE AND REPLACE ENCAPSULATED PILES WITH PT POST, ADD BRACING.
- - REMOVE AND REPLACE DETERIORATED PILE WITH PT POST, ADD BRACING.
- ⊖ - REPLACE EXISTING TWIN PILE SUPPORT WITH NEW PILE SUPPORT WITH PILE(S) THAT EXTEND FROM MUDDLINE TO TRANSVERSE CAP BEAM AT DECK LEVEL.
- REMOVE DEBRIS FROM SLOPE.

- GRID LINE "C" REPLACE FENDER PILES AND EDGE BEAM.
- CHECK BRACING FOR DAMAGE AND REPLACE.
- CHECK JOISTS AND SISTER AS REQUIRED.
- INSPECT PIER ON AN ANNUAL BASIS.

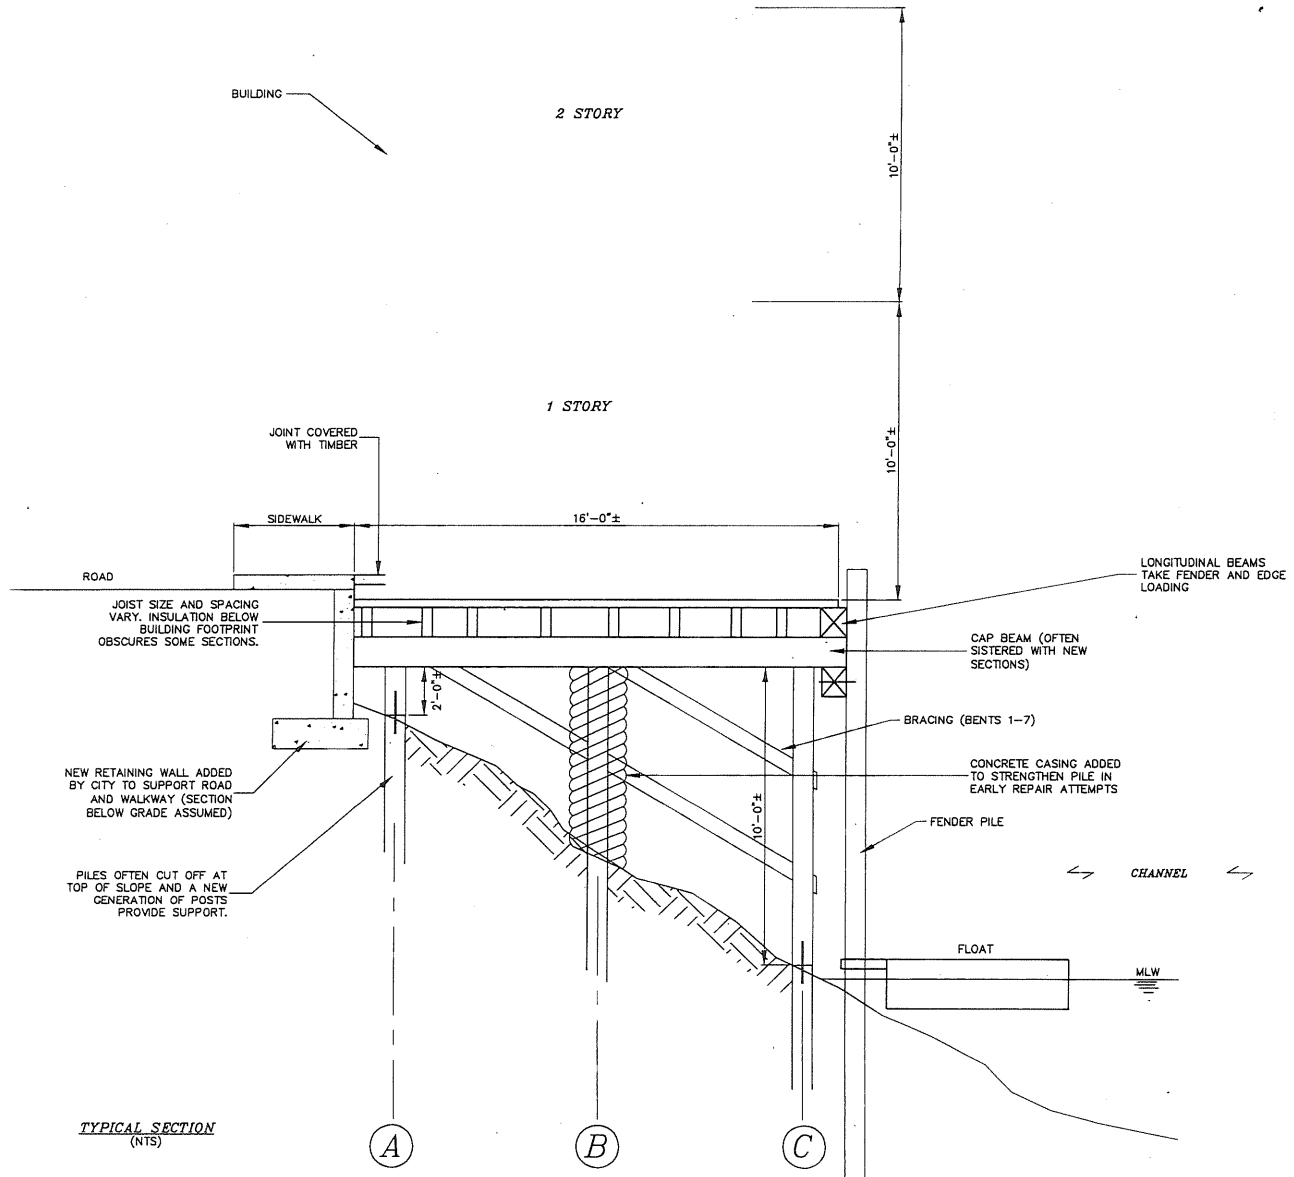
TYPICAL SECTION  
(NTS)

- *Diagonal bracing* -Diagonal bracing of the original pile configuration is minimal. This can be attributed to the fact that the piles are so short and significant lateral stability is gained from continuity with the driven section. As these piles are replaced with posts pinned to the original pile section that extends below the surface, the behavior changes. Lateral load and uplift capacity are reduced and must be compensated with the addition of lateral bracing. Refer to Sheet 2 –*Typical Section*.

3. To reduce the chance of damage caused by floating debris, all obsolete piles and timber elements should be removed below the pier. This would include waterlogged debris that may be shifted by ice.
4. Replace fourteen (14) piles that were previously encapsulated with concrete as noted on Sheet 1 – *Pier Structure Plan* and Sheet 2 -*Typical Section* located in APPENDIX D. The concrete encapsulation is failing, exposing the original timber sections. Cutting the existing pile off at the mudline and pinning an 8-1/2 x 8-1/2 PT post to remaining section is acceptable provided the pile is in good condition below the mudline. Add bracing in accordance with Sheet 2.

6. Diagonal bracing of the original pile configuration is minimal. This can be attributed to the fact that the piles are so short and significant lateral stability is gained from continuity with the driven section. As these piles are replaced with posts pinned to the original pile section that extends below the surface, the behavior changes. Lateral load and uplift capacity are reduced and must be compensated by additional lateral bracing.
