Substructure Survey  
**39 Portland Pier**  
Portland, Maine

**Client:**  
Daniel G. Lilley Law Offices  
39 Portland Pier  
P.O. Box 4803  
Portland, ME 04112

## Executive Summary

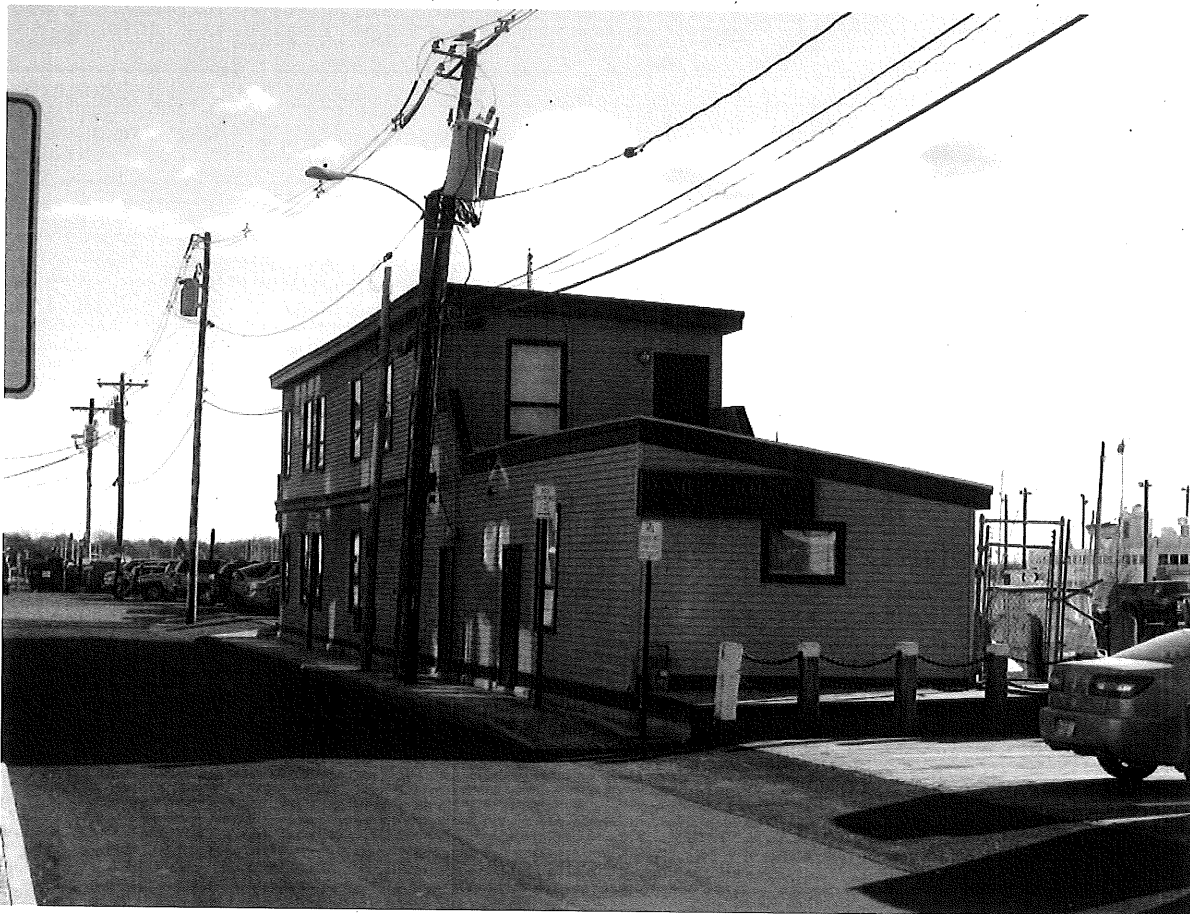
**The 39 Portland Pier building is located on a pile supported timber pier. Note new road/sidewalk construction.**

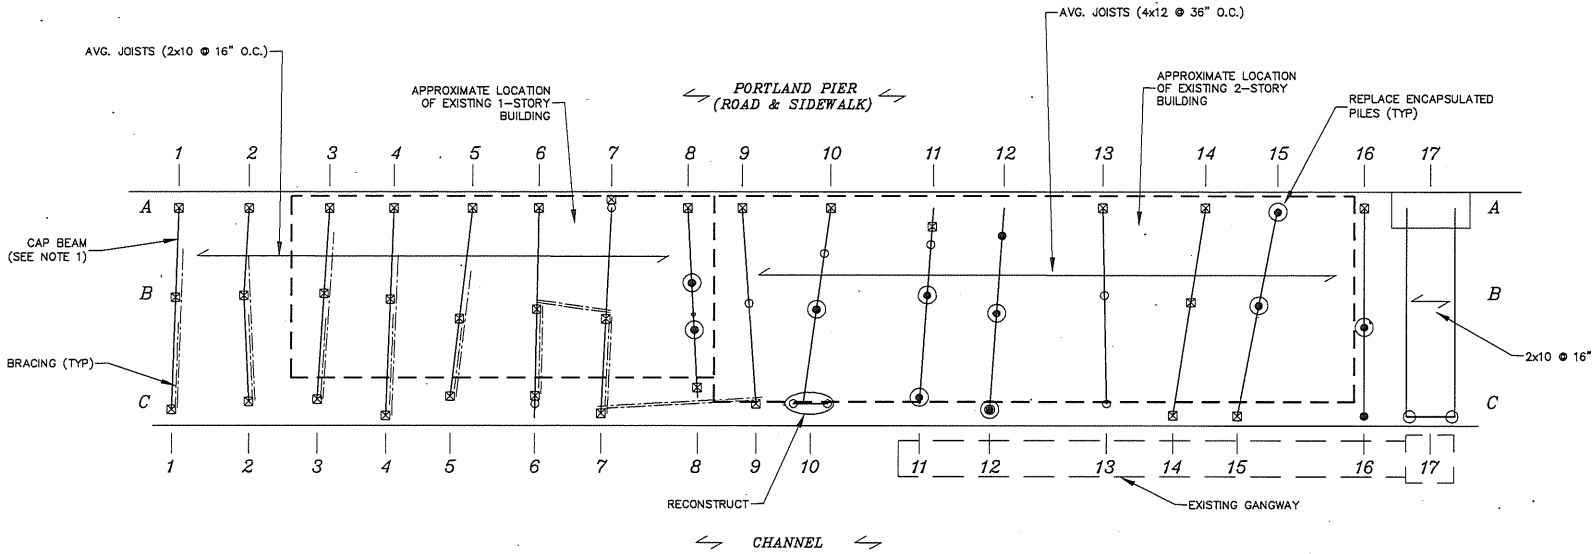
<b>SHEET TITLE: PIER STRUCTURE PLAN</b> <b>PROJECT: DANIS &amp; LILLEY PIER CONDITION SURVEY</b> PORTLAND WHARF, PORTLAND, MAINE	
DATE: 12-08-08 CONTRACT NO. 08046 SHEET NO. 1 of 2 REV.

Today, 39 Portland Pier is a pile/post supported timber structure that spans a filled slope that extends from the central pier roadway (Portland Street) to the shared channel with Long Wharf. Refer to Sheet 1 *Pier Structure Plan* and Sheet 2 *Typical Section* located in APPENDIX D. It is reported that the existing law offices were originally a sail repair business with an open plan upper floor area. Adjacent sections of the pier are used for parking.

3. To reduce the chance of damage caused by floating debris, all obsolete piles and timber elements should be removed below the pier. This would include waterlogged debris that may be shifted by ice.
4. Replace fourteen (14) piles that were previously encapsulated with concrete as noted on Sheet 1 – *Pier Structure Plan* and Sheet 2 -*Typical Section* located in APPENDIX D. The concrete encapsulation is failing, exposing the original timber sections. Cutting the existing pile off at the mudline and pinning an 8-1/2 x 8-1/2 PT post to remaining section is acceptable provided the pile is in good condition below the mudline. Add bracing in accordance with Sheet 2.

- RECOMMENDATIONS FOR 2009 REHABILITATION:**
- - REMOVE AND REPLACE ENCAPSULATED PILES WITH PT POST, ADD BRACING.
  - - REMOVE AND REPLACE DETERIORATED PILE WITH PT POST, ADD BRACING.
  - - REPLACE EXISTING TWIN PILE SUPPORT WITH NEW PILE SUPPORT WITH PILE(S) THAT EXTEND FROM MUDDLINE TO TRANSVERSE CAP BEAM AT DECK LEVEL.
  - REMOVE DEBRIS FROM SLOPE.

- LONGER TERM MONITORING AND MAINTENANCE**
- GRID LINE 'C' REPLACE FENDER PILES AND EDGE BEAM.
  - CHECK BRACING FOR DAMAGE AND REPLACE.
  - CHECK JOISTS AND SISTER AS REQUIRED.
  - INSPECT PIER ON AN ANNUAL BASIS.

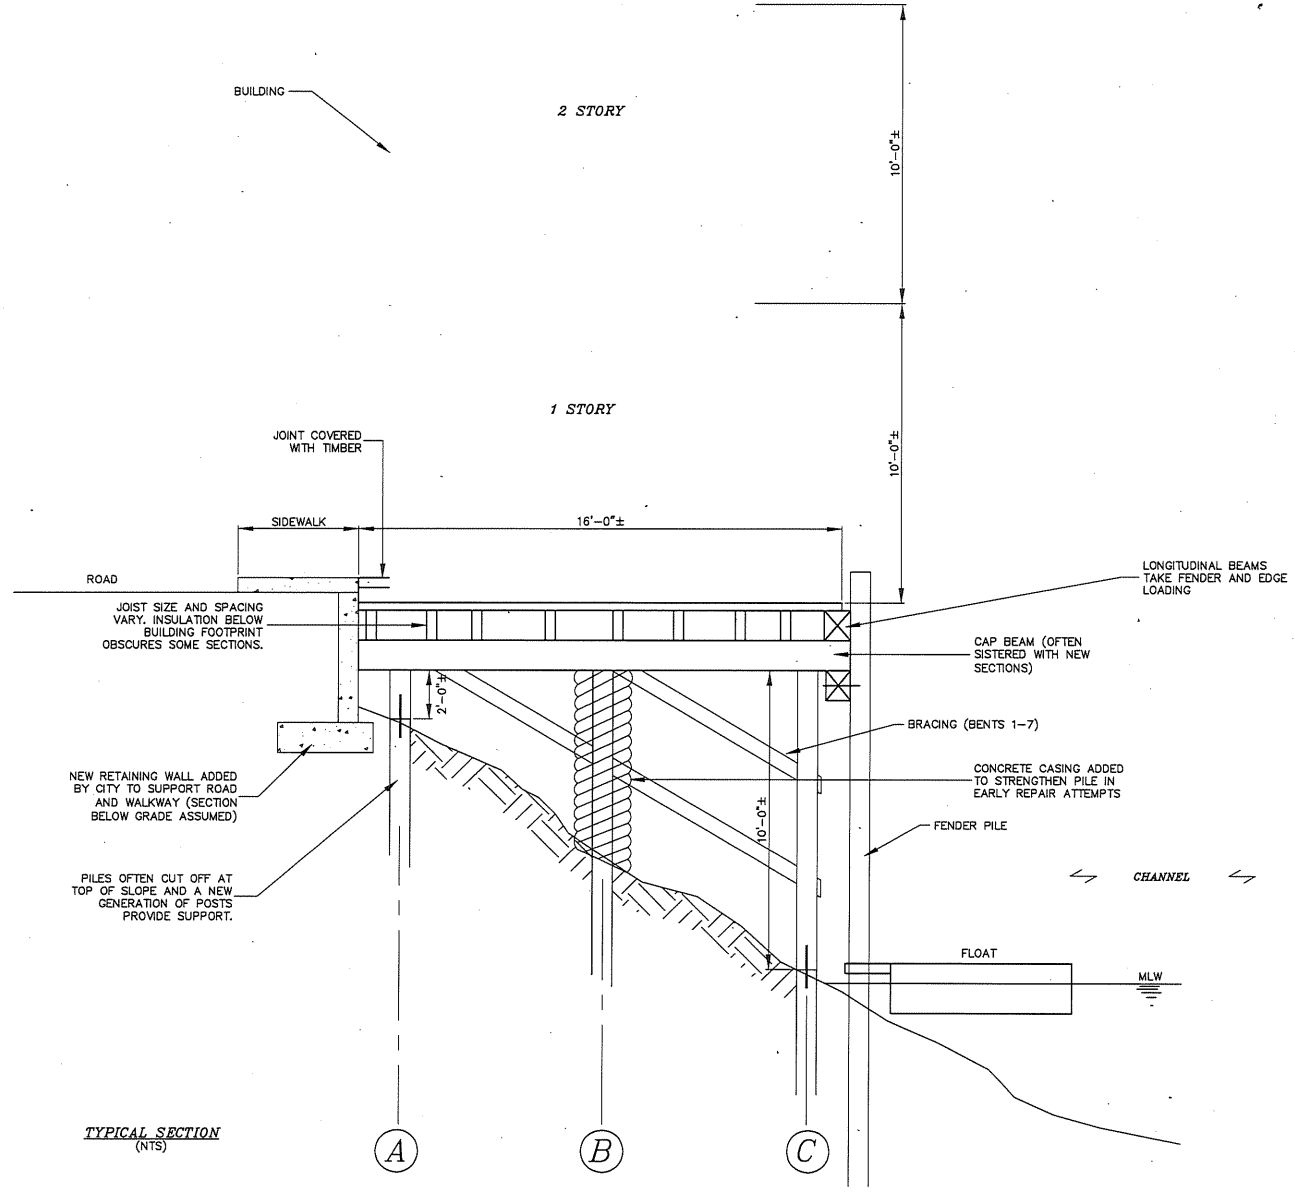
TYPICAL SECTION  
(NTS)

- *Diagonal bracing* -Diagonal bracing of the original pile configuration is minimal. This can be attributed to the fact that the piles are so short and significant lateral stability is gained from continuity with the driven section. As these piles are replaced with posts pinned to the original pile section that extends below the surface, the behavior changes. Lateral load and uplift capacity are reduced and must be compensated with the addition of lateral bracing. Refer to Sheet 2 -*Typical Section*.

6. Diagonal bracing of the original pile configuration is minimal. This can be attributed to the fact that the piles are so short and significant lateral stability is gained from continuity with the driven section. As these piles are replaced with posts pinned to the original pile section that extends below the surface, the behavior changes. Lateral load and uplift capacity are reduced and must be compensated by additional lateral bracing.
