Structural Special Inspections Report

Canal Zero

Portland, Maine
October 6, 2017

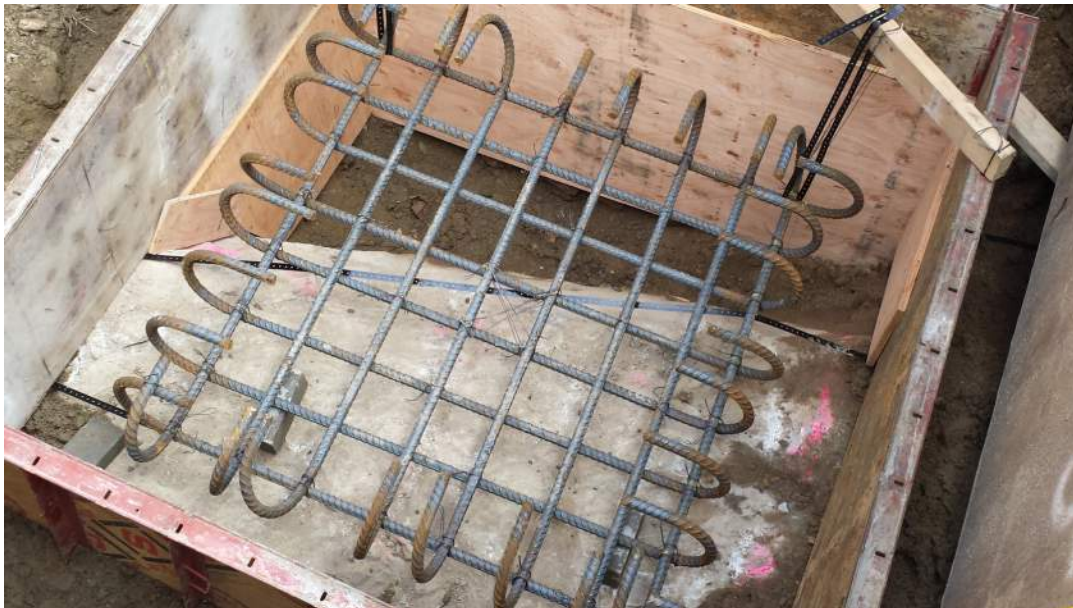
At the footing near WP-4, a sharp drop in the ledge was observed of approximately 3 feet (refer to photo 1). The drop is very steep, and then flattens out immediately. The majority of the footing bears on flat ledge, with only a small horizontal projection that encounters the sloped portion. Therefore, potential lateral forces from the uneven bearing surface will be small, and can be adequately resisted by vertical rebar pins.

Photo 1: Steep Drop in Ledge Profile at Footing Near WP-4

to be drilled and epoxied to a depth of 12" into the ledge. The GC provided photos of the completed pin installation (refer to photo 2).

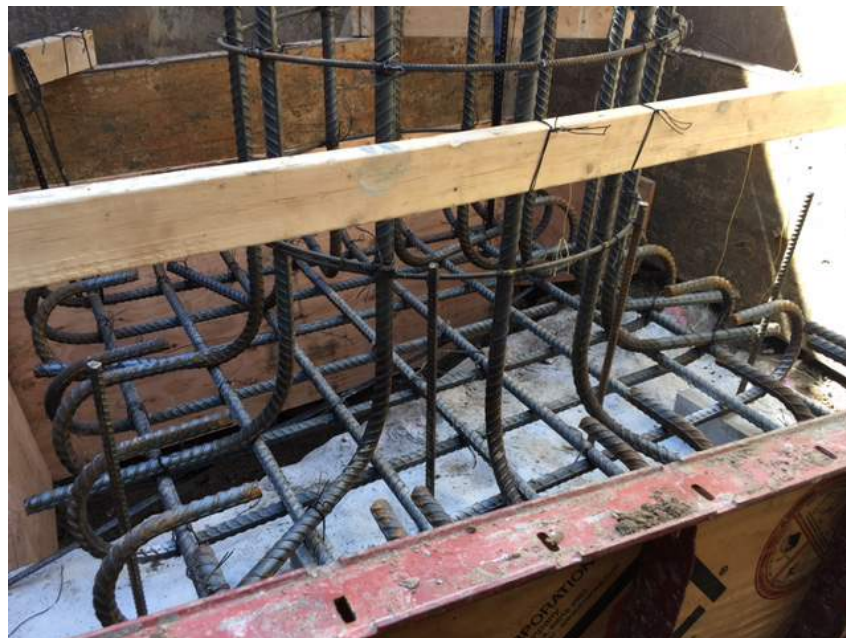
Photo 2: Vertical Pins Added to Stabilize Footing on Uneven Ledge

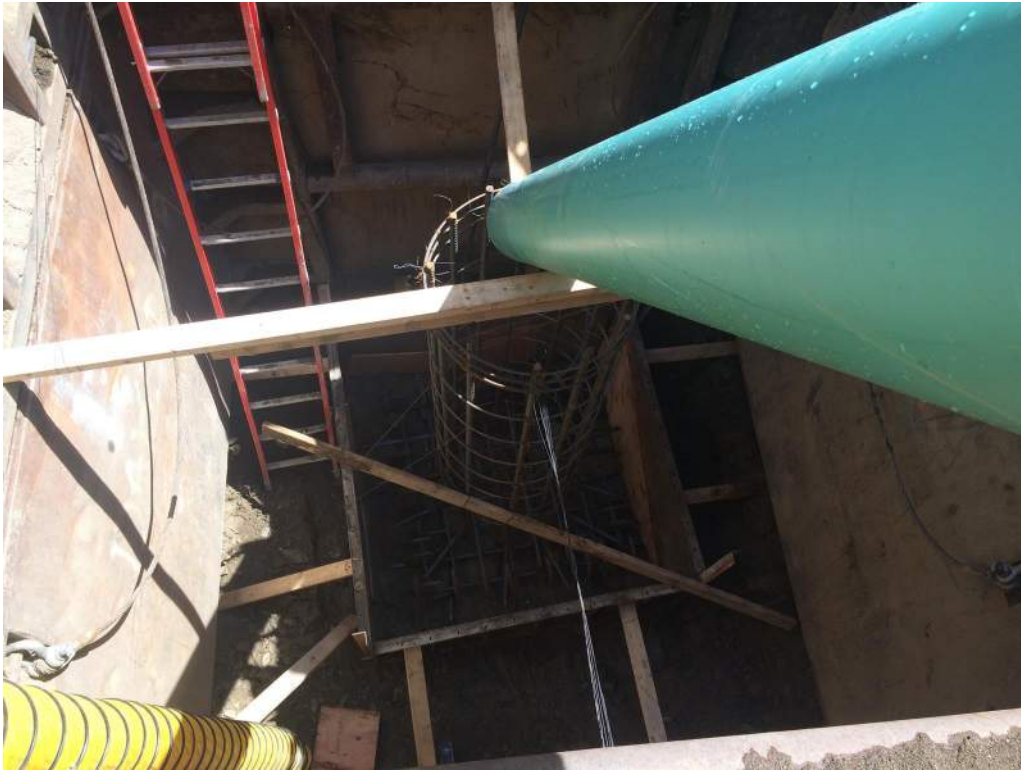
At the time of my visit the footing at WP1 was ready for placement. Excavation for the new planter wall was ongoing, and drilling of dowels for new masonry bearing shelves at existing walls had commenced. All condition appeared to conform with drawings.

Photo 1: Preplacement view of footing.

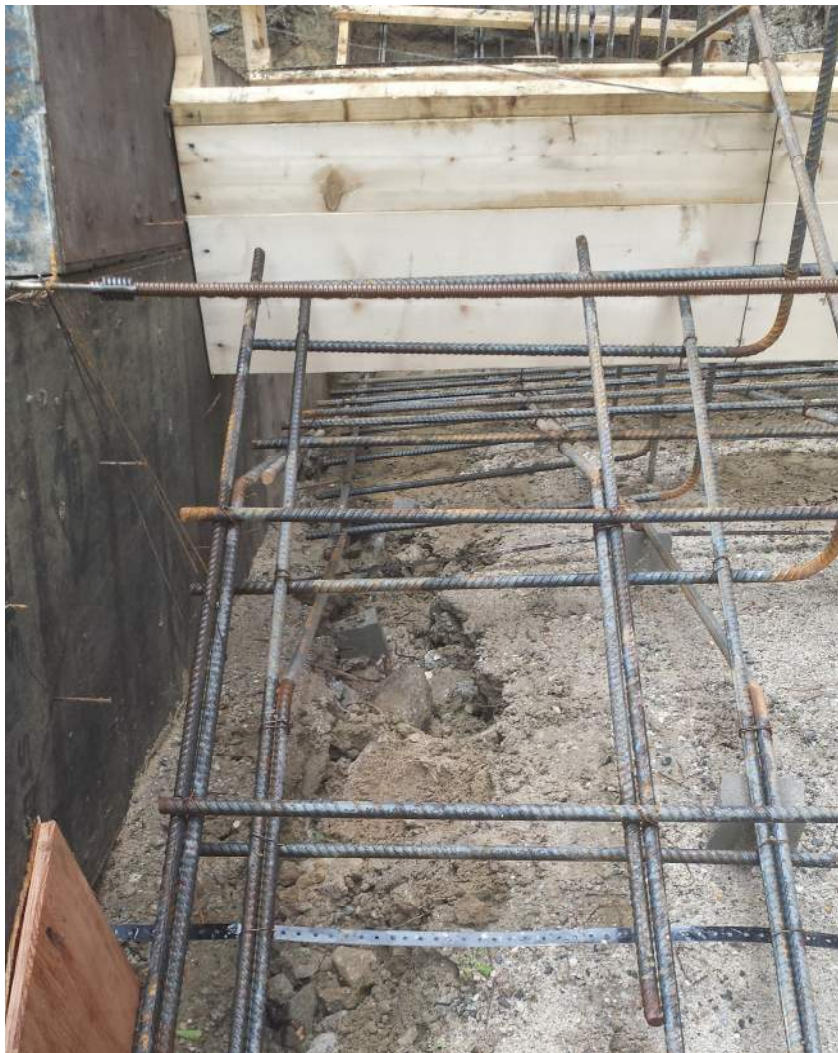
The footing steps up about 6 feet in elevation as it moves to the east. At this sloped/stepped portion, some of the grade washed out during rains over the weekend (see attached photos). These photos were sent to S.W. Cole for review while I was on site. S.W. Cole confirmed that the condition was not detrimental to the footing bearing, and the voids created by the washout could be filled with additional concrete. No further corrective action was required.

Photo 1: Washed out Grading Below Footing

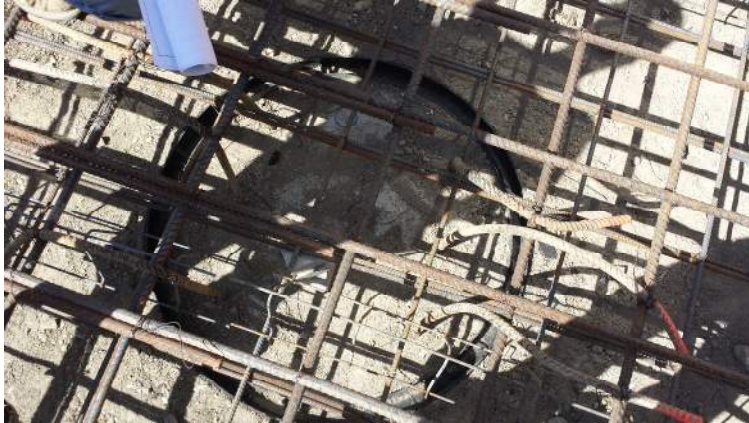
At the center pier support, the (4) of the (6) embedded dowels into the mat slab from the pier had been damaged during construction. The GC was made aware of this condition. New dowels were added to replace the damaged ones, and the original dowels were allowed to remain in place (refer to photos 1 and 2).

Photo 1: Damaged dowels at pier

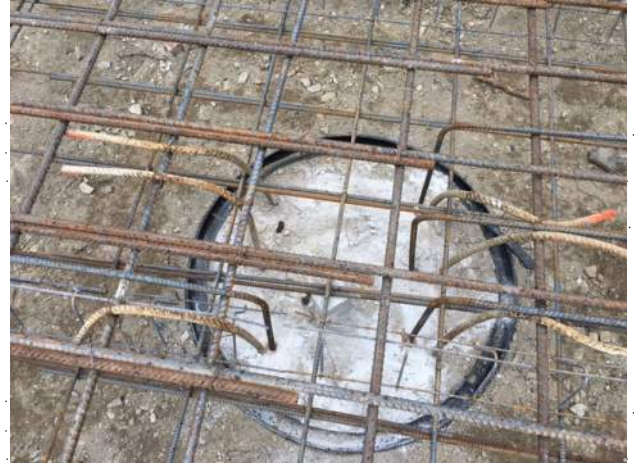
Photo 2: Four replaced dowels at pier

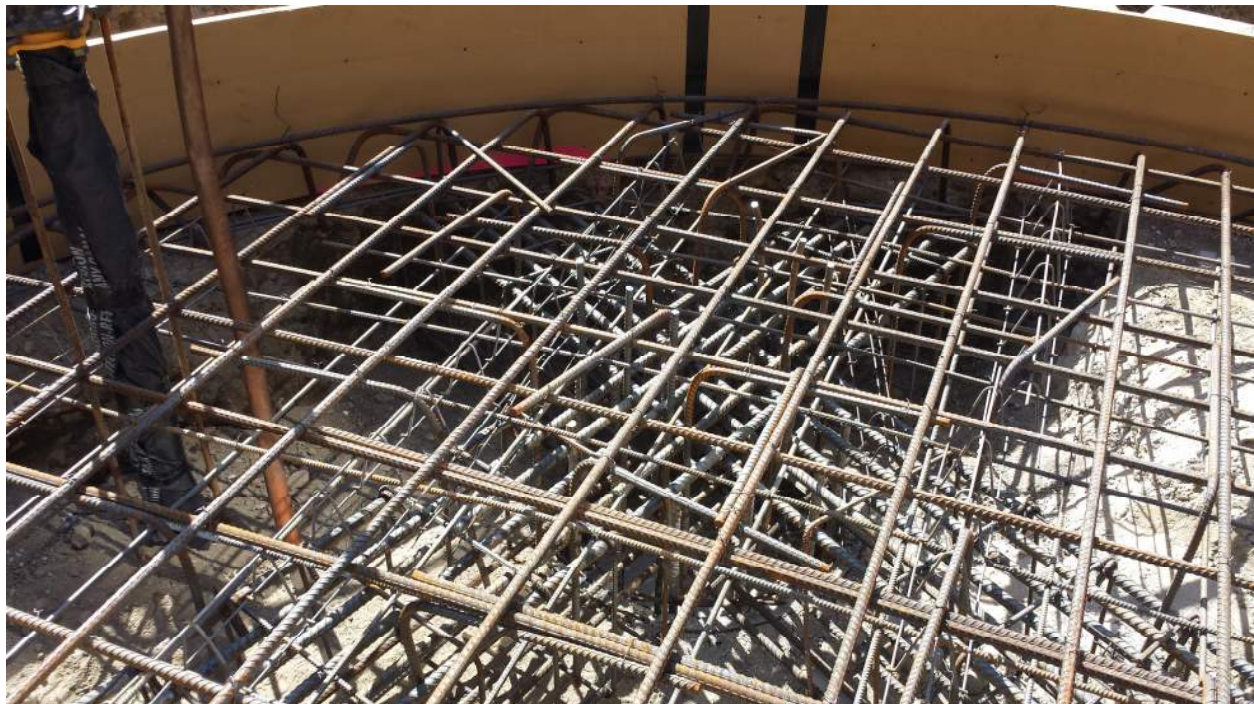
On drawing S1.1, the horizontal bars in the grade beams between WP-3 and WP-4 and between WP-1 and WP-6 are indicated to have top and bottom priority. This means that the horizontal bars in these beams shall be located as close to the top and bottom of beam as possible. I observed that the bar priority was actually reversed on site, and the priority was given to the other grade beams. The result is a decrease in bending

strength of the beams that are intended to have more strength. After performing an analysis of the as-built condition, we determined that the beams still had adequate capacity for the applied loads. No further corrective action will be required by the GC.

Photo 3: Grade beam horizontal bars with reversed priority (grade beam on right side should have top-most bars instead of grade beam on the left side)

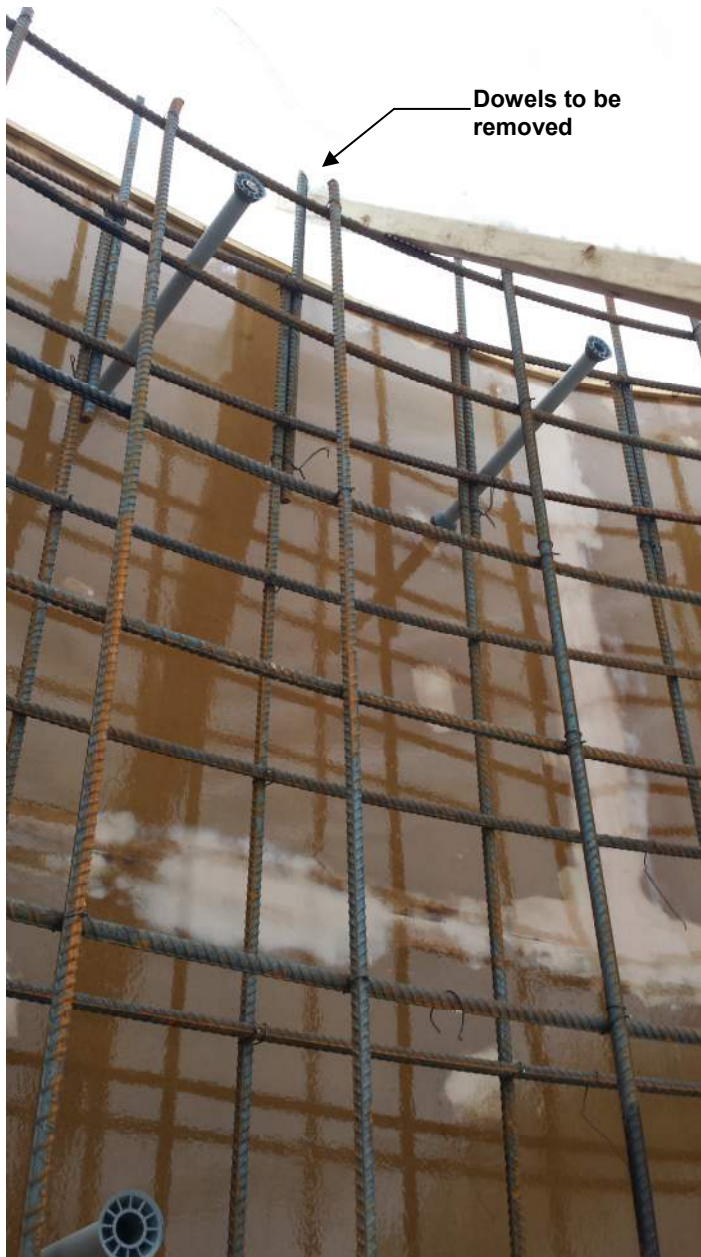
Photo 1: Vertical Dowels in the Wrong Position for Sleeve Install in Slab

installed. This is acceptable and will avoid conflicts with the install. We will observe this work during a future site visit.

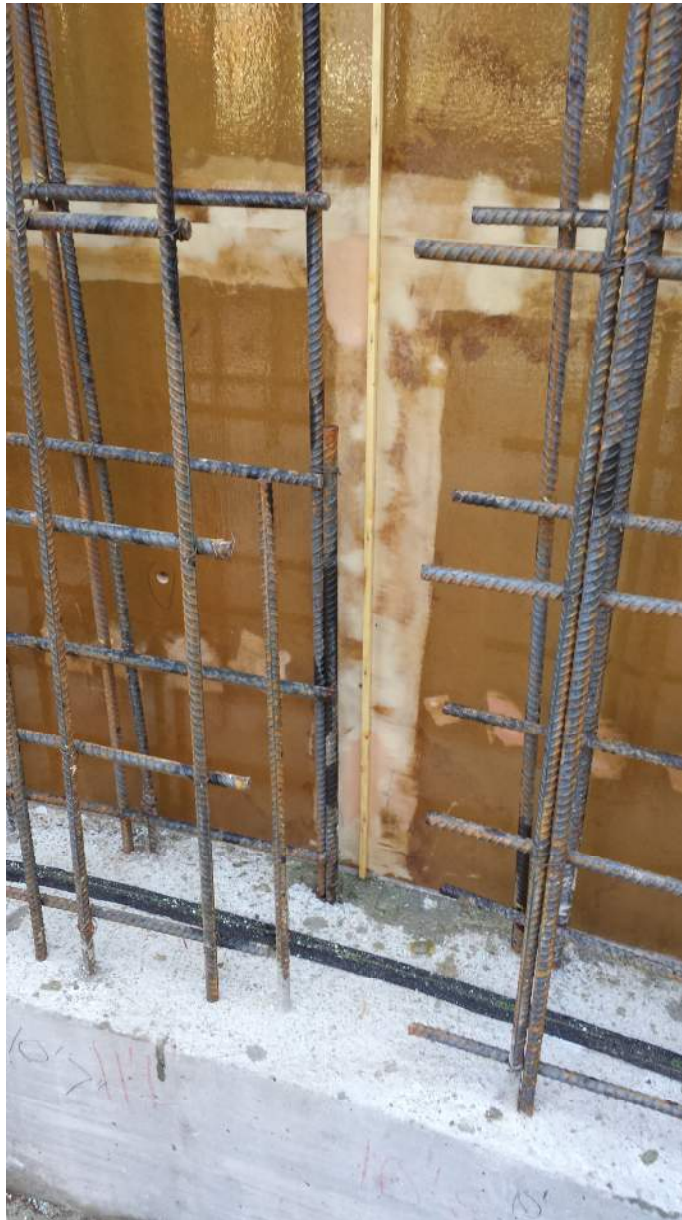
vertical void in the wall to ensure that the concrete is weakened at the joint. Otherwise, future cracks could occur at locations beyond the control joint. It was decided to use a piece of composite trim board (Azek) to form the bondout. A formal sketch incorporating the correct horizontal bar cutting and the Azek bond out will be issued in the near future.

**Photo 1: Vertical Control Joint w/ Horizontal Bars
Cut at Both Wall Faces**

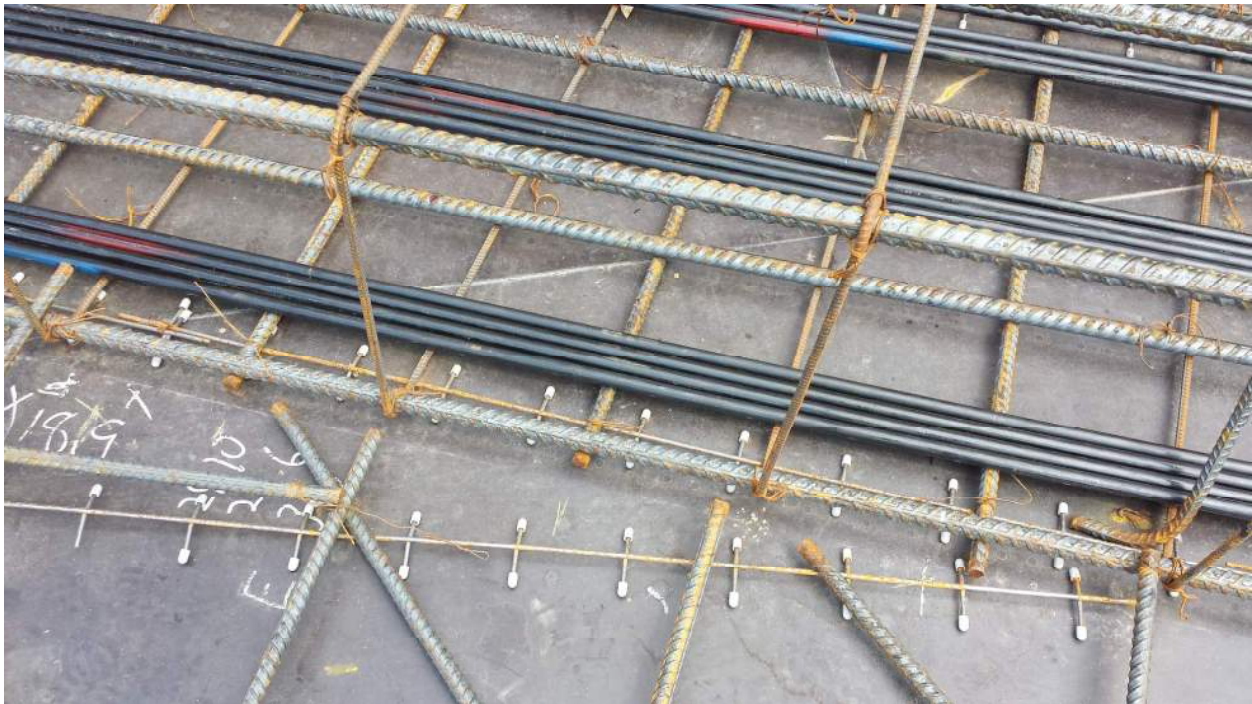
Photo 1 – Bottom Reinforcement Not Extended into Beam

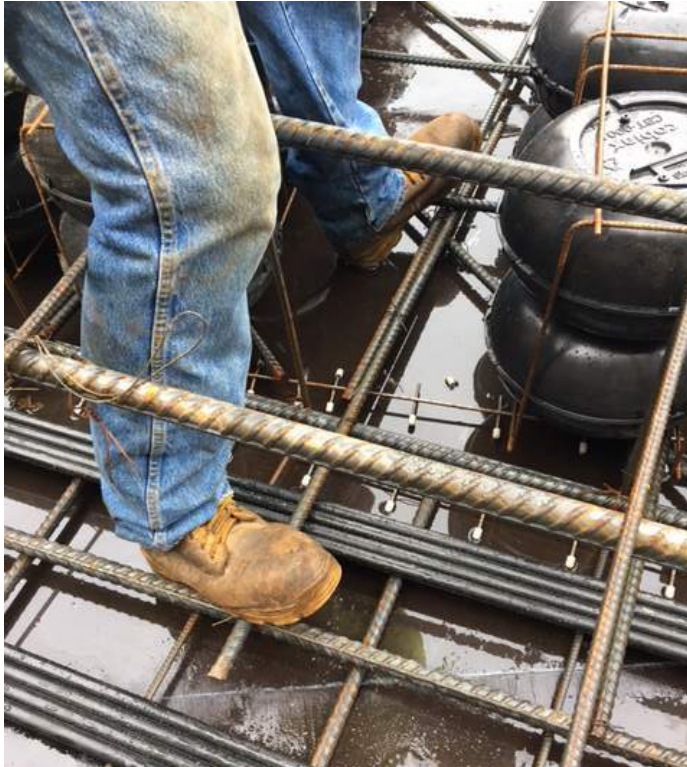
Photo 2 – Lapped Bars Added to Extended into Beam

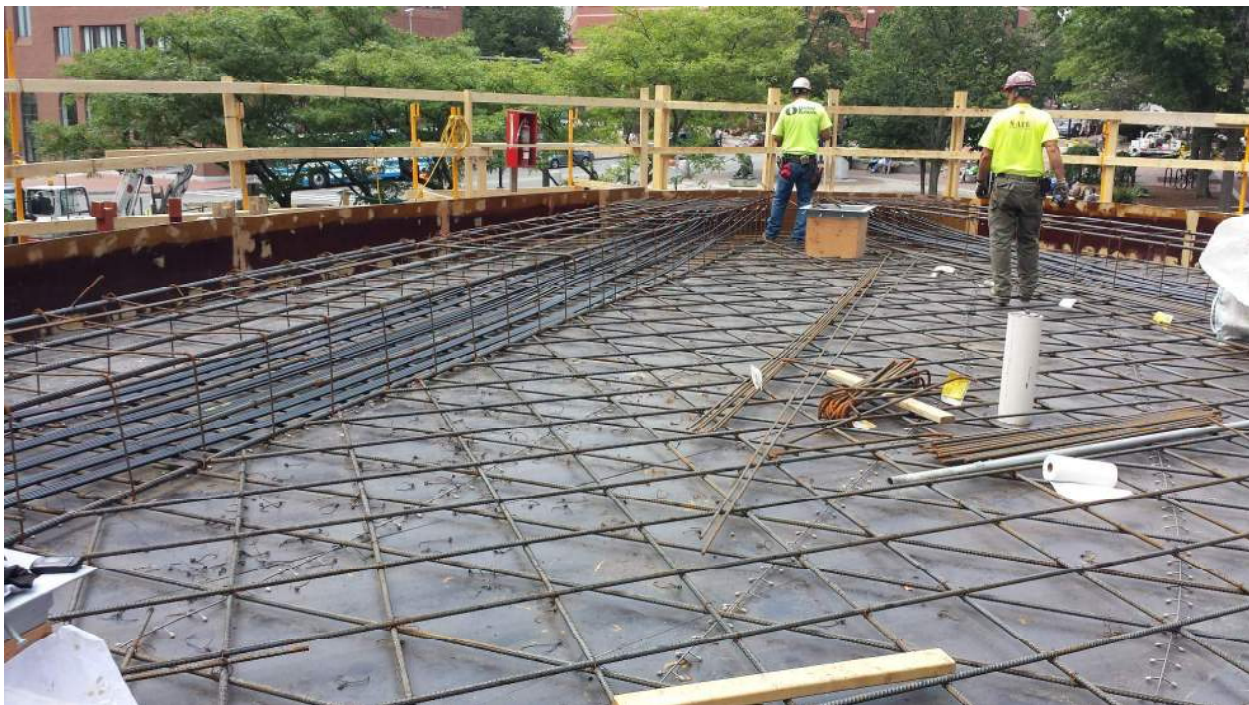
All post-tensioning tendons were laid into the beams at the correct locations. However, since reinforcing construction was on going, the final profile of the tendons has not been set. Thus, the continuous curved profile shown on the drawings is not represented by the actual condition at this time (the tendons "wave" up and down, see photo 3). The GC indicated that the tendons will be set to the correct elevation prior to the final placement. We will inspect this work during a future visit to the site.

Photo 3 – PT tendons in beams not yet laid to correct profile

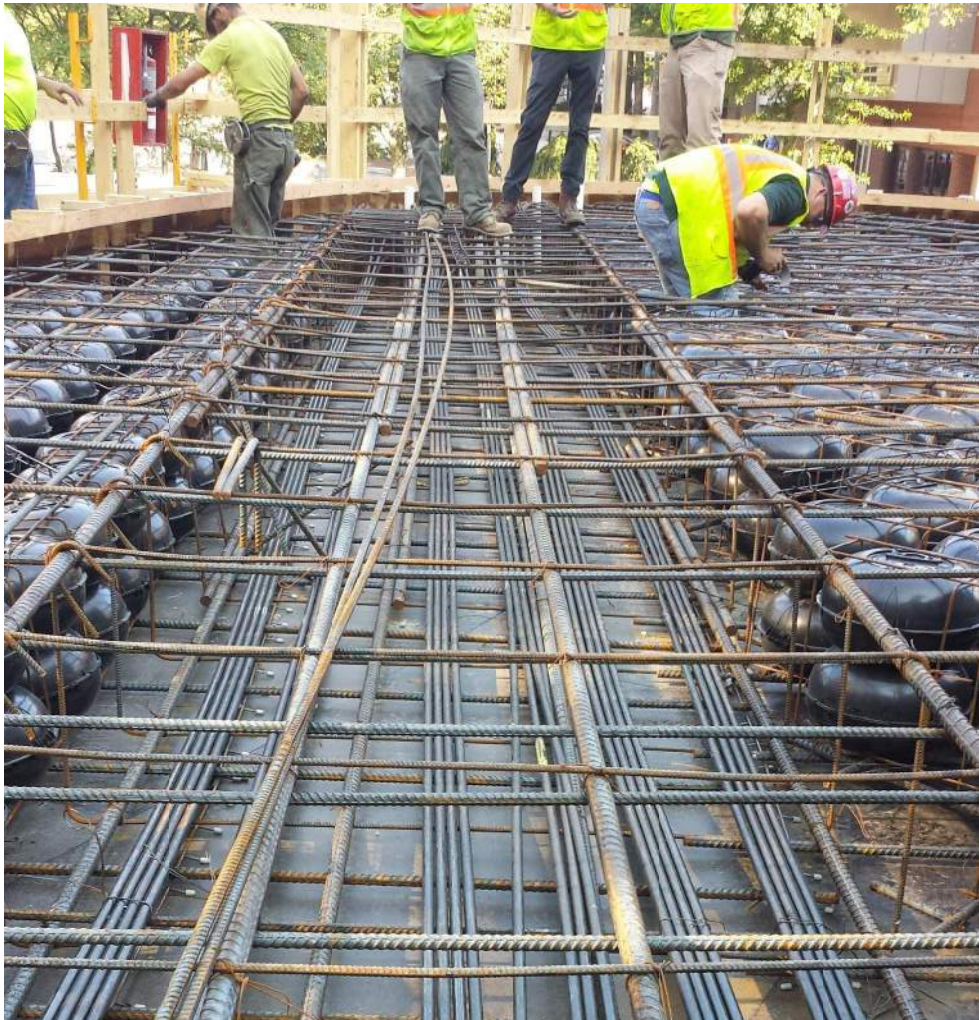
Photo 1 – “Kinked” Tendon Bundle at the end of Beam 1

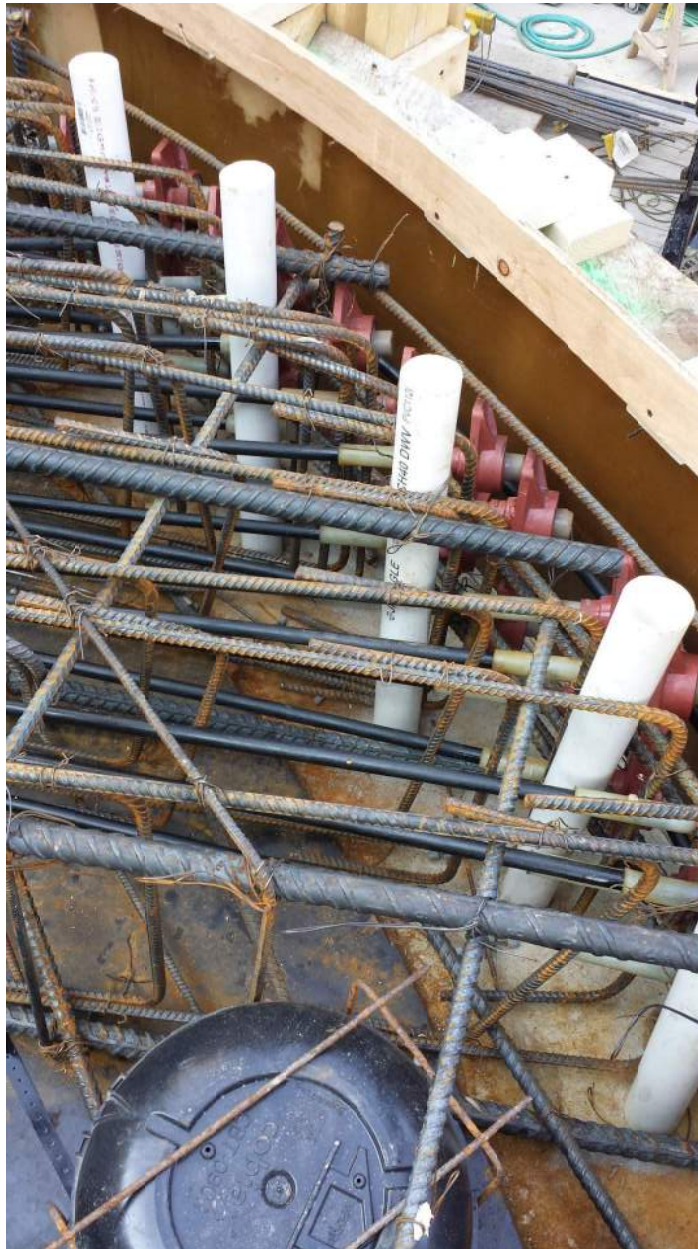
Photo 2 – Hairpins not aligned straight vertical at end of Beam 1

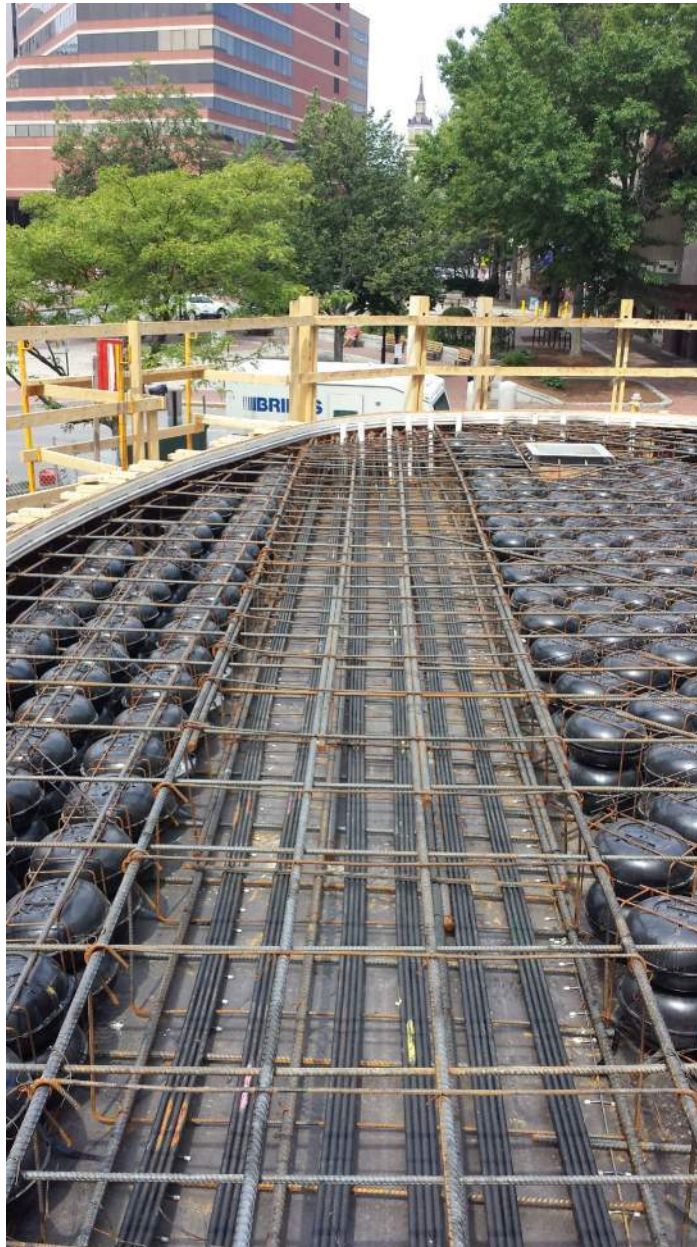
Photo 1 – Straightened Tendons in Beam 1

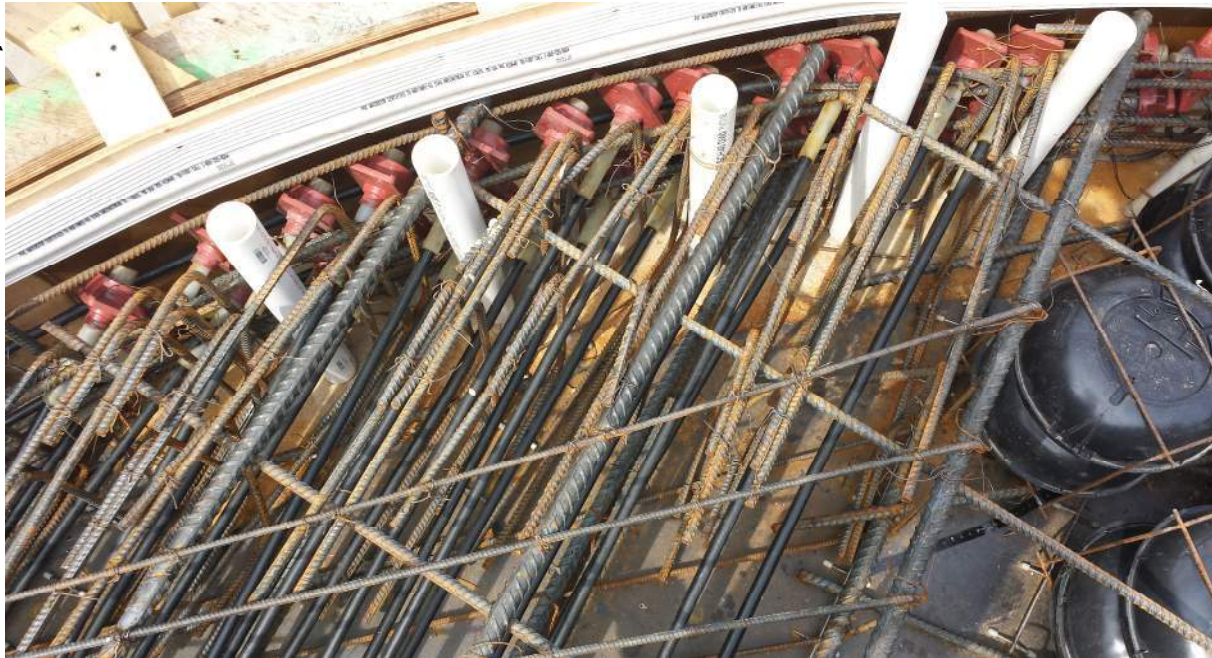
Photo 2 – Hairpins Straightened to Vertical

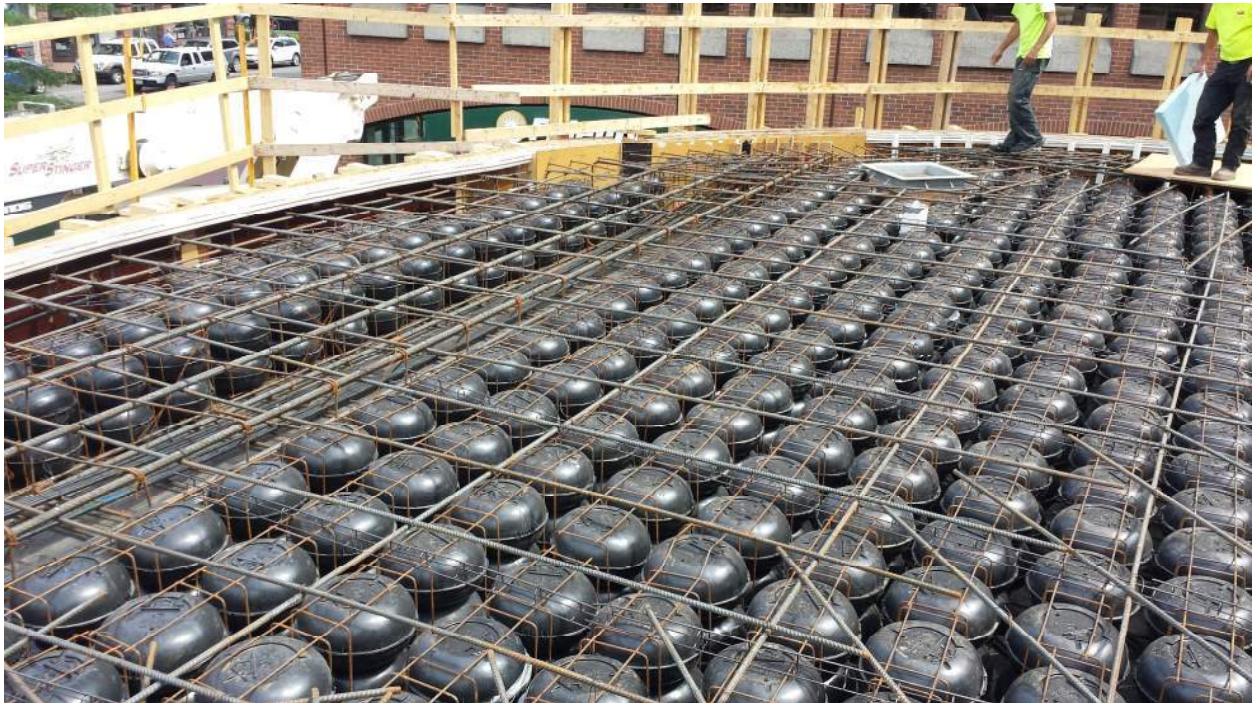
During the previous visit, many of the void formers were found with little to no clear space between them. The GC had repositioned all of the voids with the correct spacing (see photo 3). No further corrective action is required.

Photo 3 – Void formers positioned with the correct spacing

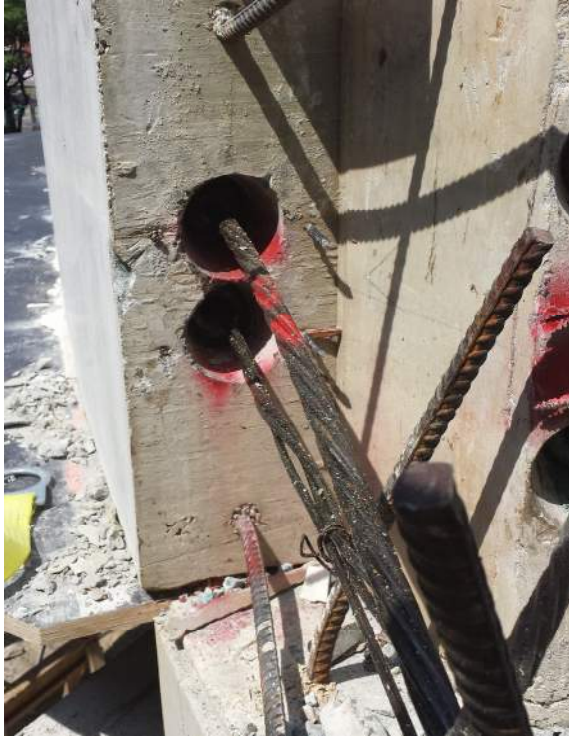
Photo 1: Broken perimeter temperature strand

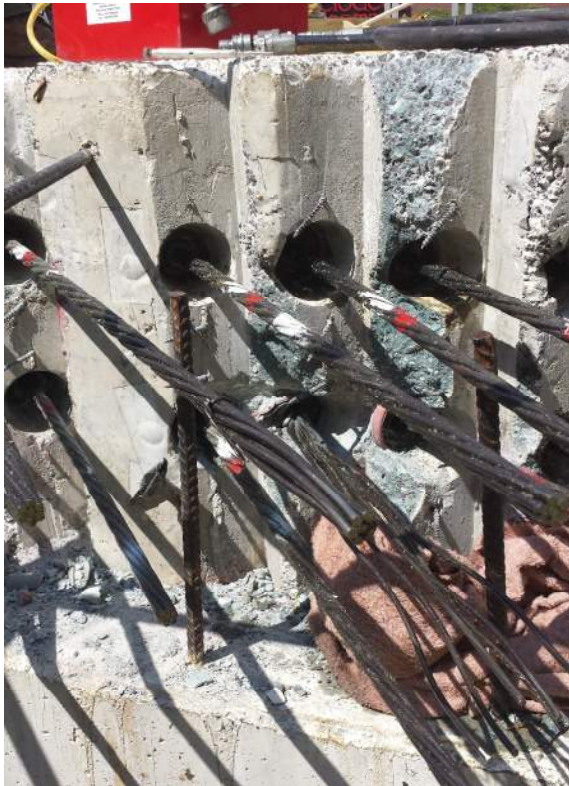
Photo 3: Broken strand at PT Beam 1

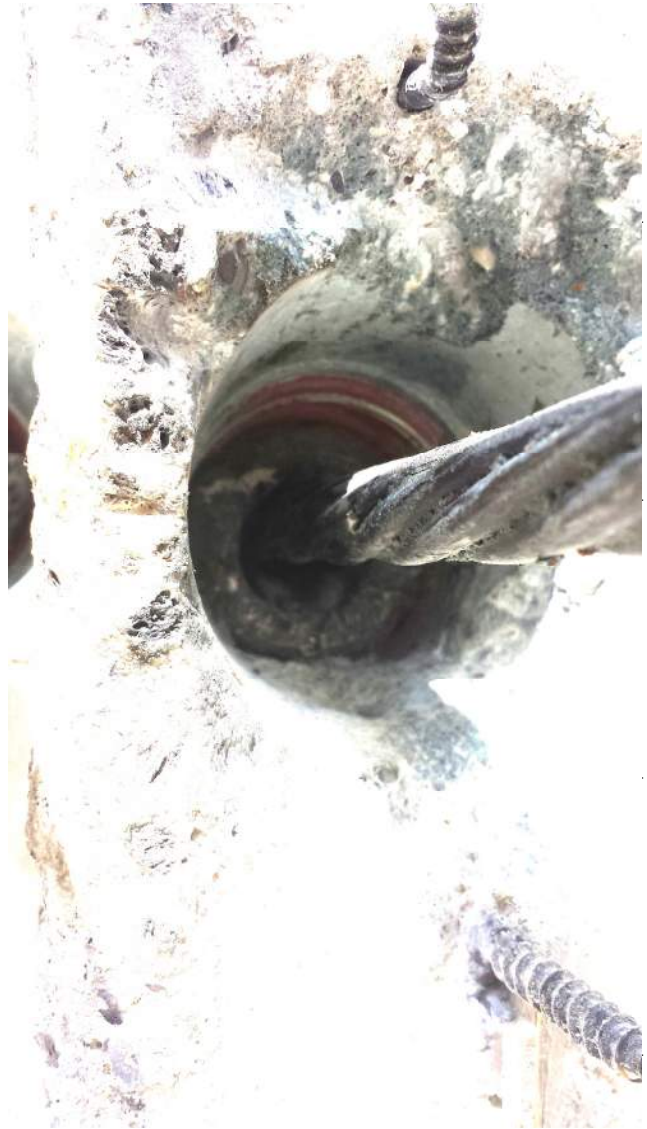
Photo 2: Concrete observed inside anchor where wedges are to be seated

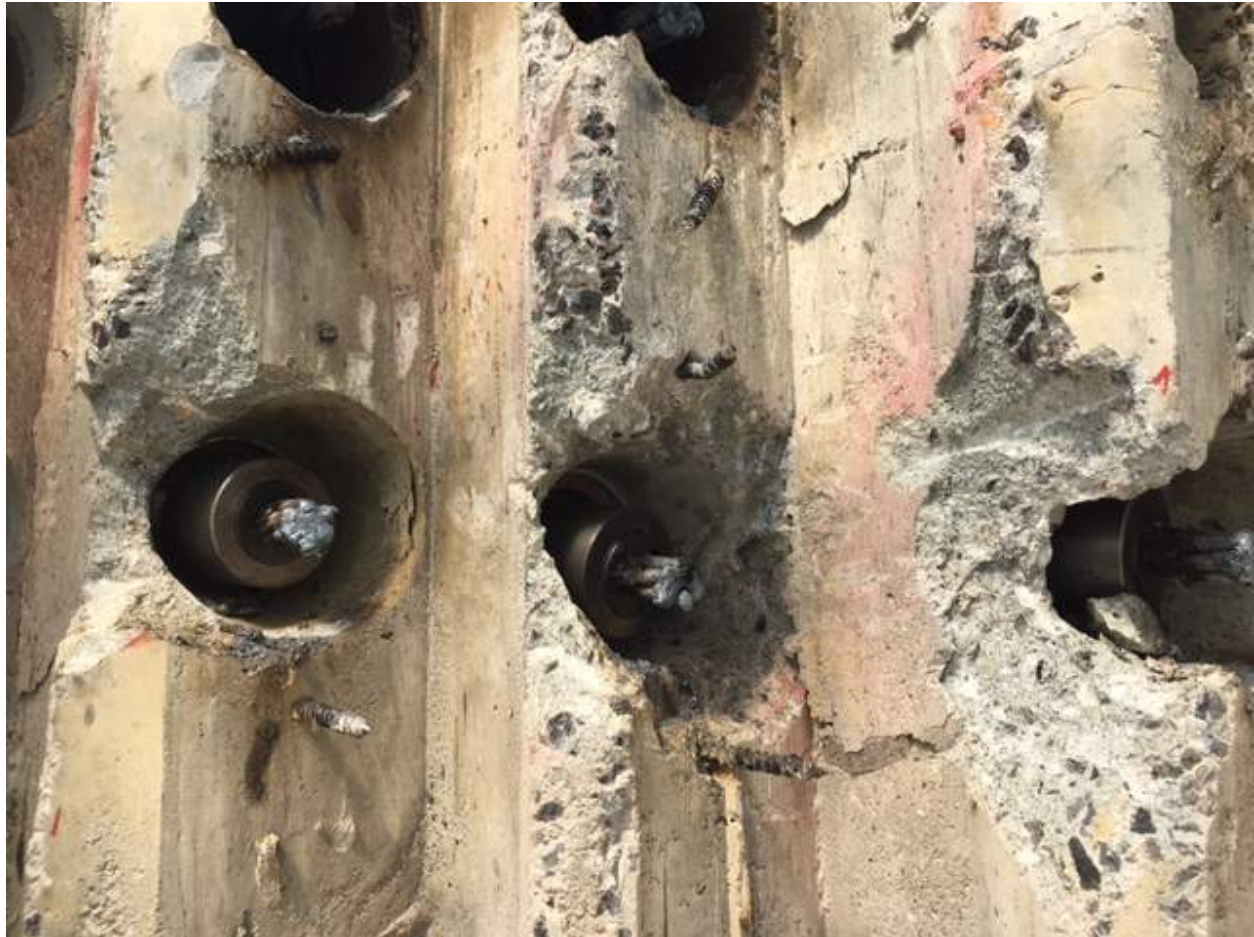
Consigli's PT subcontractor reviewed the condition of the broken strands and determined them unsuitable for re-tensioning. We will now begin the process of evaluating the roof beam capacity without the broken strand. The perimeter strand that broke was determined to not affect the performance of the roof slab.

Photo 1: Barrels installed at the anchors of the PT strands
