APPENDIX - IMAGES

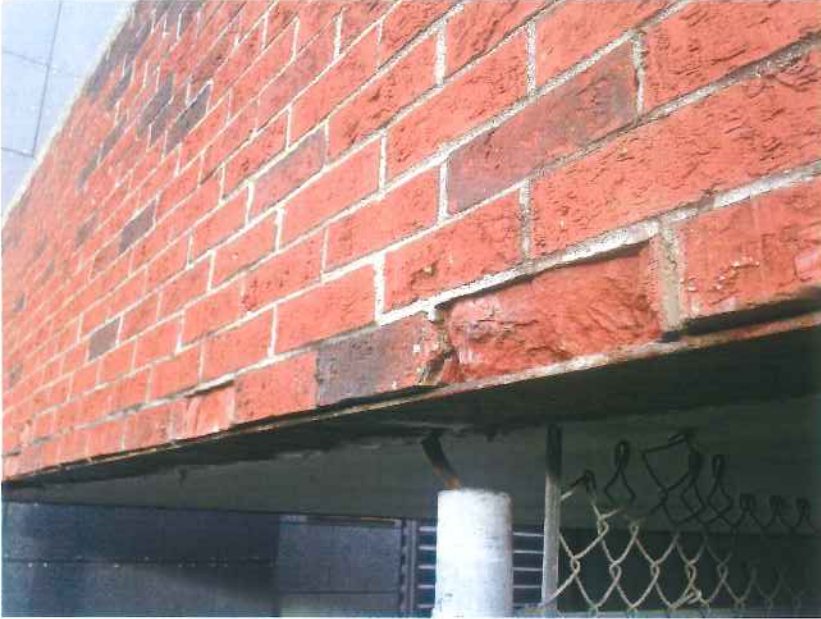
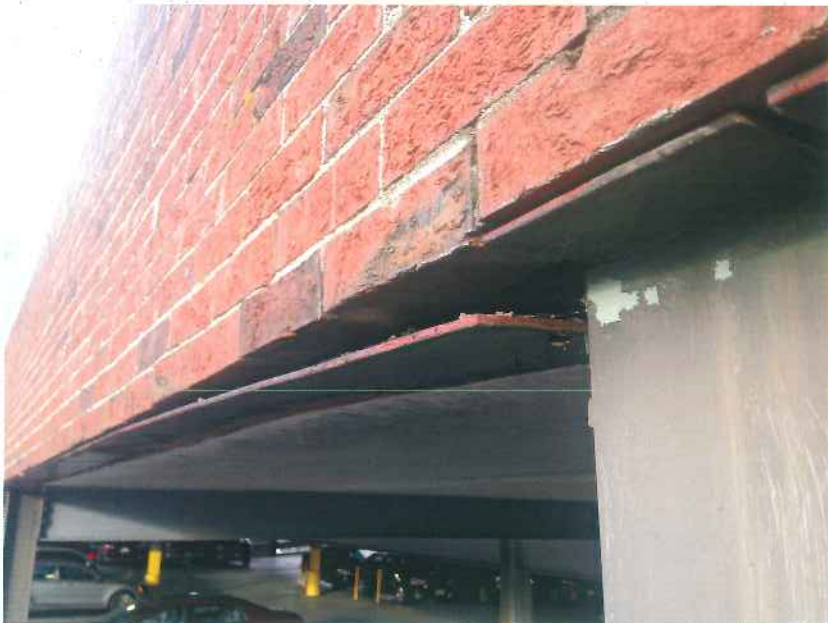
Images-1 and 2

These photographs illustrate damage caused to steel structure in contact with brick. The moisture and salts attack the steel causing it to quickly rust and ultimately to fail, as the bottom photo shows a weld failure.

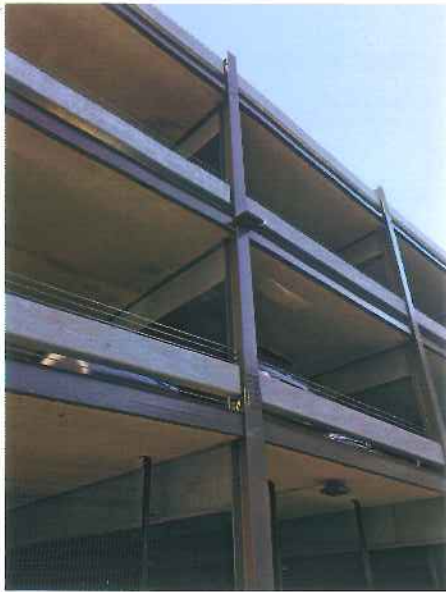
Image-03
West (Hyatt Place) facade showing garage after brick is removed, steel refurbished and galvanized automobile guard added.

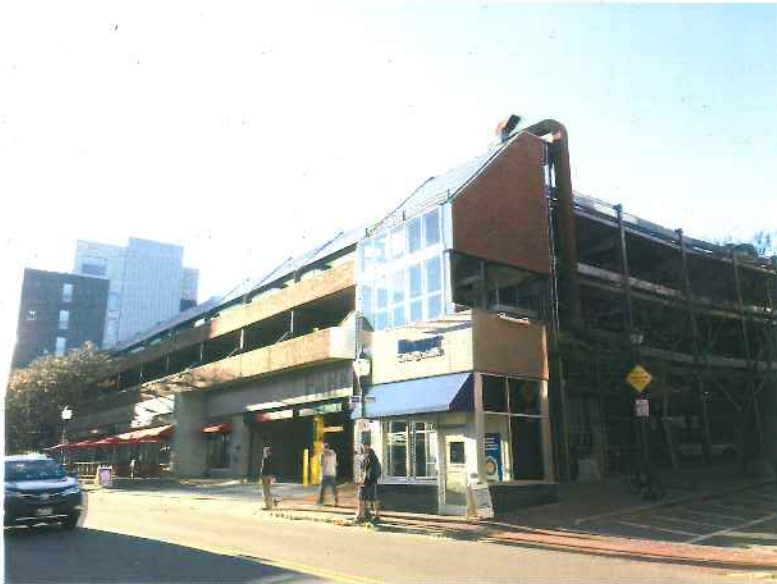
Image-04
South (Fore Street) Facade with Hyatt Place Hotel beyond, as currently exists.

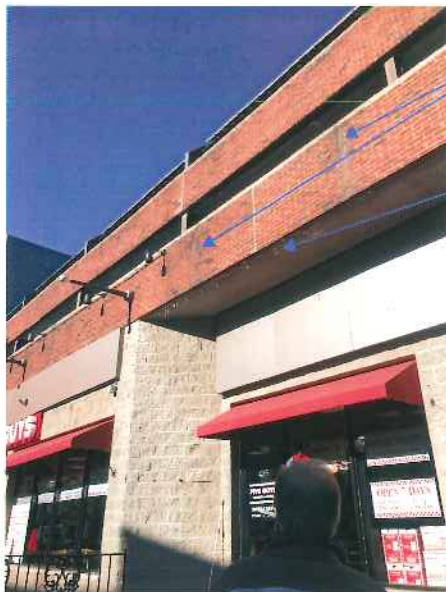
DETERIORATING BRICK

EFFLORESCENCE STALACTITES (SALTS)

Image-05
Fore Street facade showing the deterioration of brick and stalactites formed from years of moisture and salts seeping from masonry.
