BUILDING INSPECTION

416-420 Fore Street
Portland, ME 04101

Inspection No. S14-1152 - 416-420 Fore Street
Date of Inspection: 09/25/2014
Engineer: Jack Carr, P.E.

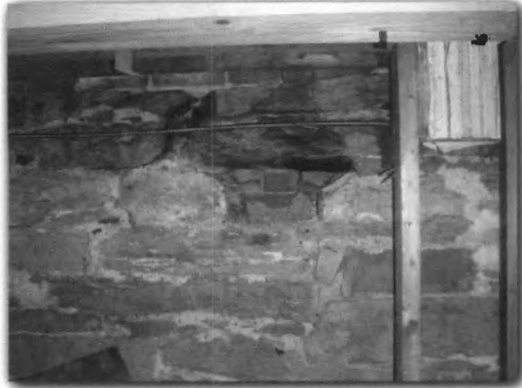
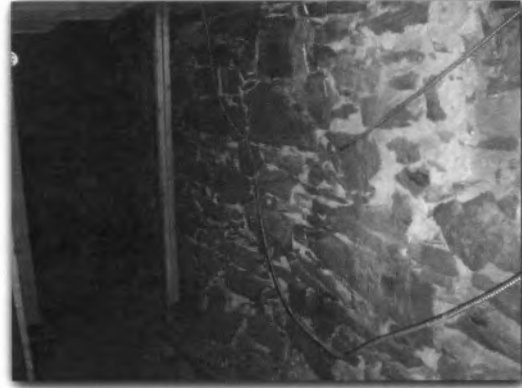
Where visible, the foundation walls with stone masonry below ground level and brick above ground level are generally in good condition at this time.

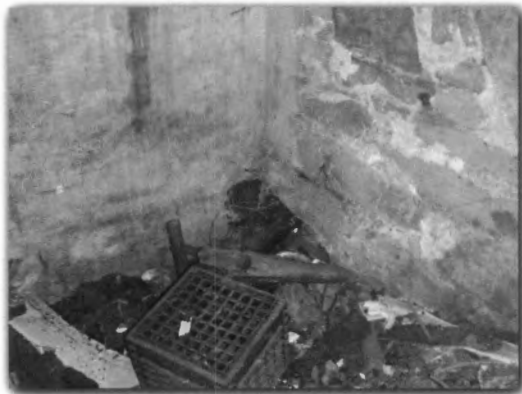
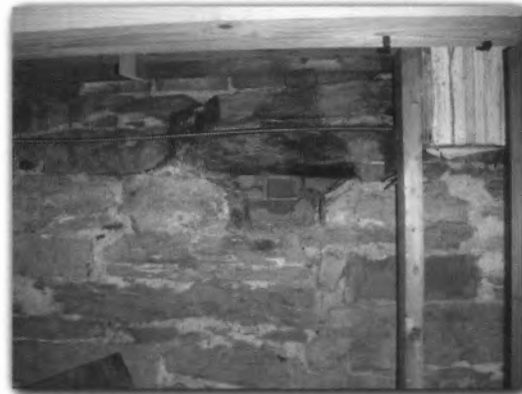
Maintenance of this foundation wall includes packing any soft or open mortar joints with cement mortar. This is an ongoing process. Walls should be inspected periodically for signs of such problems and the recommended maintenance undertaken. We noted two cavity areas where stone had fallen leaving voids.

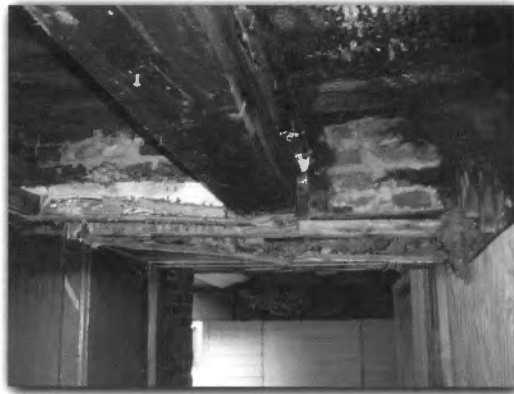
We found evidence of a structural fire occurring in this building in the past. The damage appeared to be concentrated in the Wharf Street first level and spread to the basement area below. It appears that the damage is in the process of being repaired; however, we strongly recommend that you discuss this with the current owner and/or the local fire marshal to fully understand the extent of the damage and nature of the repairs.

This internal damage to floor structural components as well as exterior components noted in the entrance way should be reviewed by a licensed structural engineer. Of particular concern is the exposed charred timber beam whose end connection to a steel girder and its associated masonry appears to be incomplete and damaged.

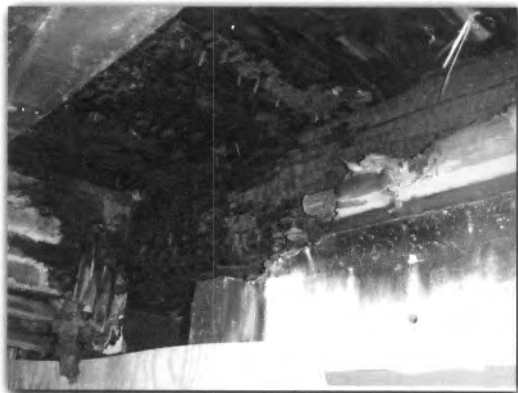
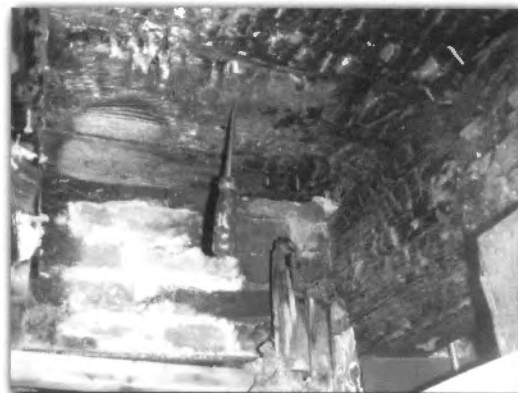
We performed a limited review of the fire damaged and charred timbers in the basement and the first level. This survey revealed that the char on the surface of the timber framing was relatively light (1/4" - 3/8" in areas inspected) and did not materially affect the structural integrity of the timber components.

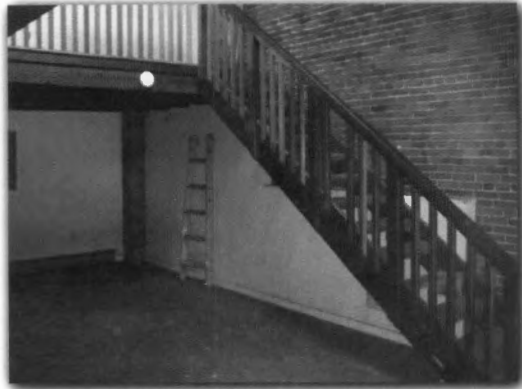
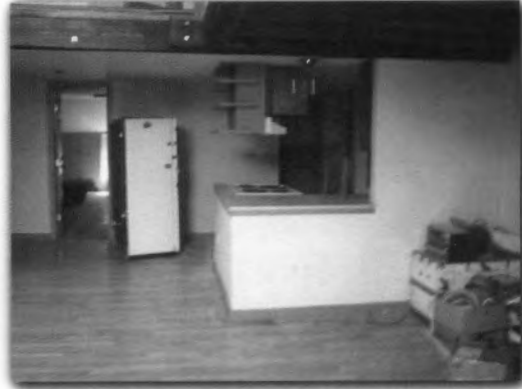
The floor finishes were primarily carpet, wood, laminate and ceramic tile. Their condition was poor. It is our understanding future renovations will be replacing most floor surfaces.

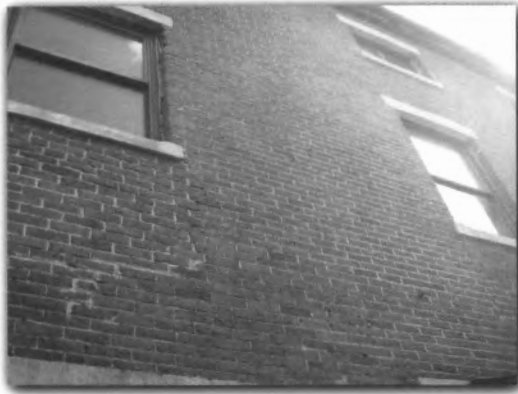
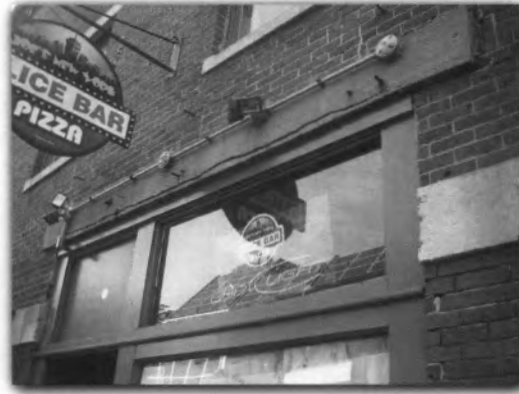
The exterior walls are surfaced with brick and are in good condition. In general the brick mortar joints and other details have been well maintained over the years. We noted some minor stairstep cracks and missing mortar requiring some re-pointing within the next 3 years.

Further it was observed some of the original lintels have been repaired with concrete that has cracked with time. These cracks and other joints should be filled with suitable materials to avoid further spalling or damage to these components from freeze thaw conditions.

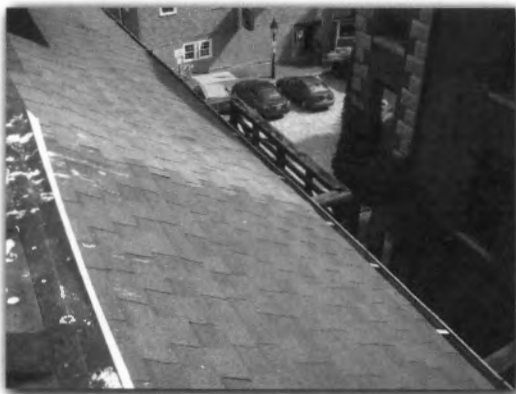
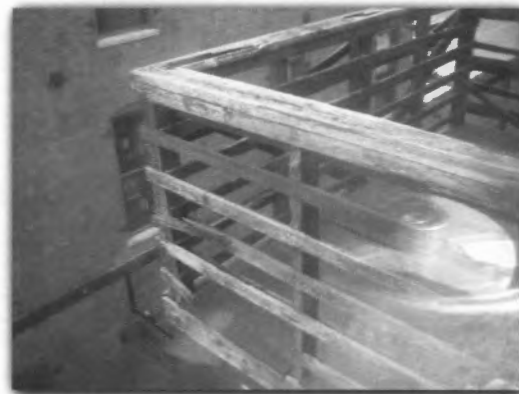
Due to debris and other material blockages we were unable to physically inspect the rear decks. Our limited observations indicate that all the decks need repairs and improvements to railing and balusters to meet today's code requirements. Currently one of the decks houses the evaporator component of the split system HVAC for one of the commercial tenants. This may require special approval for the deck to support this equipment.

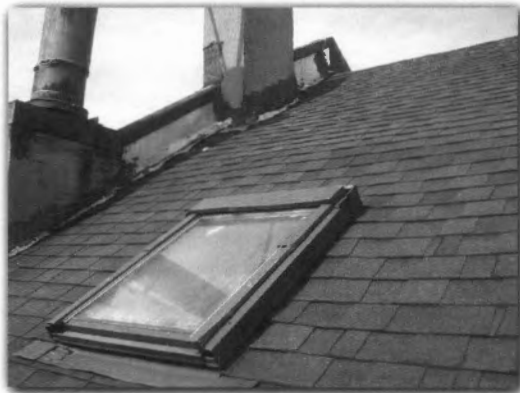
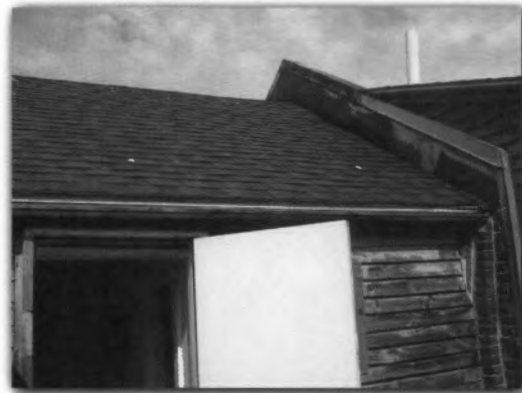
The roof is surfaced with asphalt shingles and is in good condition. Some of the flashing along the demising firewall on the roof exterior appeared to be functional, but needing some improvement. It was reported future renovations of the building will include encapsulation of these firewalls with aluminum covering.

The roofing appears to be relatively new and of standard quality. It should provide 25 years of relatively problem-free service with proper maintenance.

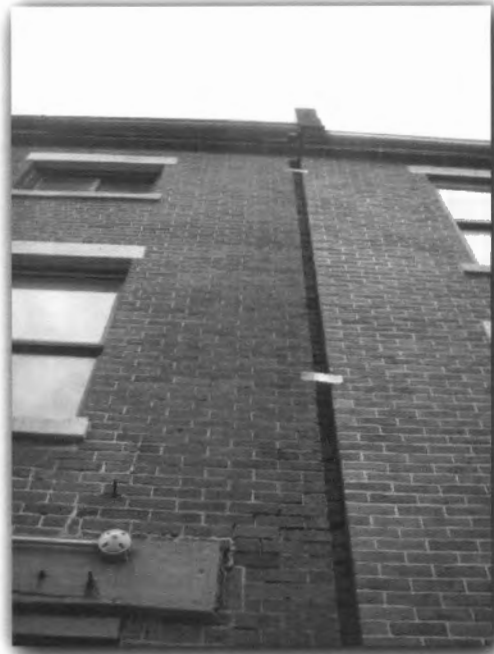
It was noted that the gutter system on the front Fore Street side needed some immediate repairs. The gutter at 420 Fore Street was blocked with vegetation and active grass was visible growing from it. In addition the downspout at this area was missing.

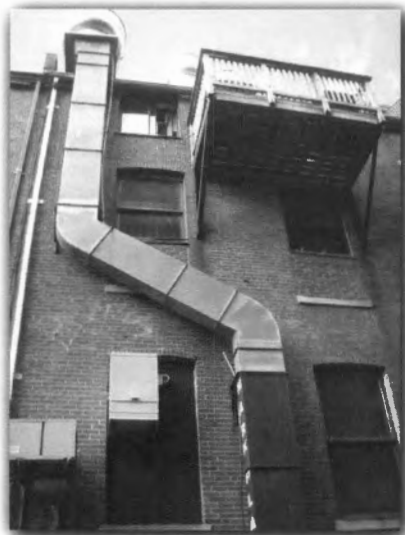
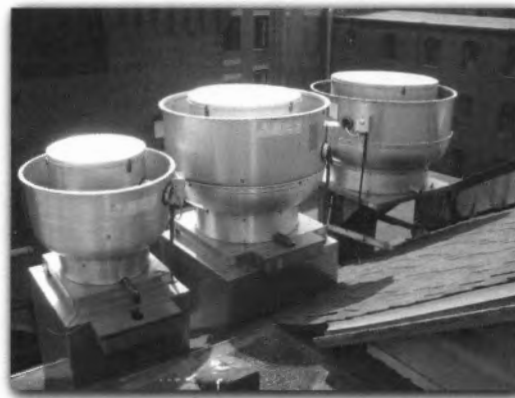
We observed two abandoned chimneys while appearing structurally stable, are probably unlined and should not be used without prior inspection by a licensed chimney sweep.

There are three existing metal power vented kitchen vent stacks at the rear of the building. Two of them are internal and one is external to the building. These stacks were not inspected.

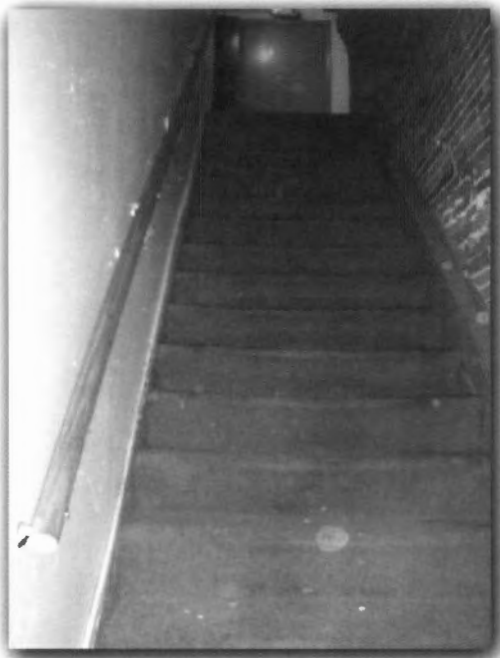
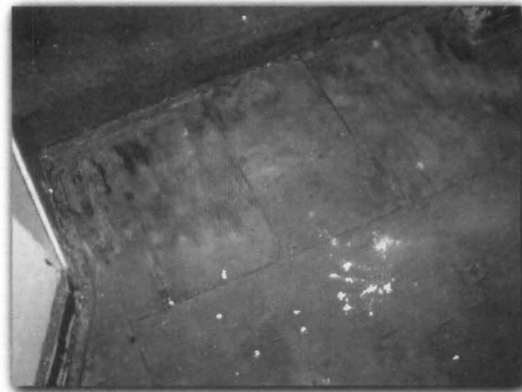
Many of the egress stairs had handrails not meeting current code guidelines for returns. Carpeting on some stairs was in poor condition. The Fore Street foyer entrance subfloor was spongy and needs further stiffening. As emergency egress is always an issue with the code inspection department we recommend the current configuration of primary and secondary egress paths be approved by the City.

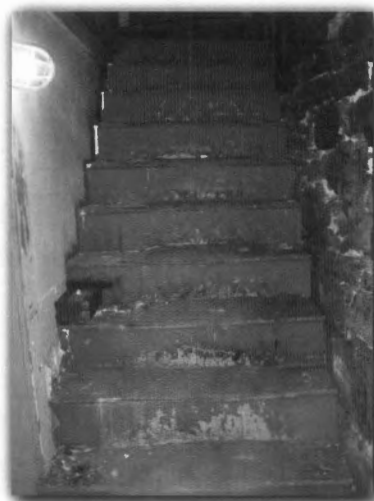
The front basement stairs will require rebuilding while the rear basement stairs will be removed. It is also our understanding the upper level apartment stairs will also be rebuilt.

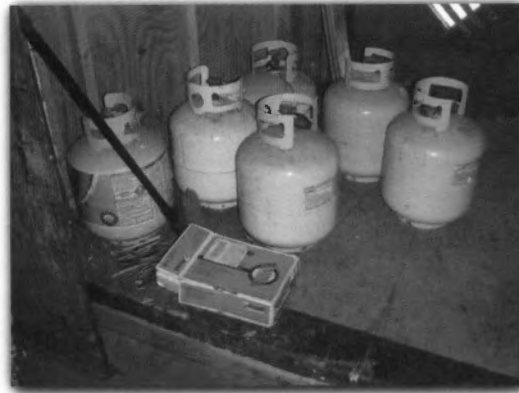
We observed several propane fuel tanks at the rear of the first level of one of the commercial spaces. Propane fuel tanks should never be stored in the interior of a building. We recommend these tanks be removed to a safe location.
