Project: *Salvation Army Dining Hall V2*
Date Prepared: **October 25, 2017**

Final Report of Special Inspections (SSIC/SI 1)

Project: *Salvation Army Dining Hall Addition*
Location: *88 Preble St, Portland Me*
Owner: *Salvation Army Adult Rehab Command Center*
Owner's Address: *440 West Nyack Rd, West Nyak NY 10994*

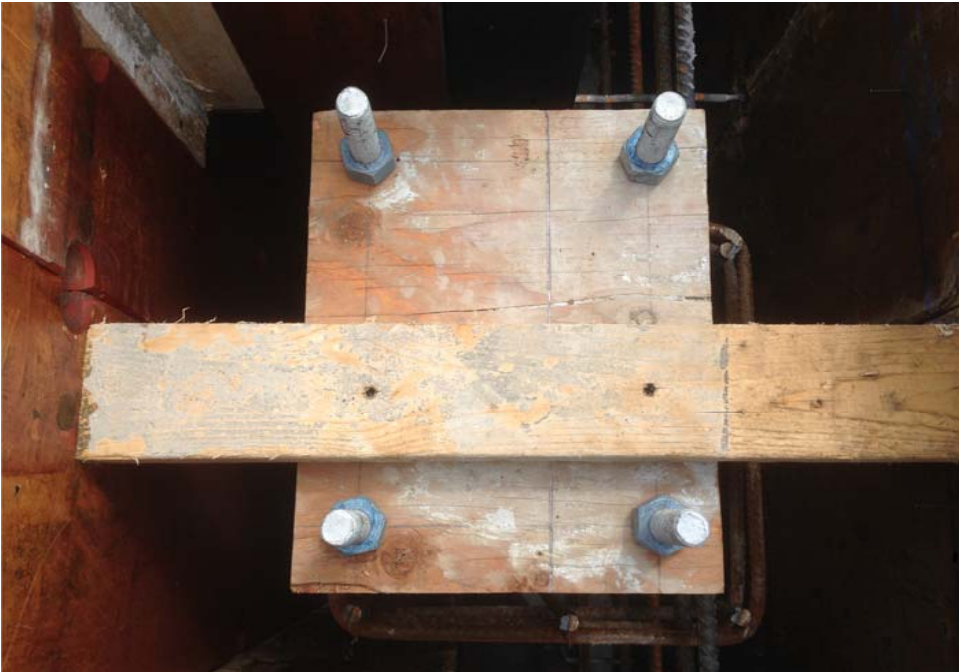
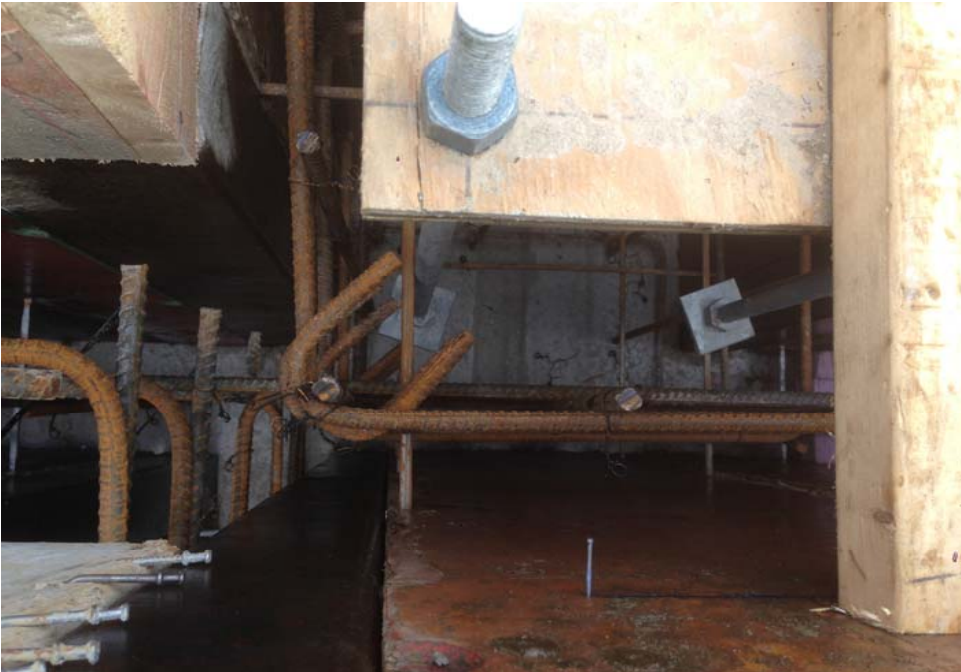
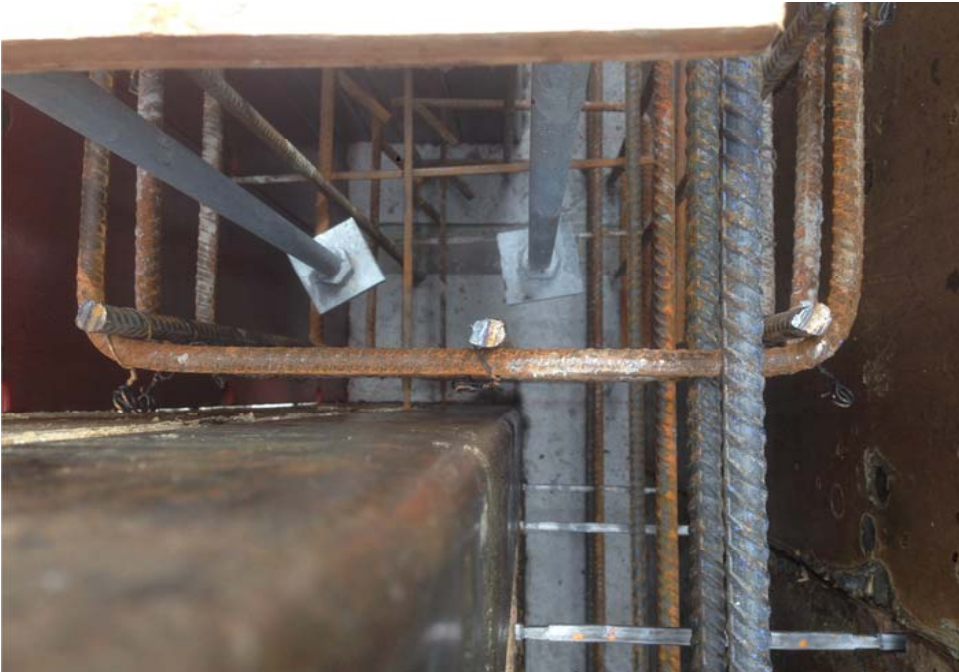
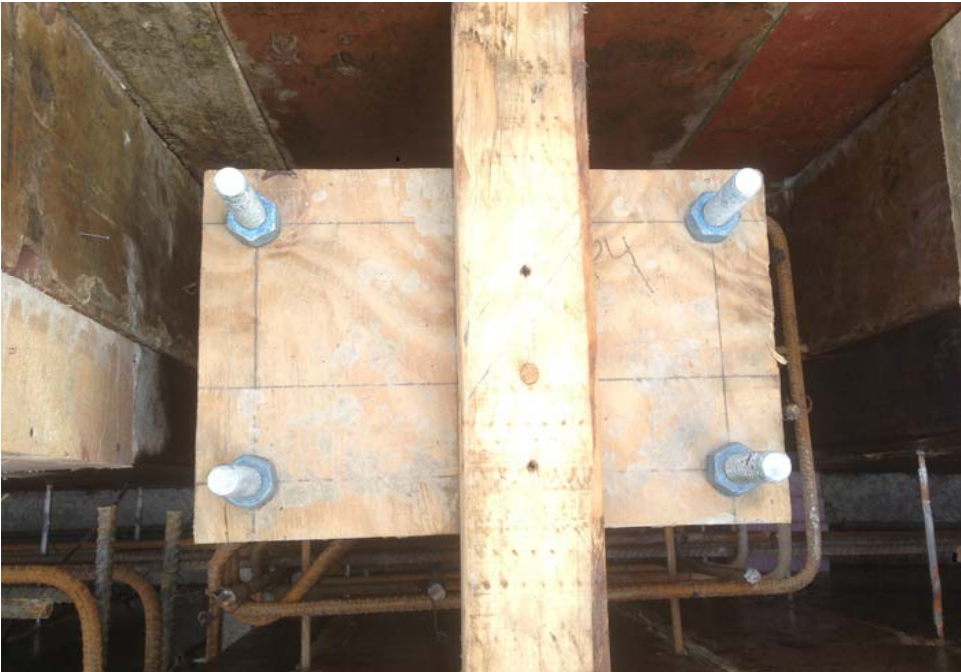
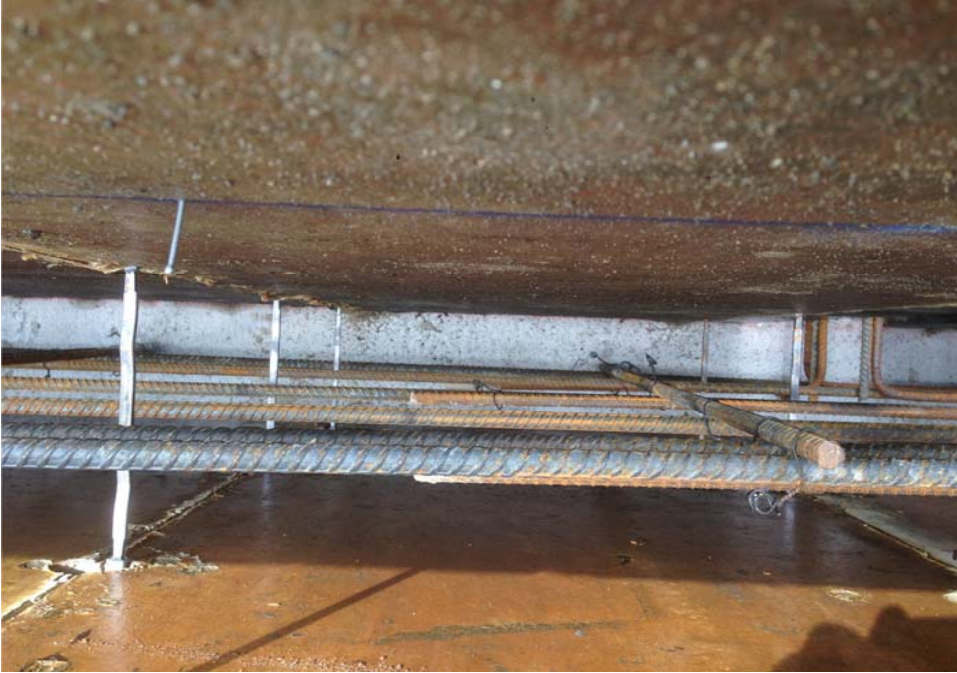
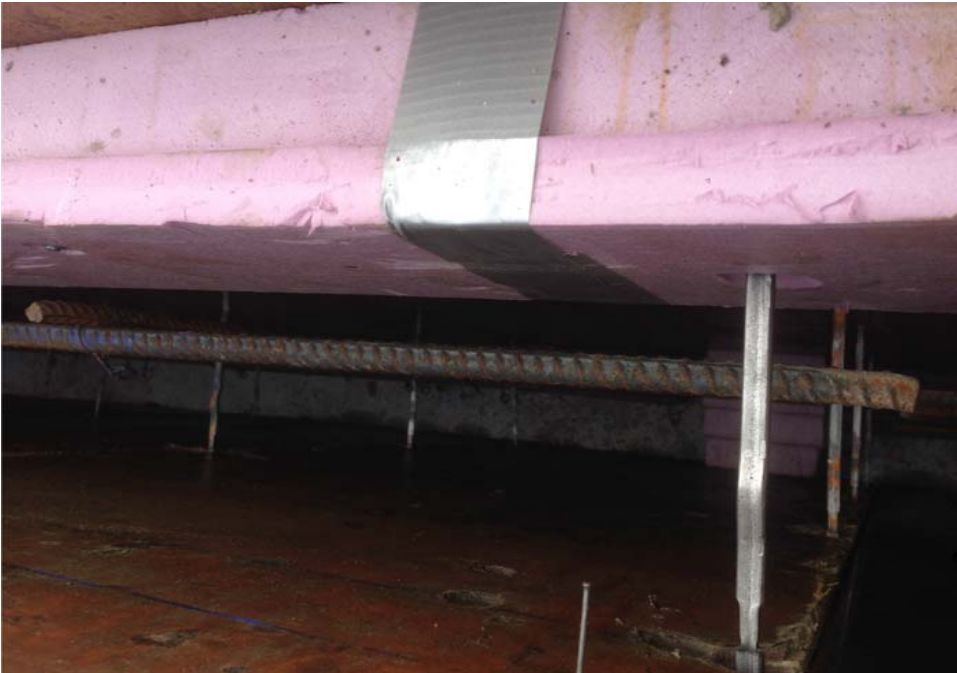
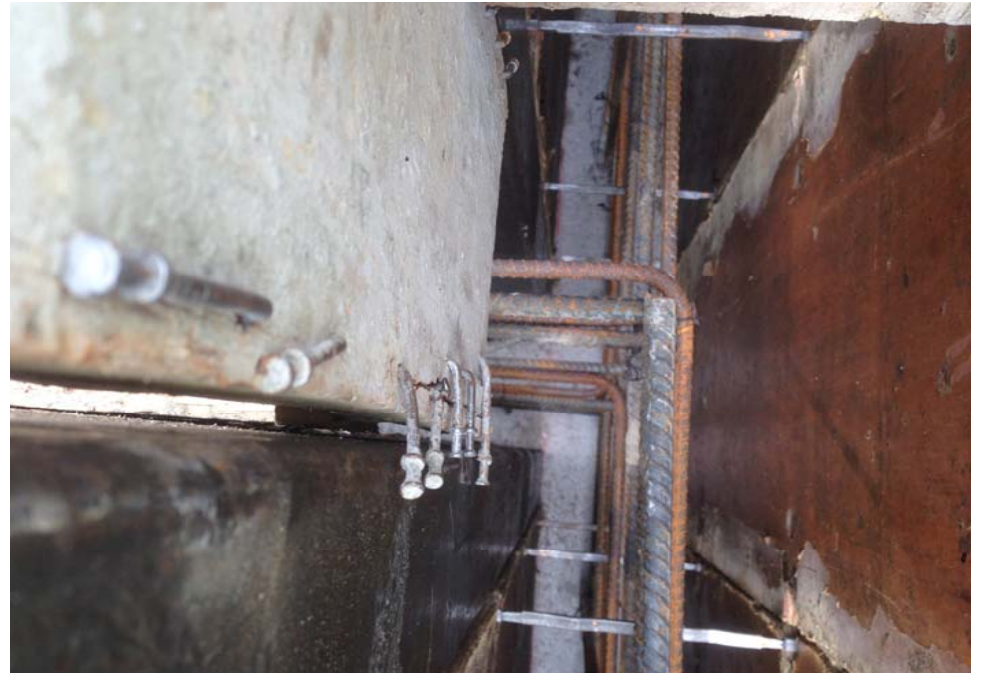
SW Cole was onsite as scheduled for reinforcing observations and to perform field testing on concrete placed. Reinforcing appeared consistent with above referenced documents. Concrete field testing indicated mix was within project specifications.

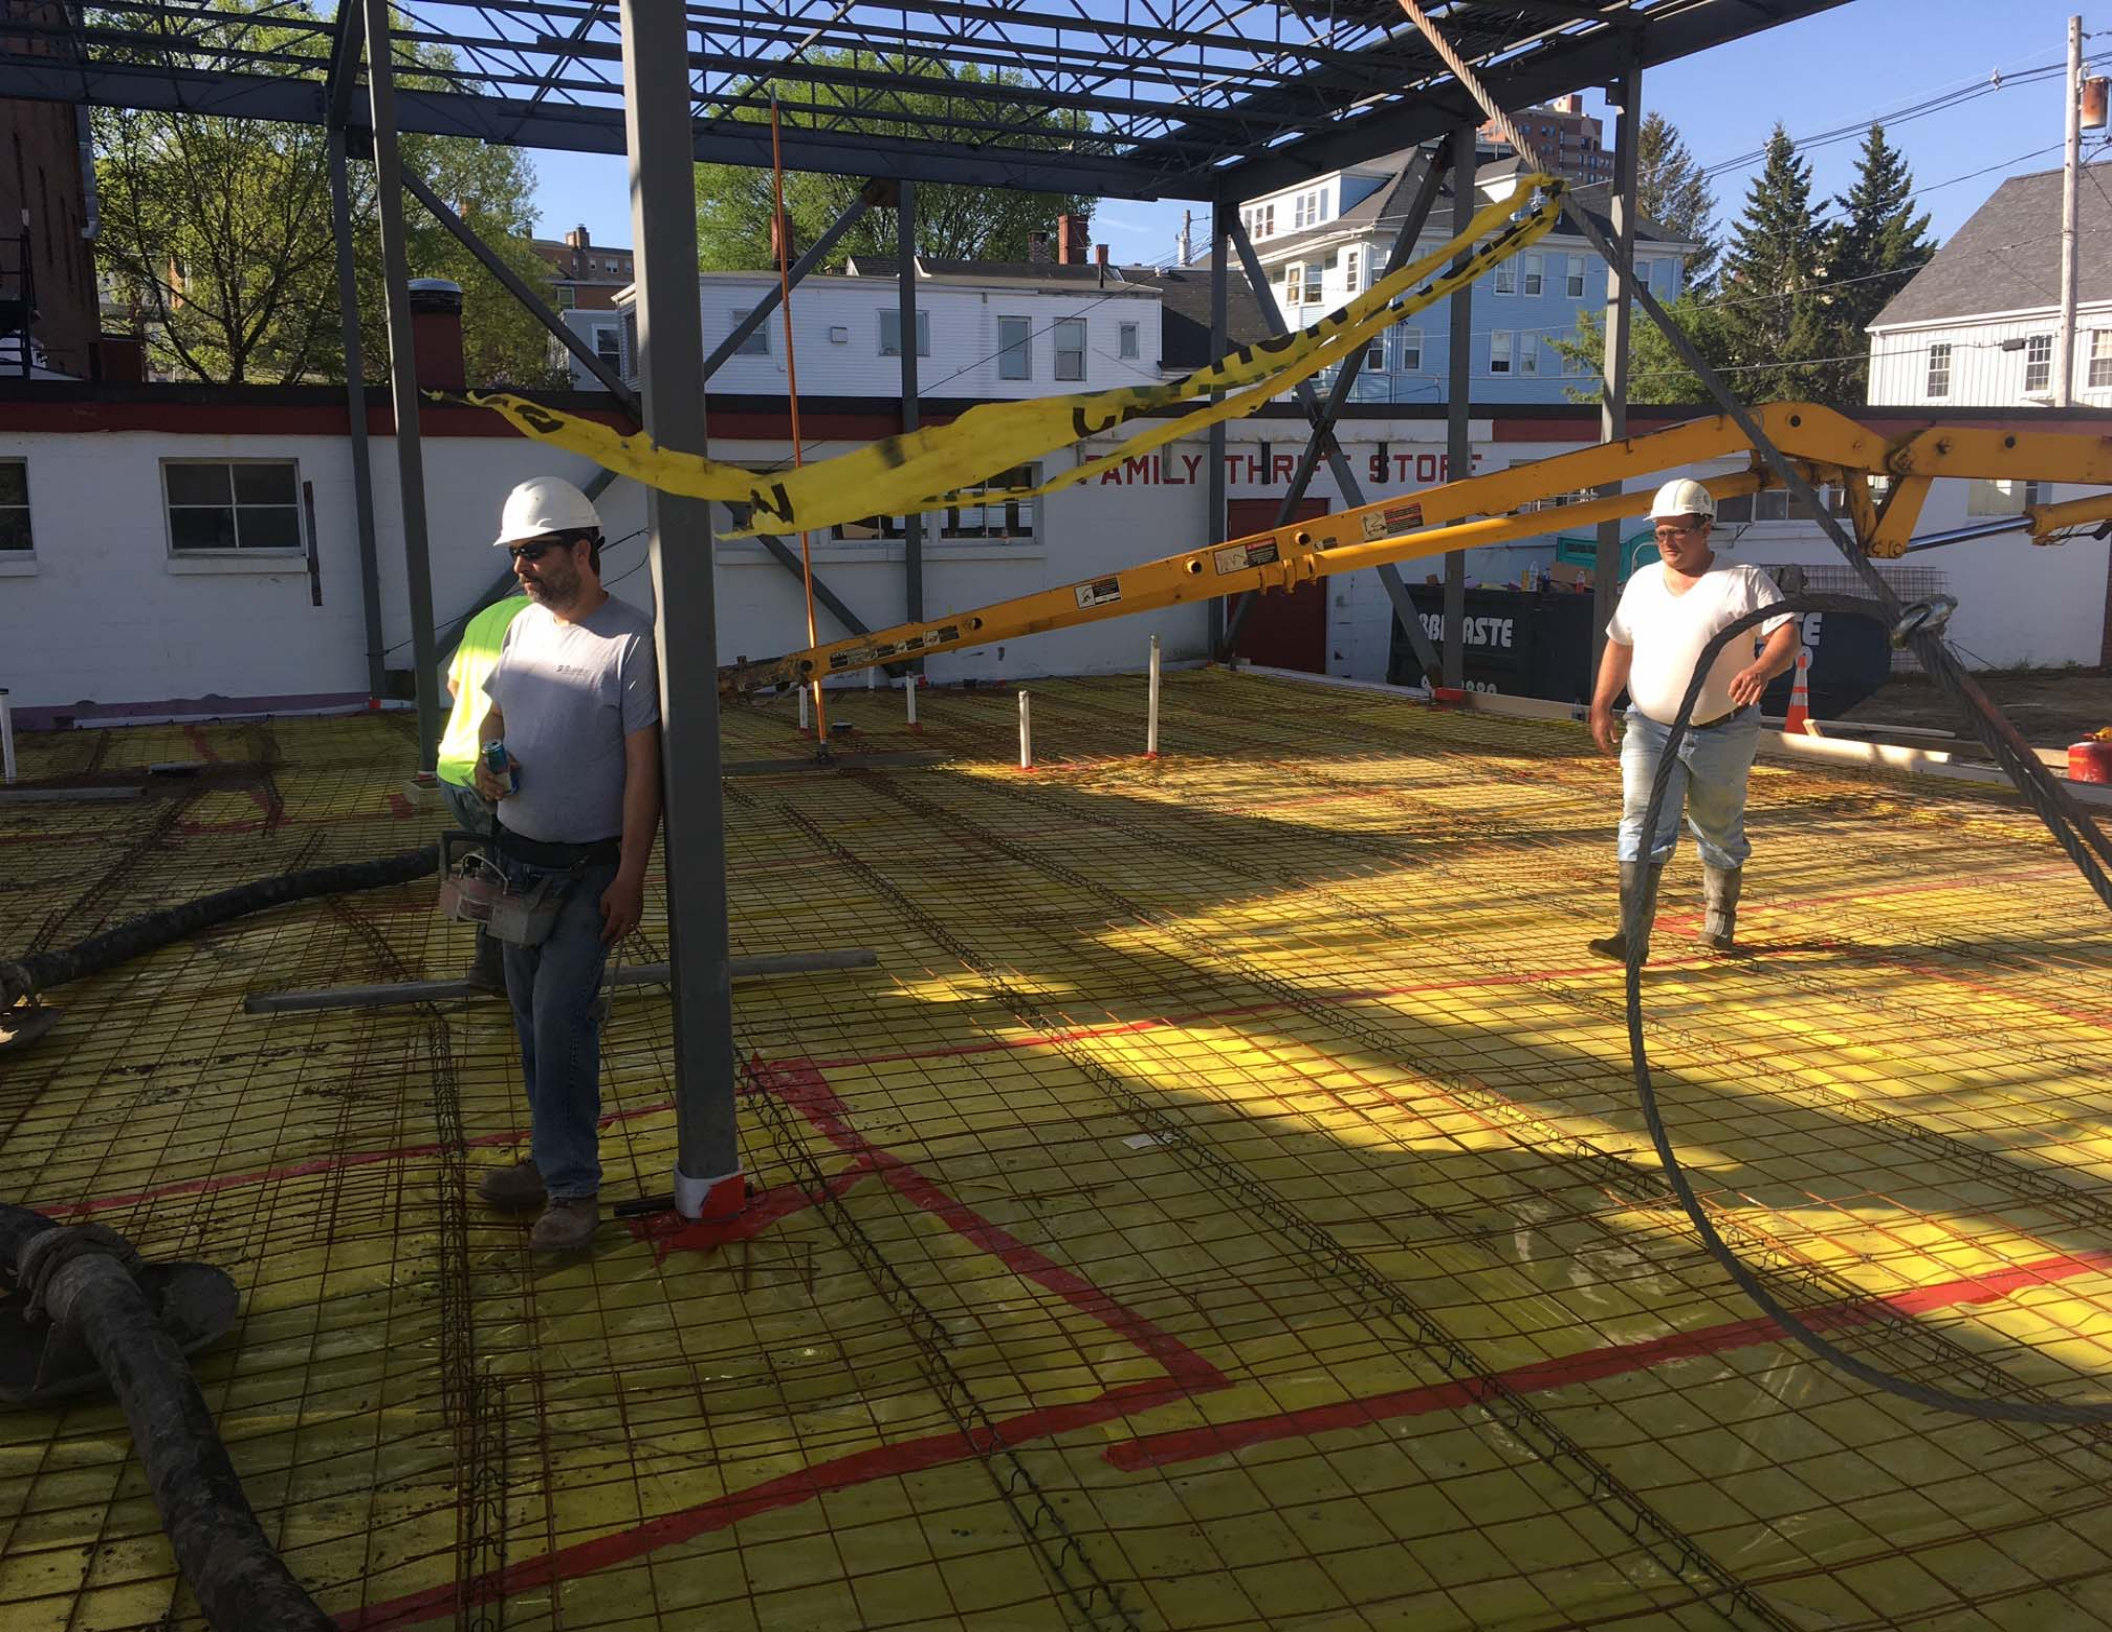
SW Cole was onsite as scheduled for reinforcing observations and to perform field testing on concrete placed. Reinforcement appeared to be consistent with above referenced project documents. The concrete supplied by Auburn contained a mid-range water reducer. One mid load sample was obtained from load 2 for field testing and compressive strength specimens. Testing indicated concrete being placed was in compliance and one set of four cylinders were cast. All results were reported verbally to the supervisor onsite from Benchmark Construction.
