Class Acts Property Management -- Attn: Mr. Bill Simpson, re: 8 Alder Street, Portland, ME

Jan 20, 2012

### OBSERVATIONS AND EVALUATION

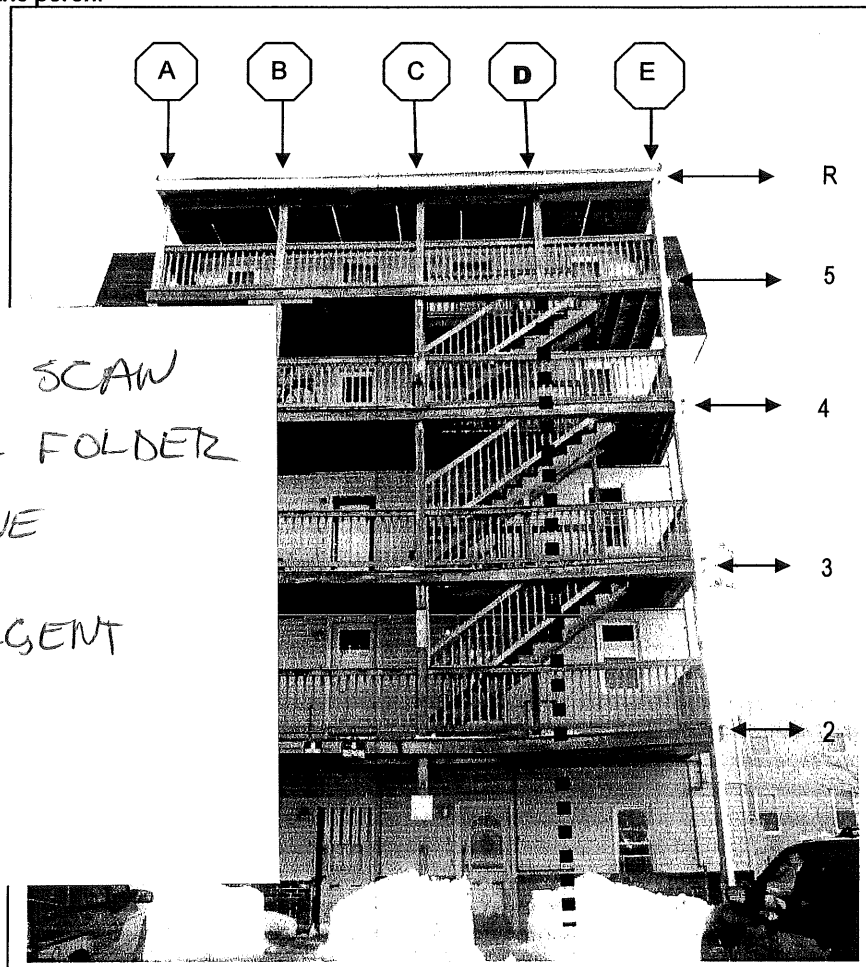
For purposes of this report, the primary structural grid of this porch and stairwell is shown below.

The most obvious deficiency in this structure is the lack of a continuous post from roof to ground at column line "D". A new post should be installed along this line as soon as snow has melted and the ground thaws. Installing this post and lightly jacking up the framing in this area will ultimately improve the strength and durability of the porch.

- 1.1 Further assess the post bases after snow leaves to check base condition and anchorage;
- 1.2 Install supplemental post and sonotube at line "D" and jack deck as required at all levels;

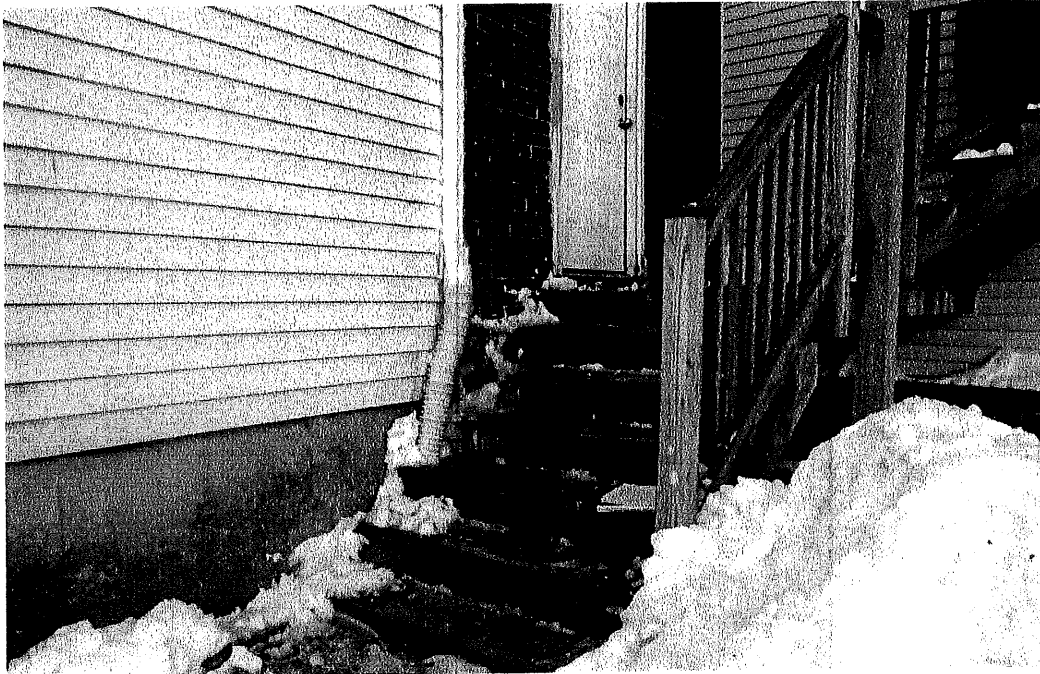
**PHOTO**  
**#2**

Overall, the grading on the site slopes downhill away from the foundation of the building, allowing water to drain away from the building. A downspout drains water from the upper roof to the base of the stair (Photo #2). At the time of the inspection, the downspout was icing over, causing ice to build up on the bottommost stairs. Roof runoff and site shade in this area may promote conditions favoring framing rot and fastener corrosion, since the area likely remains damp, holds winter snows, and is treated with the city's sand/salt mixture. You discussed that you planned to re-roof the area above the downspout to redirect water from that downspout and eliminate the ice problem.

8 Alder Street: Bottom stair with downspout and ice buildup.

- 1.14 Redirect Roof Downspout at base of stairs, to keep ice buildup away from stairs.

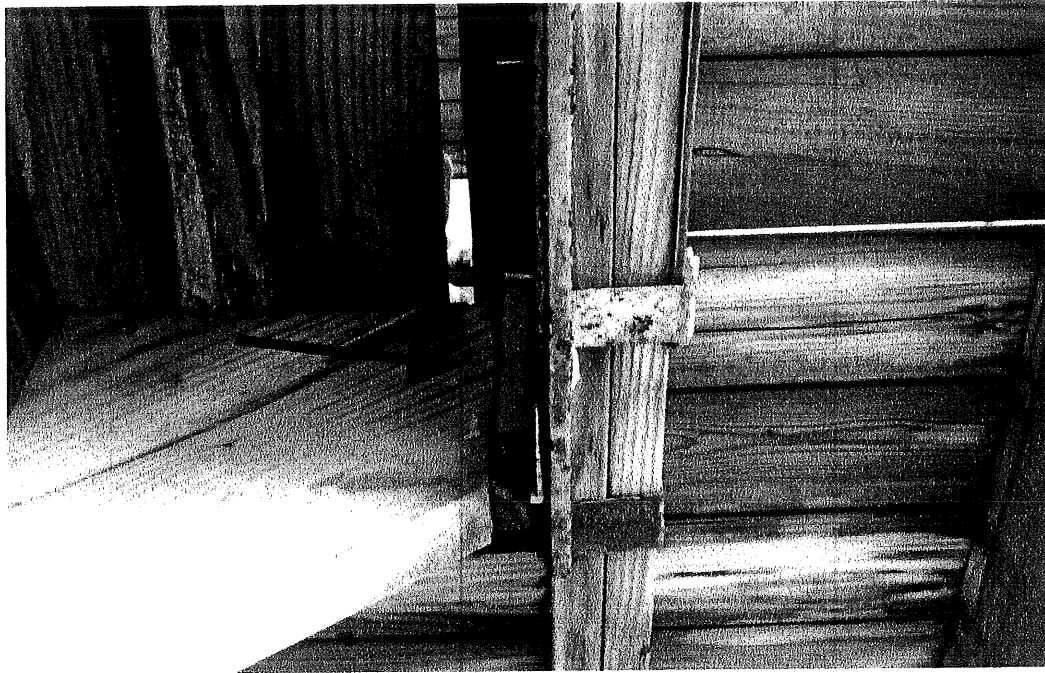
**PHOTO**  
**#3**

1 to 2	No significant deficiencies observed, beyond what has been discussed above.
2 to 3	Observed a significant split in the end of the 2 x 6 at the top of the stringer, where a lag bolt is fastened into the stringer's end grain (Photo #3). This is a significant concern that will need to be addressed as soon as possible with temporary shoring.
3 to 4	Similar split as described in previous stringer, but not as damaged. Will need an alternate detail to support the top of the stringer as soon as possible.
4 to 5	Observed a yellow steel angle bracket lengthwise (Photo #4). Conditions are part of a larger structural problem in this area that will need to be addressed as soon as possible.

8 Alder Street: Fasteners from Bolted Steel hanger have split end grain of 2x6 stair stringer (arrow).

- 1.3 Strengthen all splices in columns using Timberlok Screws or by removing, cleaning, and recoating corroded steel splice plates;
- 1.4 After jacking structure near line D, resupport stair stringers at headers and improve support near midspan of each stringer;

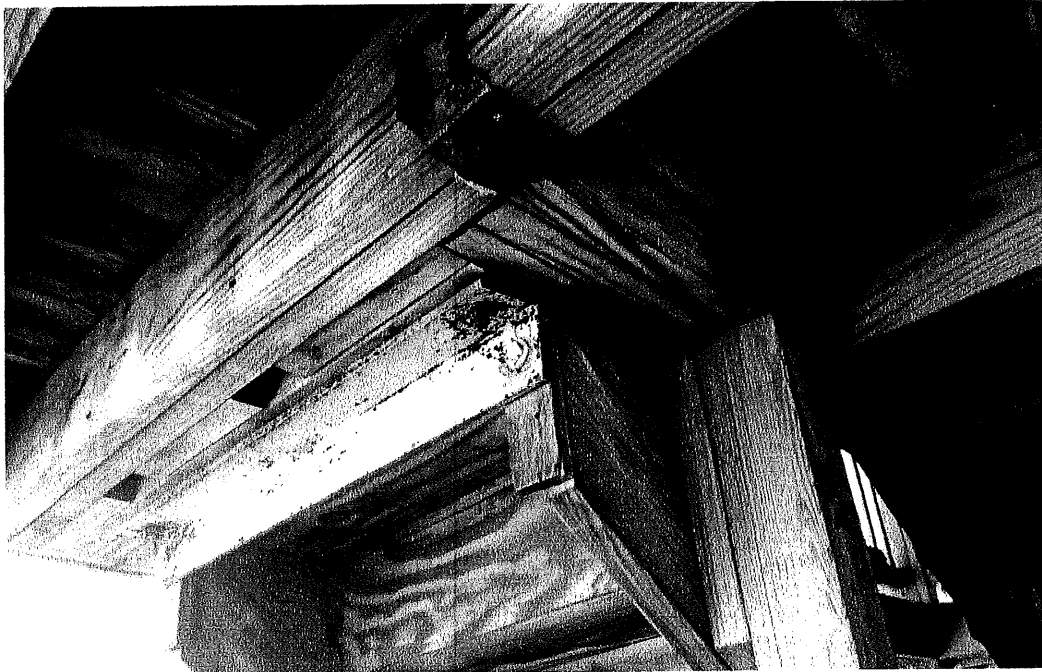
**PHOTO**  
**#4**

Steel bracket connection. This connection provides damage to end grain of stringer, and places bolts in top of angle in tension, which is not advisable. Also note severely corroded Simpson Bracket at top center of photo.

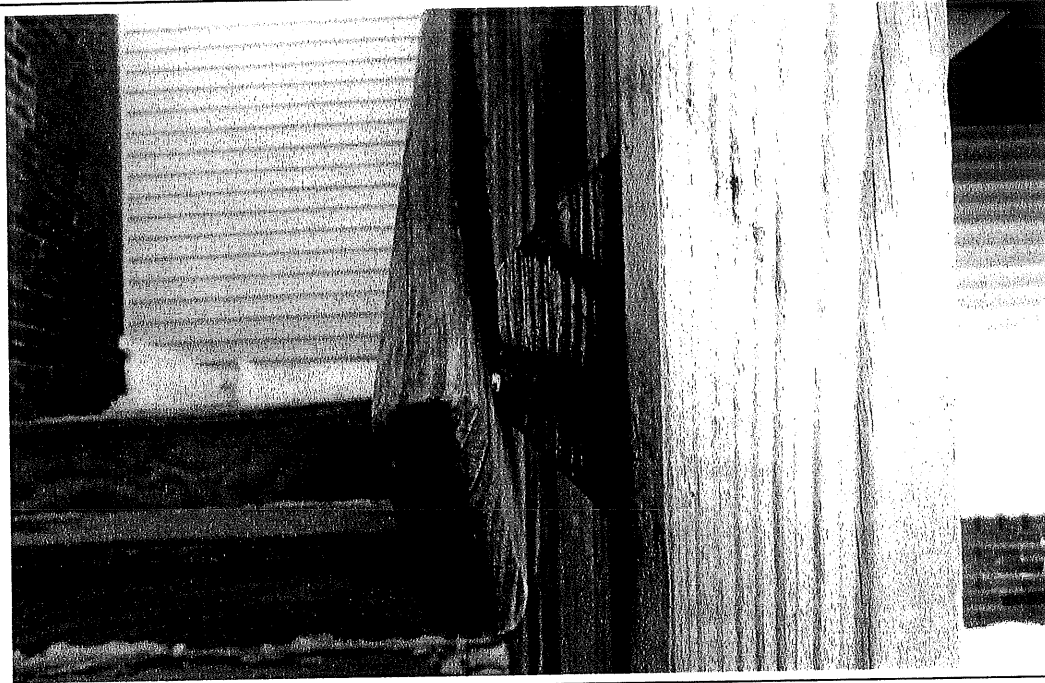
**PHOTO**  
**#5**

1 to 2 rails	Bottom-most rail is split and broken (Photo #5). Needs to be replaced. Also suggest adding a rail on other side of stair.
Railings Level 2	Railing attachment to posts is insufficient and should be strengthened, typical throughout porch (Photo #6) in approximately eight locations per level.
2 to 3 rails	
Railings Level 3	Porch rail connections are a concern where they tie into the steel mending plates (Photo #7). This happens in approximately four locations on this level.
3 to 4 rails	
Railings Level 4	Similar problems as Level 2 railings.
4 to 5 rails	
Railings Level 5	Similar problems as Level 2 railings.

Bottom Stair. Extremely loose railing at base of stair. Fastening block has split. Top of railing is split at landing above. This should be repaired immediately. Also suggest a post-mounted handrail at other side of stair.

- 0.1 Repair bottom handrail and provide sand bucket at frozen downspout;
- 0.2 Provide temporary shoring and supplemental framing under 3<sup>rd</sup> and 4<sup>th</sup> floor stair headers. It is important not to create shoring that will complicate future jacking of porch framing;
- 0.3 Improve anchorage of handrail leading up from first landing to the second floor;

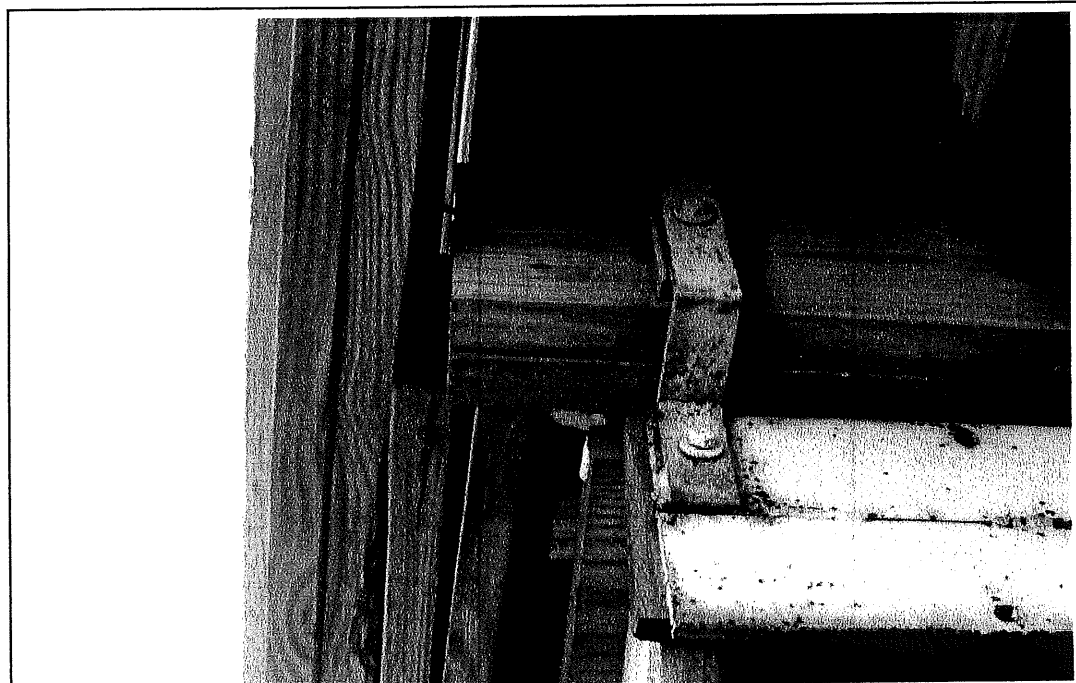
**PHOTO**  
**#10**  
0116 1749.jpg

Joists and Girders Level 2	
Joists and Girders Level 3	
Joists and Girders Level 4	There is significant concern about the stair header at this level (Photo #9, Photo #10). The header girder and surrounding joist framing has pulled away from the outside girder. This framing deficiency needs to be addressed immediately.
Joists and Girders Level 5

8 Alder Street: Detail from Photo #9. Header nails have pulled downward away from perimeter girder. This repair needs immediate repair..

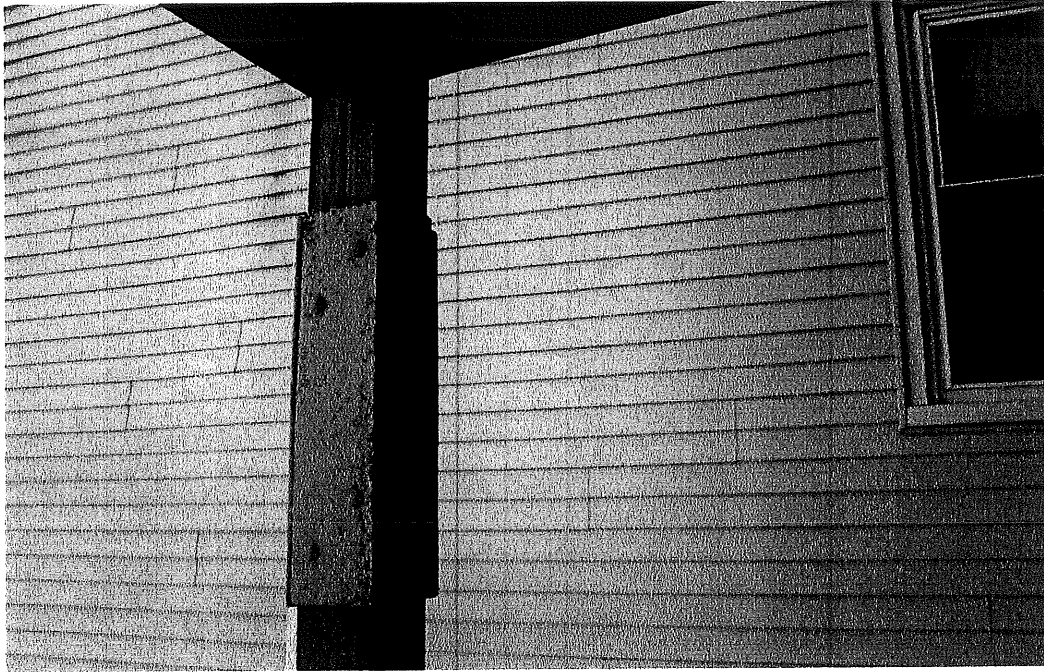
**PHOTO  
#13**

<b>Steel Plates on Columns</b>	<b>We suggest removing steel plates to properly clean and recoat them prior to reattaching them to the columns. Refer to Photo 13</b>
<b>Single Screws at Balusters</b>	<b>Suggest adding screws to existing balusters after all the lifting and jacking is complete on the porch. Many of these screws have slightly loosened over the years as the deck sagged and the wood shrunk. Refer to Photo 14</b>
<b>Corroded Simpson Brackets at Stairs</b>	<b>Corroded Simpson Brackets near the stairwells should be replaced in kind, or, if not practical, with an alternate hanger system. Refer to Photo 15</b>
<b>Small angle bolted connection at exterior beam lines</b>	<b>The two-inch wide angles with a single bolt providing outsider girder support should be replaced with a wider galvanized angle that has holes field drilled into it for four timberlok screws into the column and two timberlok screws into the girder. Refer to Photo 16</b>

Column Reinforcement Plates. These plates are beginning to corrode and they likely trap moisture behind them. Repair or replace in the next year.

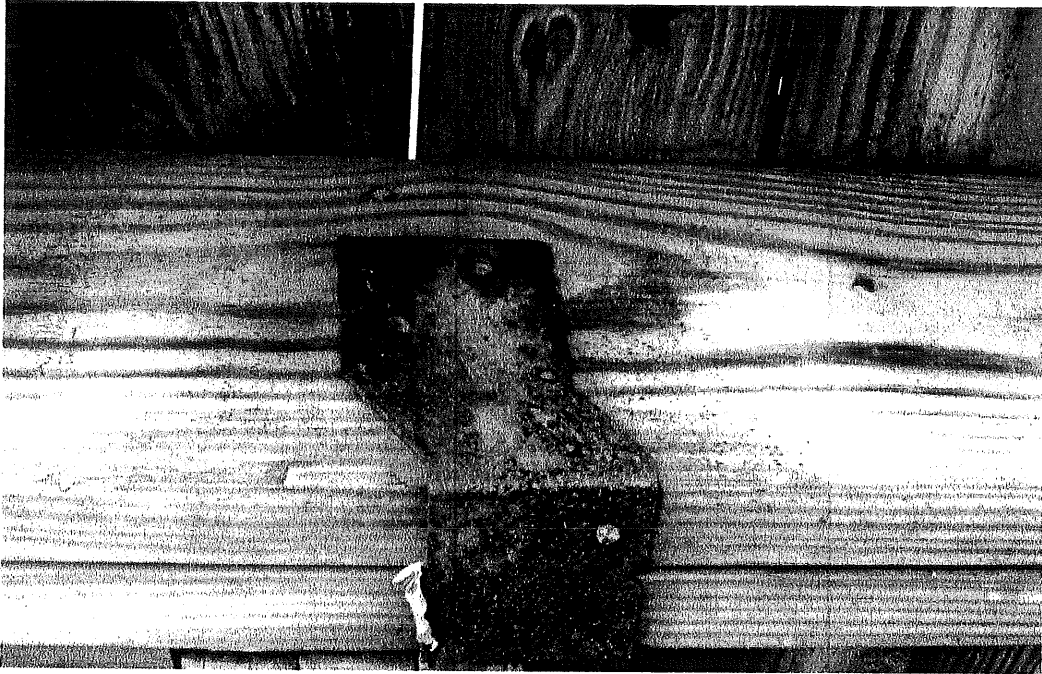
**PHOTO**  
**#15**  
0116 1732.jpg

Corroded Simpson Bracket at Inside of stair header. Remove and Replace.

- 1.10 Fill all joist hanger small round holes with galvanized joist hanger nails, and replace corroded hangers as determined by engineer;
- 1.11 Strengthen perimeter girders as determined by engineer at specific locations. This could be as simple as adding Timberlok Screws to improve load sharing between individual girder plies, or as complicated as removing and replacing girders in areas that now have supplemental, corroding steel angles installed;
