Project: Gateway PG - High St Façade Repairs Phase 1
Project #: WO 3521
Date/Time: September 21, 2015, 10:15 a.m.
Observers Adam Sampson, Author (BSE), Josh Martin-McNaughton (BSE)

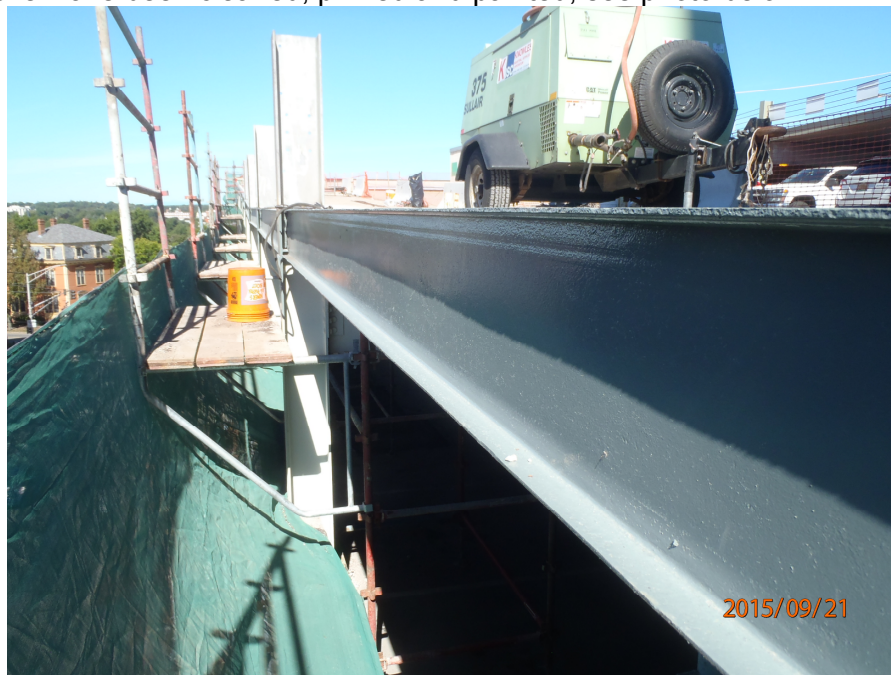
1. KISC has removed all of the CMU and brick masonry façade at the 4th level. All steel beams on the 4th level have been cleaned, primed and painted, see photo below.

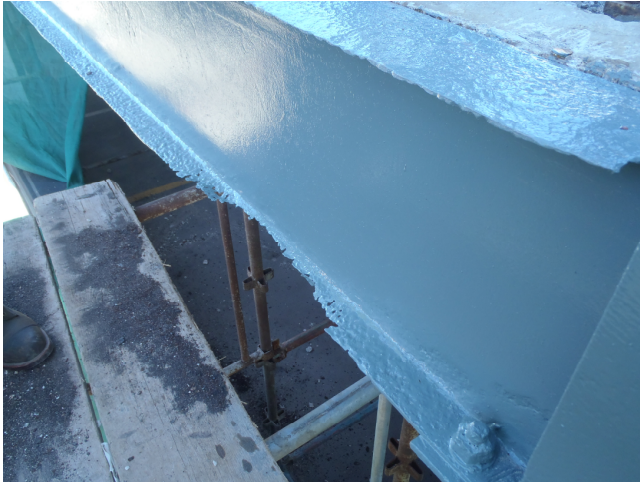
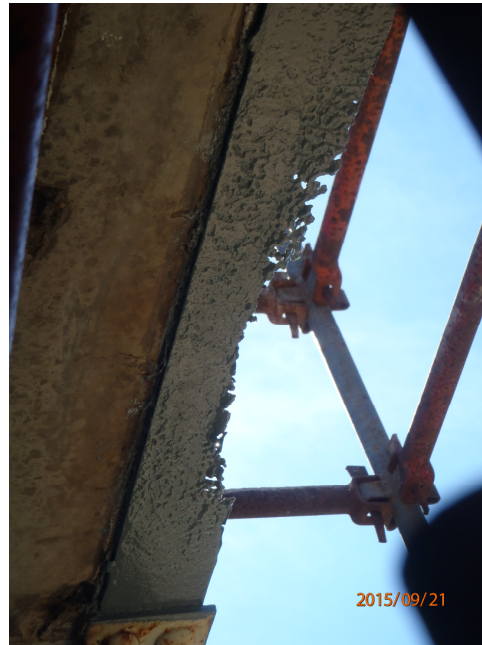
2. Generally, the existing steel is in fair to good condition with the exception of one beam end. Dan, the onsite foreman pointed out an existing W12 on the 4th level near column line 1 that has experienced section loss on its bottom flange, see photos below. BSE will provide a sketch for Smith Custom Fabrication (SCF) to weld a plate to the bottom of the flange, see attached sketch.

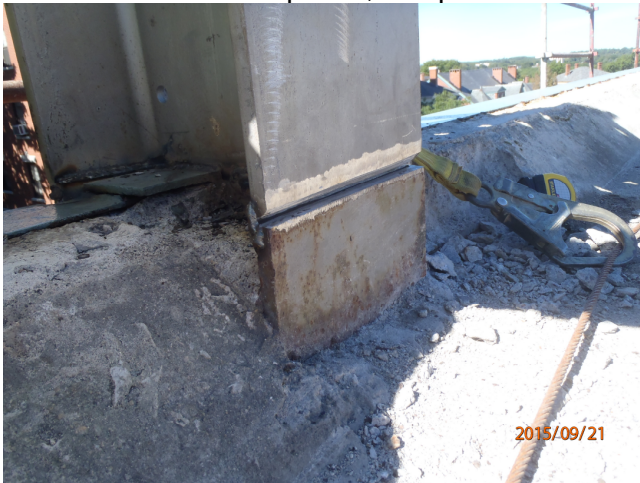
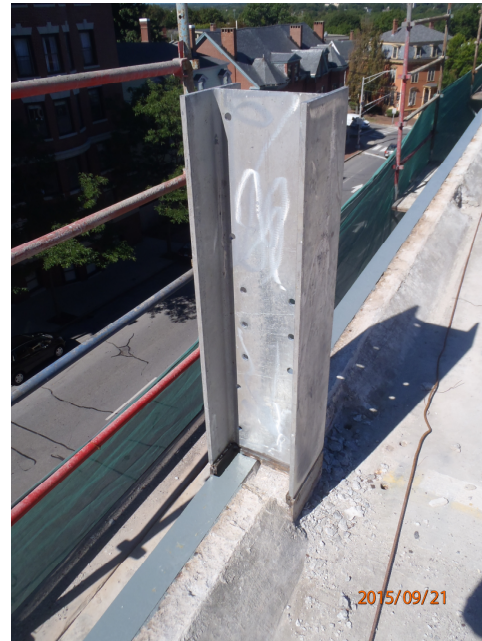
3. SCF has begun to install column extensions at the 4th level. The majority of the column extensions have been tack welded in place and will be fully welded later. Existing steel columns will need to be cleaned, primed and painted before concrete repairs around the columns are completed, see photos below.

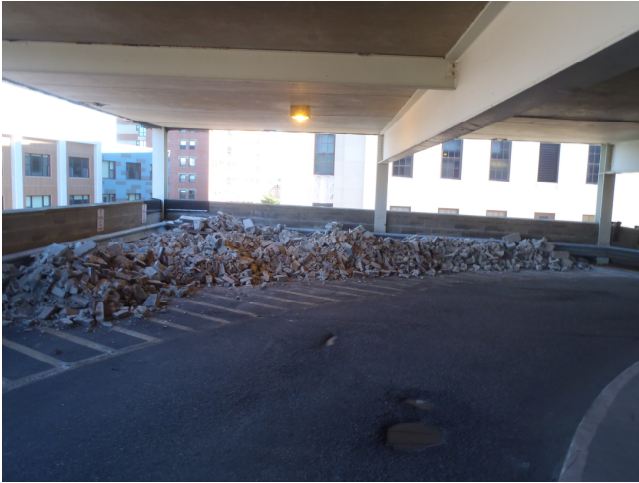
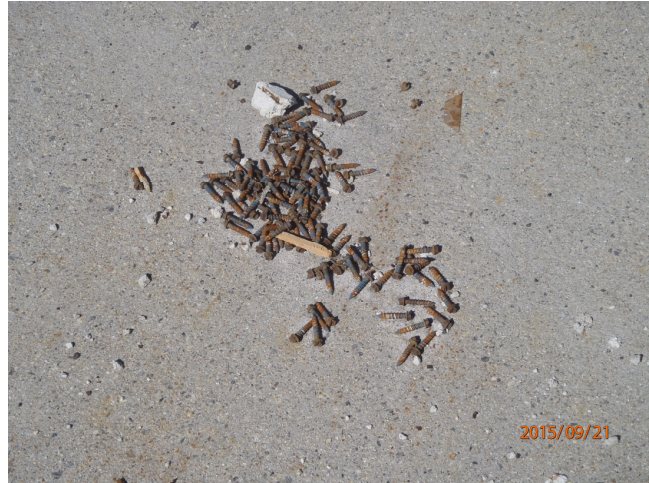
4. Bolt holes for the column extension at column line 4 are located 1 3/4" higher than what was intended. BSE is providing SCF with a sketch to alter this connection.
5. CMU and brick demolition debris are stored on the 1st level. The debris should be removed from the site at a minimum weekly basis. A pile of fasteners was observed on the 4th level and should be disposed of to prevent them from being kicked into the drive lane. See photos below.

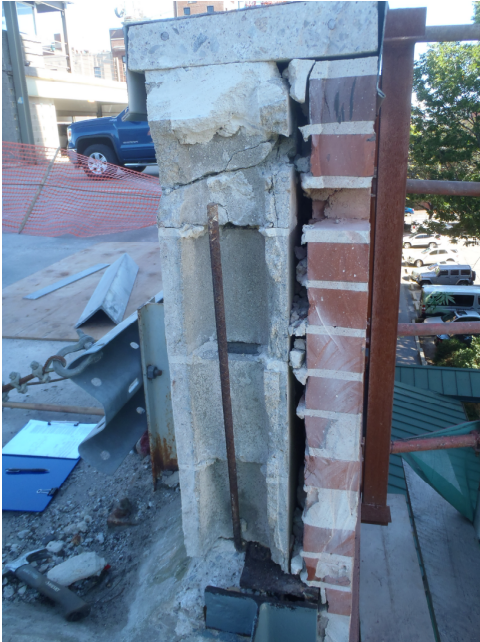
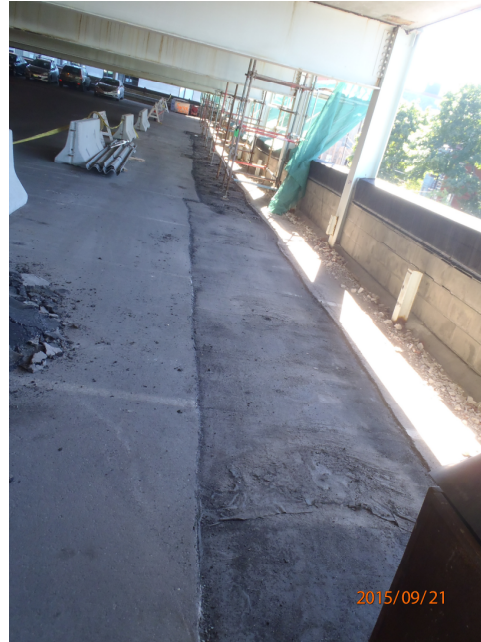
6. At Column line 1, the exposed CMU, is reinforced but un-grouted providing no lateral resistance to the wall, see photo below. This is representative of what we have found along the High Street façade as well.
7. KISC has continued to prepare asphalt potholes and other tripping hazards at the 3rd level. KISC has begun to set up shoring and staging for work at the 3rd level, see photo below.
