Field Report #7

No. 3521

Project: Gateway PG – High St Façade Repairs Phase 1
Project #: WO 3521
Date/Time: December 17, 2015, 9:30 AM.
Observers Adam Sampson (BSE) (Author), Josh Martin-McNaughton (BSE)

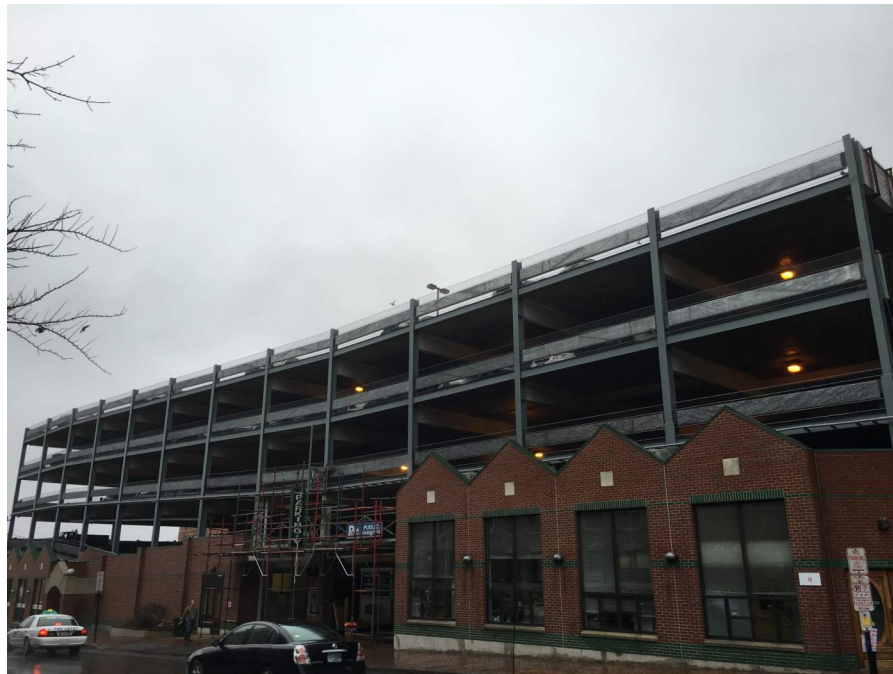
1. Knowles Industrial Services (KISC) has removed all of the brick and CMU façade. All HSS bumpers and pedestrian cables have been installed. The fencing was in the process of being installed at level 2. (See photos below).

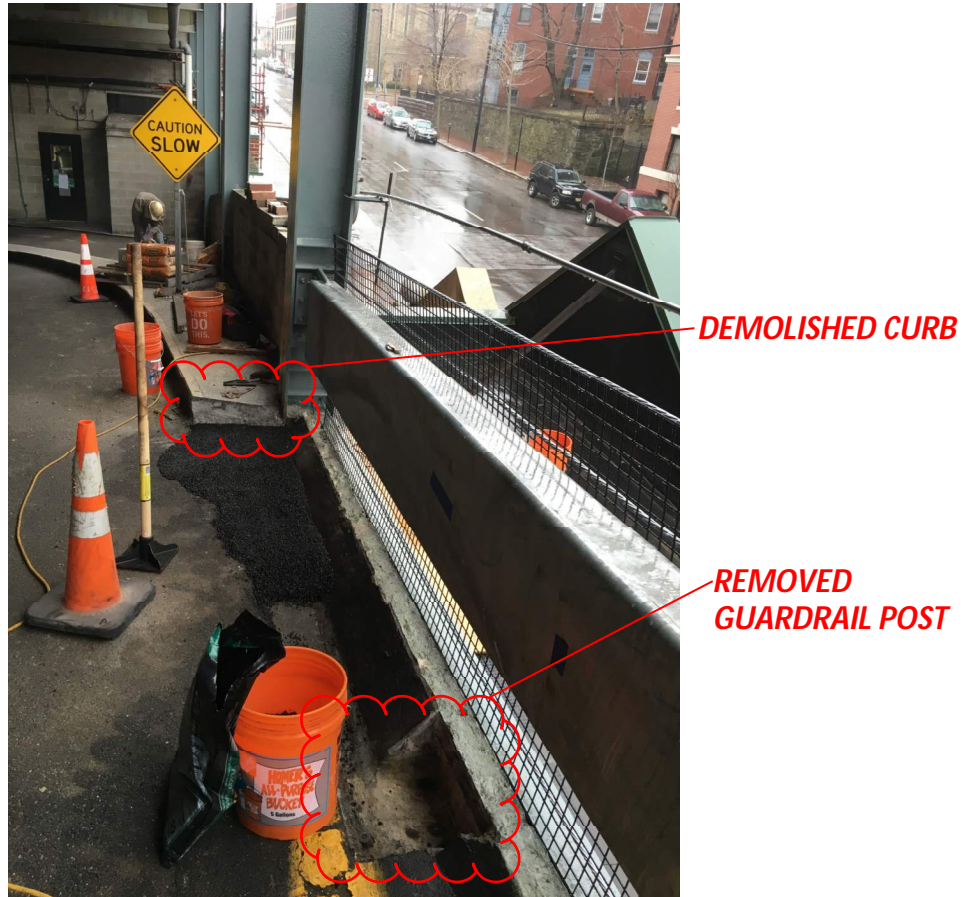
2. At level one BSE advised KISC to repair pavement at the demolished curb with cold patch asphalt and to provide 18" max height from drive surface to bottom of vehicle barrier. KISC will paint the face of the demolished curb safety yellow. (See photo below).
3. Dan the onsite foreman indicated KISC will be relocating the conduit at level one and securing it to the top pedestrian cable. (See photo below).

4. KISC is in the process of repairing the concrete curb where the removed guardrail posts were located. (See photo below).

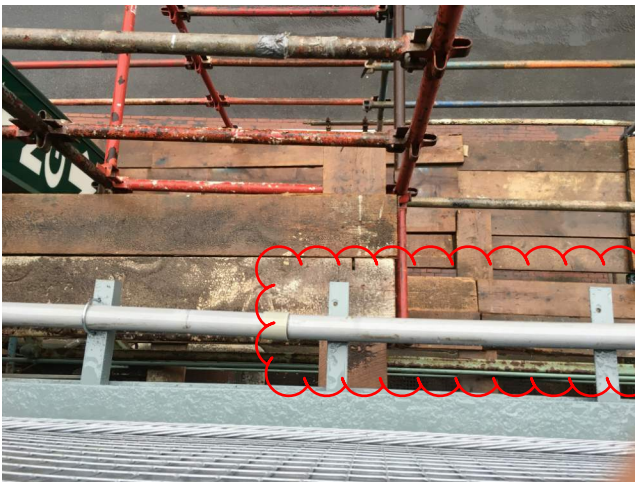
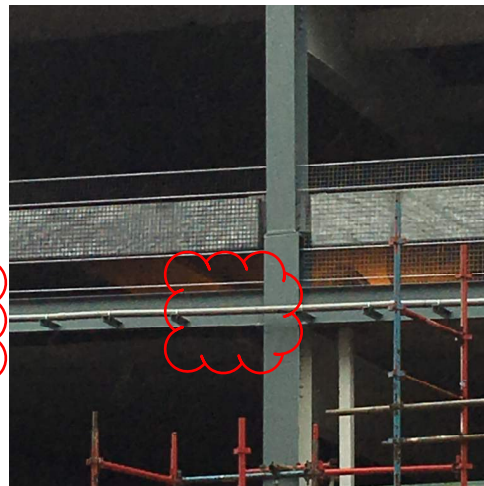
5. Dan indicated that U-bolts were missing from the clip angles supporting the data cable at level 2. KISC indicated they would install the remaining U-bolts. (See photo below).
6. Two clip angles to the left of column lines 8 & 6 (facing the garage) have not been installed; the clip angles and U-bolts should be installed to support the data cable. (See photo below).

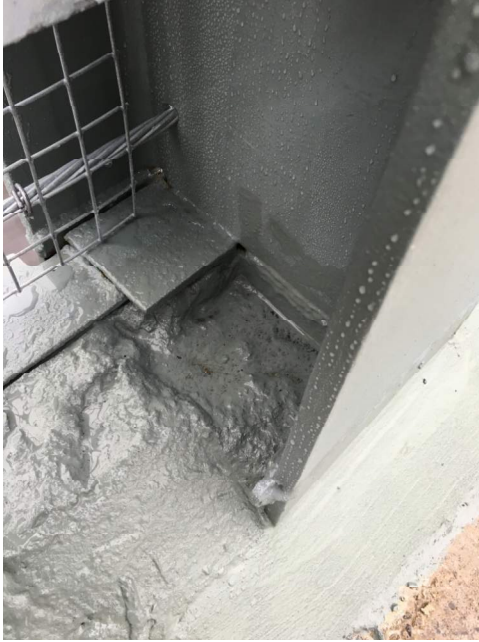
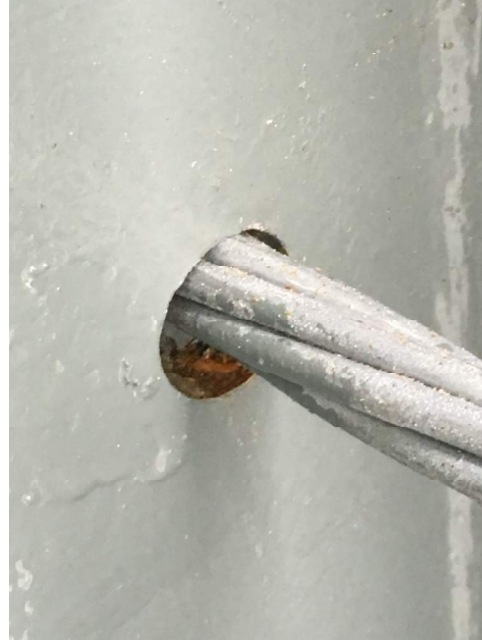
7. At the roof level, water is ponding at a pocket within the concrete curb at both sides of the column extension. KISC needs to chip away the concrete to allow the water to drain or place a sloped concrete patch, and repaint the curb. (See photo below).

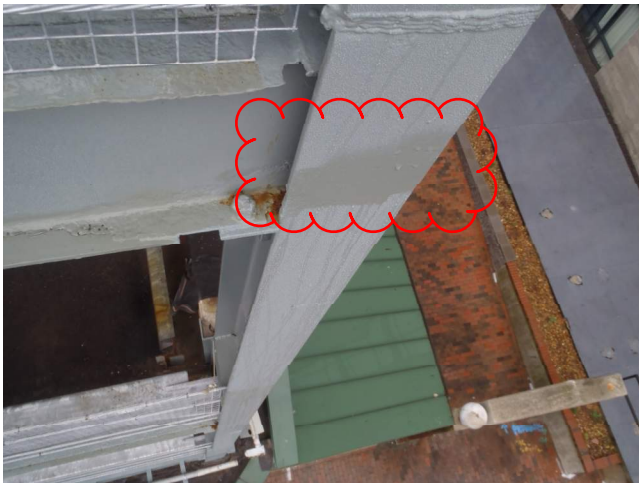
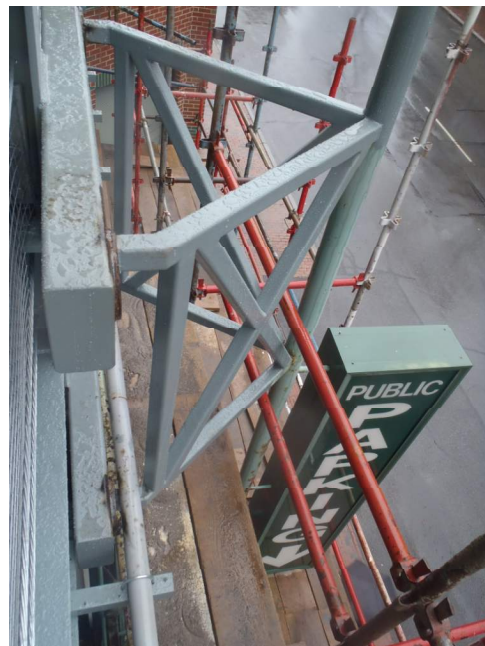
8. Each column, cable hole, and beam should be inspected for touch ups to any scratches, dings or areas missing paint. KISC is aware that final coats need to be applied to several locations at the external face of the columns. The existing "Public Parking" sign has been attached to the new steel frame, the remaining areas of the sign frame needs to be cleaned, prepped, primed and painted.

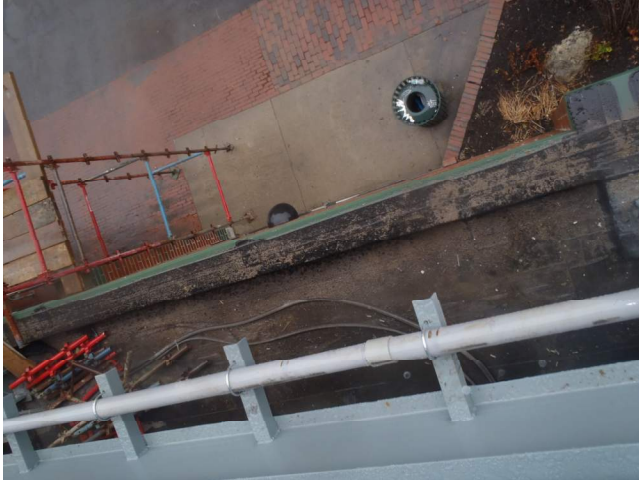
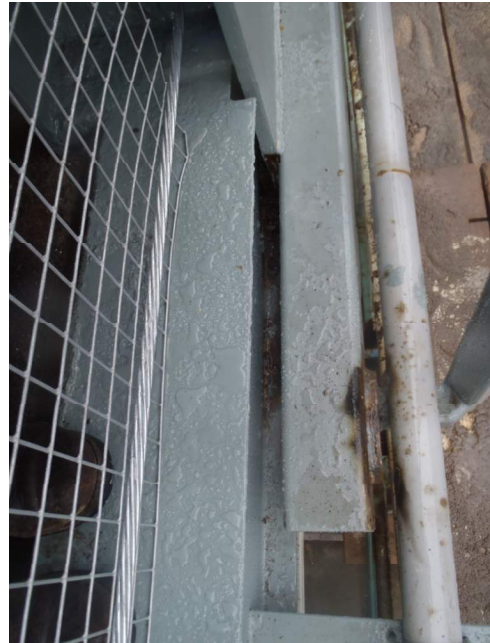
9. Remove staging and debris from the condo and parking office roof. (See photo below).

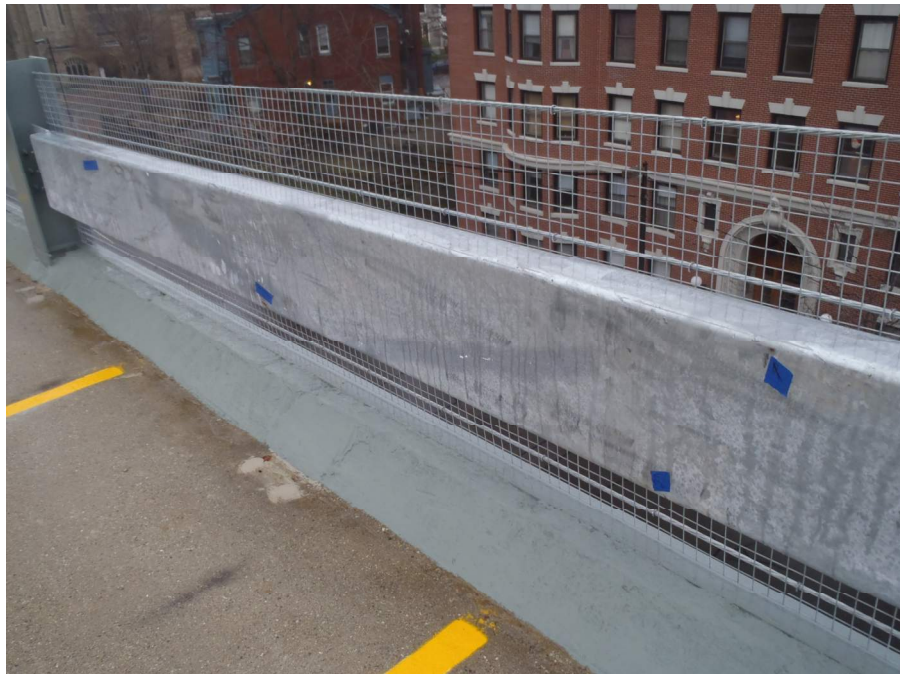
10. BSE has marked locations on the HSS bumpers with blue painter's tape where the galvanizing has been damaged. It was difficult to differentiate the difference between rust, dirt or grease so the contractor should inspect each bumper to determine if the coating needs to be repaired. (See photo below).

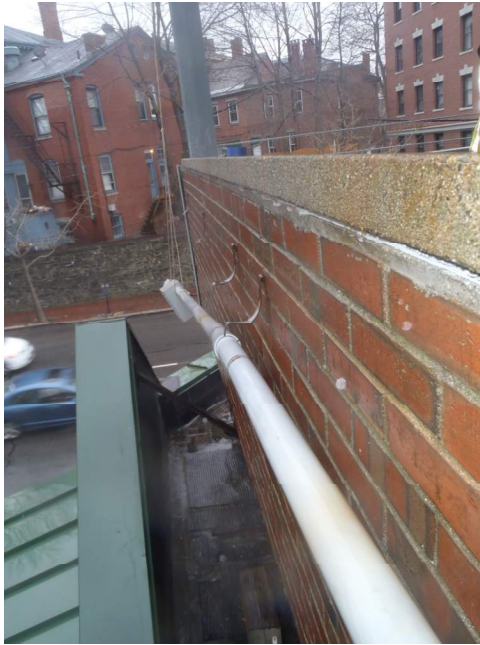
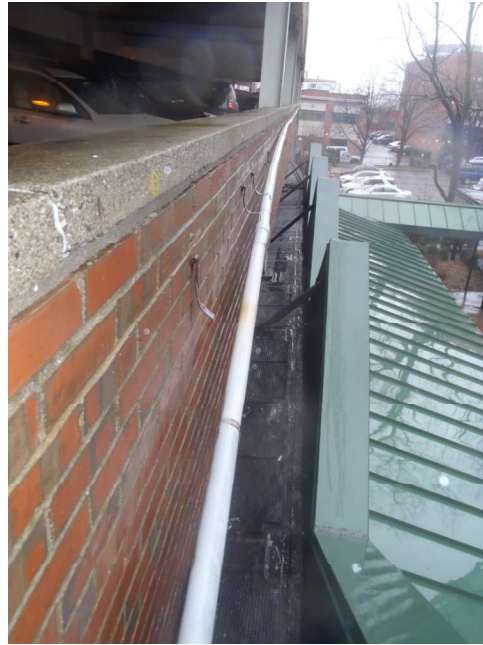
11. Dan indicated Time Warner Cable would be onsite to relocate the data cable and junction box along the Hotel façade. It is recommended to match the elevation of the data cable along the High St. façade since this façade will be removed in the future. (See photos below).

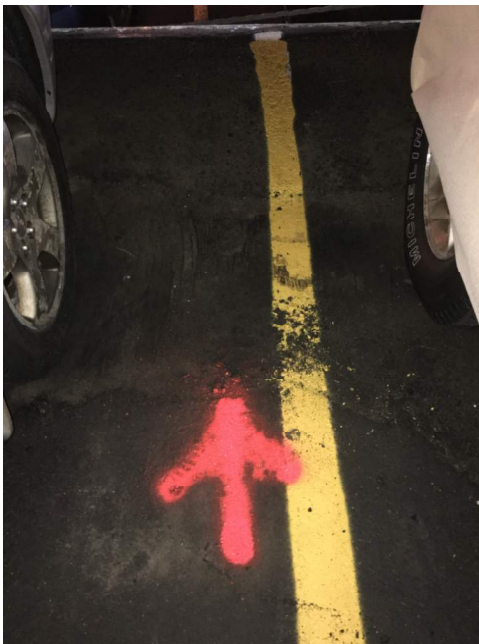
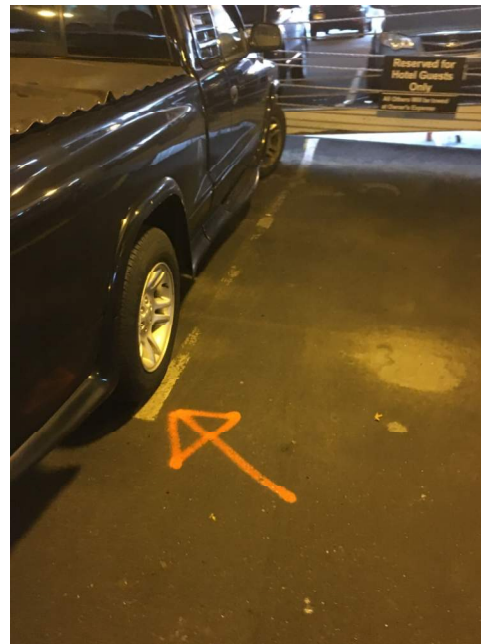
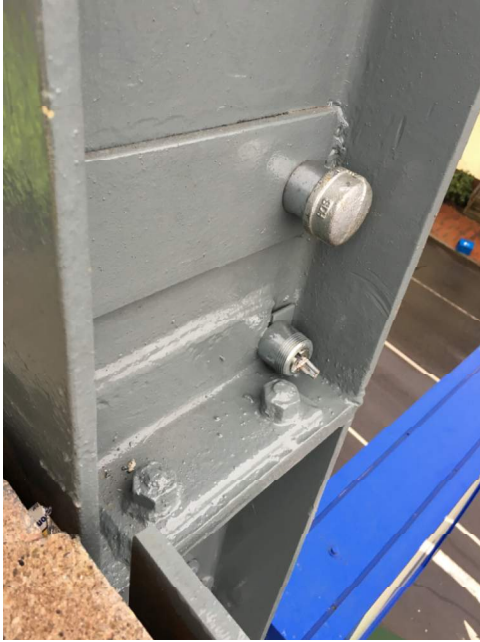
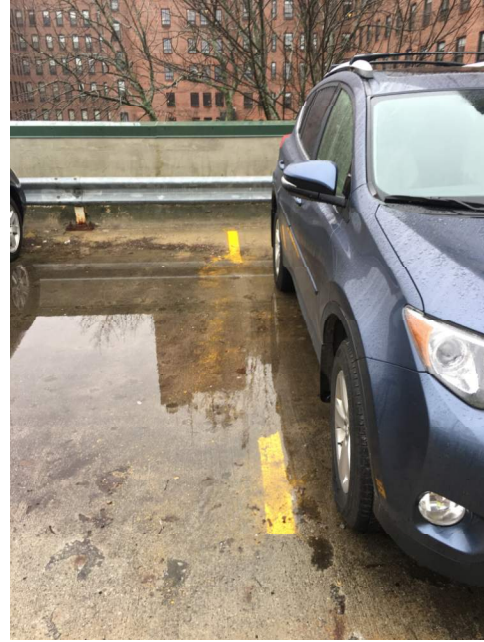
12. Pavement repairs and line stripping have been completed within the garage with the exception of a few areas. These areas were not completed because vehicles have remained stationary since work has begun in the garage. KISC is aware of these locations and vehicles may need to be towed temporarily to access these areas (approximately 4-5 spots). At the roof level where ponding water is present the parking stall striping has deteriorated and needs to be restriped. (See photos below).
