## Field Report #2

**No. 3917**

**Project:** Gateway PG – Forest Ave. Façade Repairs Phase 2  
**Project #:** WO 3917  
**Date/Time:** January 25, 2017, 9:30 a.m.  
**Observers** Adam Sampson (BSE) Author, Josh Martin-McNaughton (BSE)

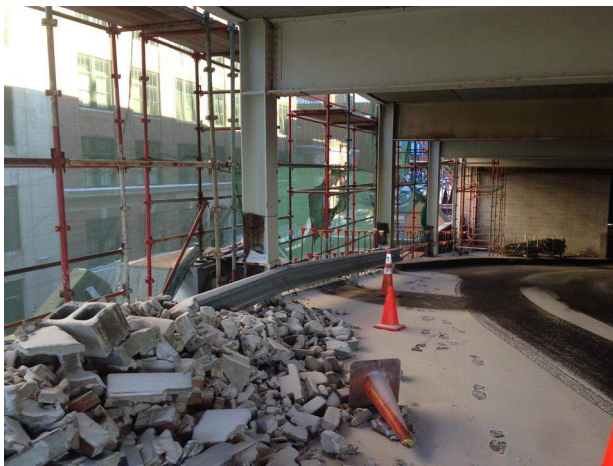
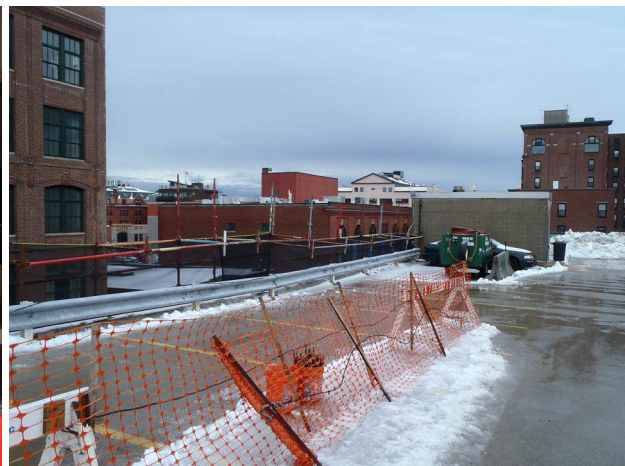
1. KISC has completed demo at level one and was in the process of demoing the CMU and brick façade at the roof level. They are expected to complete the roof demo by the end of the week. See photos below.

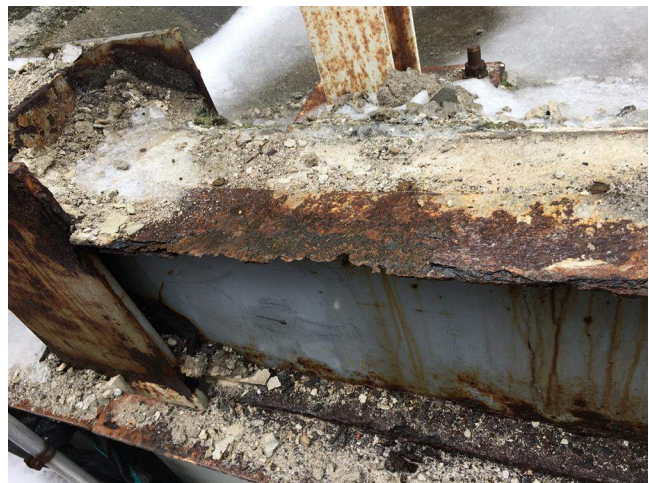
2. While staging is erected at the roof level, KISC will use needle guns and mechanically grind the steel beams to remove rust and corrosion. It is anticipated that there will be repairs required to deteriorated steel. Once all repairs are made, KISC will prime and paint all beams, cold weather precautions need to be considered when painting.

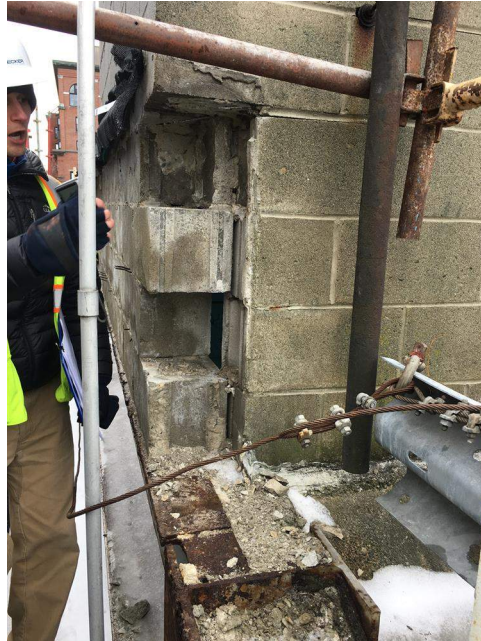
3. The existing CMU wall was toothed into the corner of the stair tower wall and KISC removed those units. See photo below. New fully grouted or solid CMU corner units will have to be reinstated.

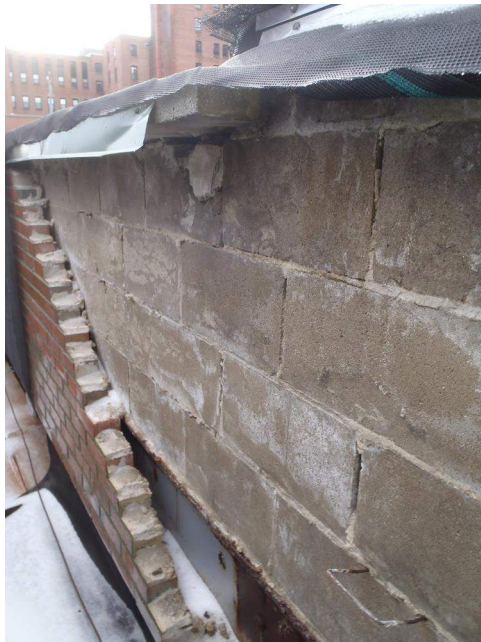
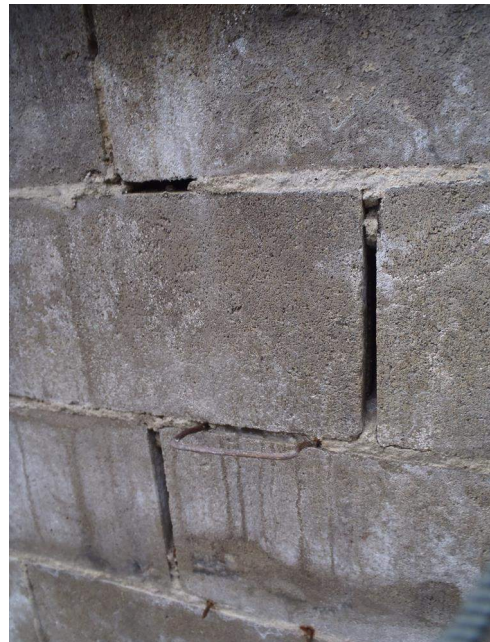
4. Where the brick masonry was removed in front of the stair tower it exposed open CMU joints and cracks that will have to be repointed. See photos below. Masonry ties should be ground flush with the CMU.

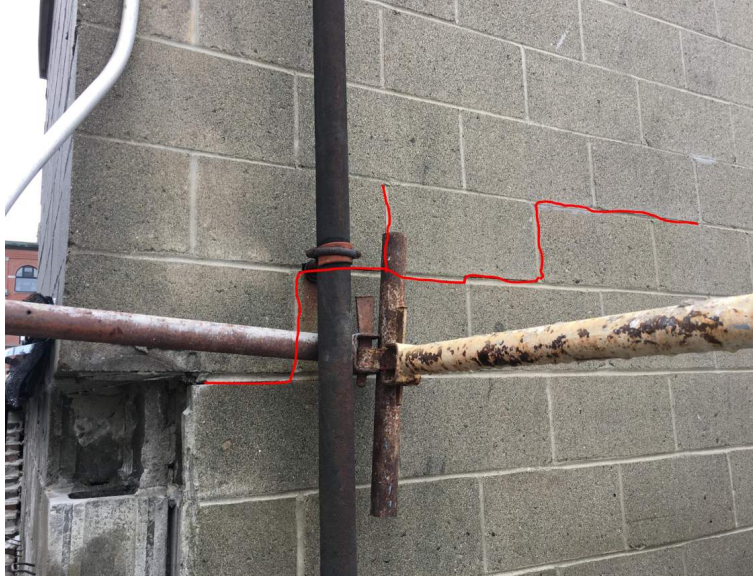
5. Step cracking in the stair tower should be repointed prior to painting of the CMU. See photo below.
