## Field Report #4

**Project:** Gateway PG – Forest Ave. Façade Repairs Phase 2  
**Project #:** WO 3917  
**Date/Time:** February 23, 2017, 1:30 p.m.  
**Observers** Adam Sampson, (BSE) Author

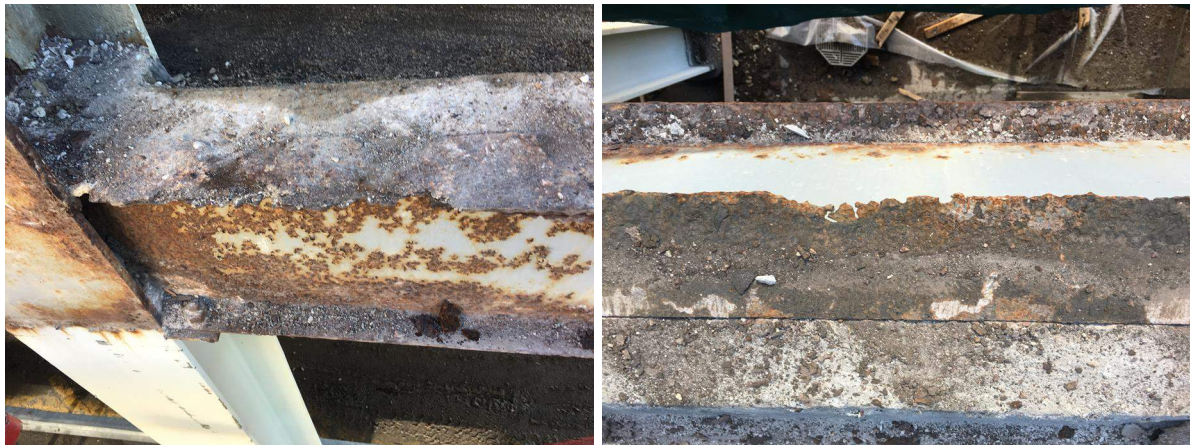
1. KISC has completed demo at the second level and has begun to prep the existing steel beams and columns using needle guns to remove loose and unadhered rust. (See photos below).

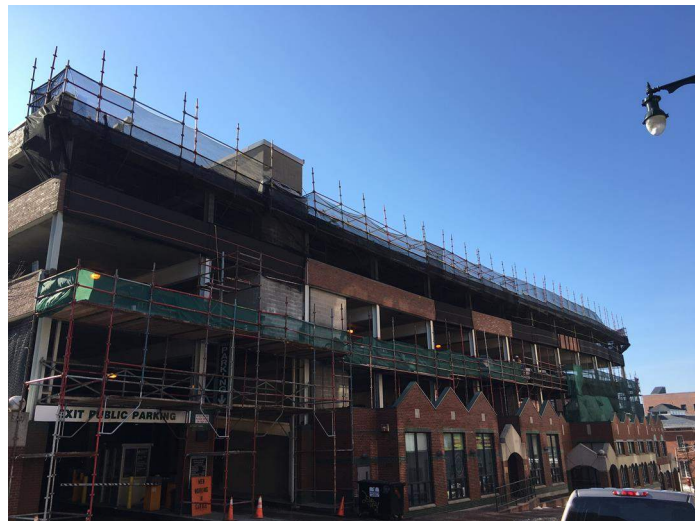
2. It is anticipated that there will be similar section loss issues with the existing W12 beam top and bottom flanges that were experienced at the roof level. When the beams are cleaned BSE will review the conditions and mark locations requiring repairs.
3. Once the column extensions are installed at the roof level and all painting of the existing steel beams and columns are completed, KISC will move its staging to level 3 and begin demo at that level.

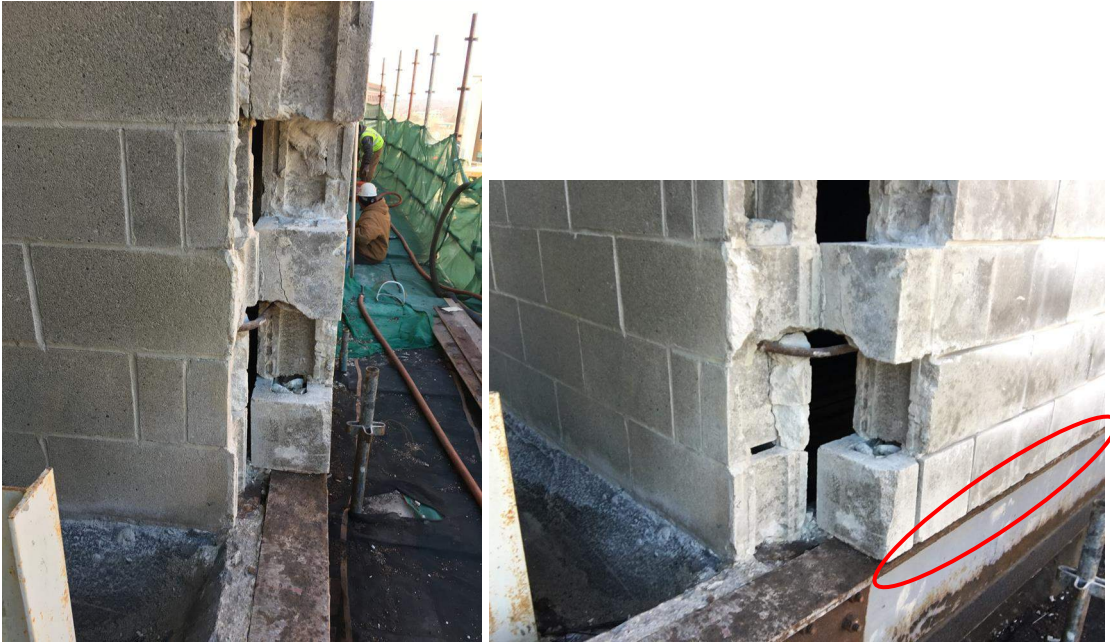
4. New fully grouted or solid CMU corner units will need to be reinstalled at the corner of the stair tower. KISC will also need to rout and repoint the open CMU joints where the brick masonry was removed in front of the stair tower. (See photos below).

5. KISC will need to rout and seal with sealant the joints between the stair CMU wall and the existing steel beam top and bottom flanges, see the photo above (red outlined area). The sealant should be compatible with the paint.
