Field Report #6

No. 3917

Project: Gateway PG – Forest Ave. Façade Repairs Phase 2
Project #: WO 3917
Date/Time: April 3, 2017, 1:30 p.m.
Observers Adam Sampson, (BSE)

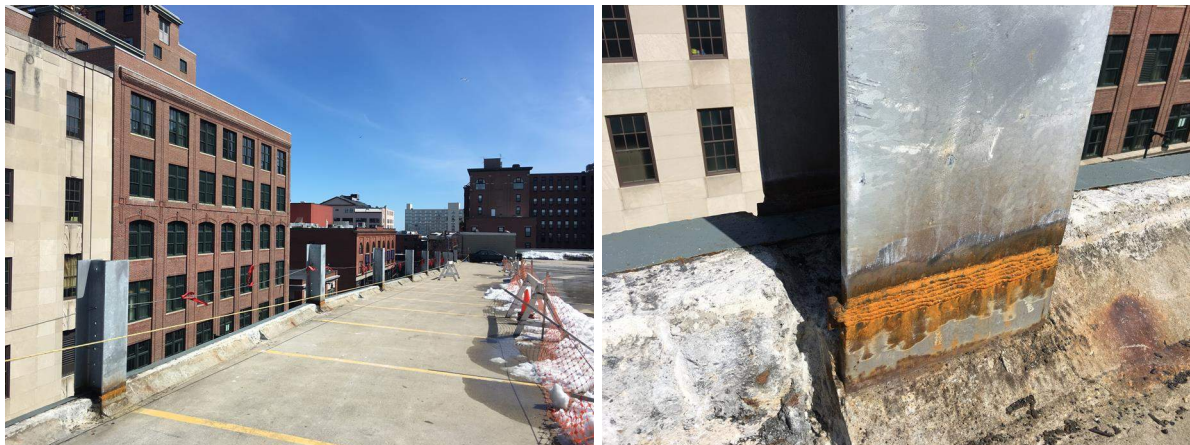
1. SCF has completed welding all column extensions at the roof level. The welds & the tops of the existing columns need to be cleaned and coated with cold galvanizing prior to painting. It was noted by SCF that a few of the existing columns were twisted and did not align with the new extensions, resulting in multiple weld passes to establish the complete joint penetration. (See photos below).

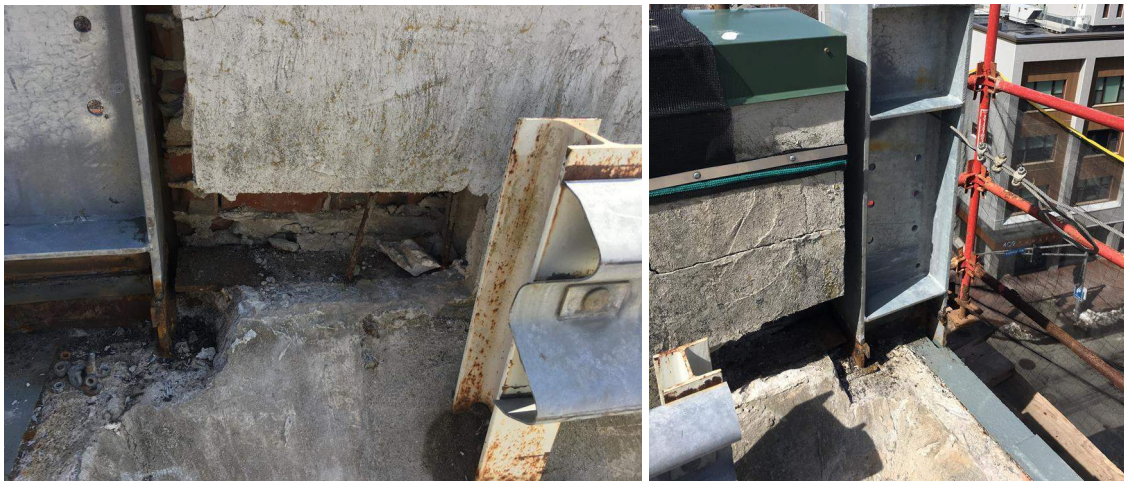
2. At the roof corner columns, a portion of the CMU wall removed to allow access to weld the column extensions. These blocks will need to be reinstated prior to the installation of masonry restraint plates. (See photo below).

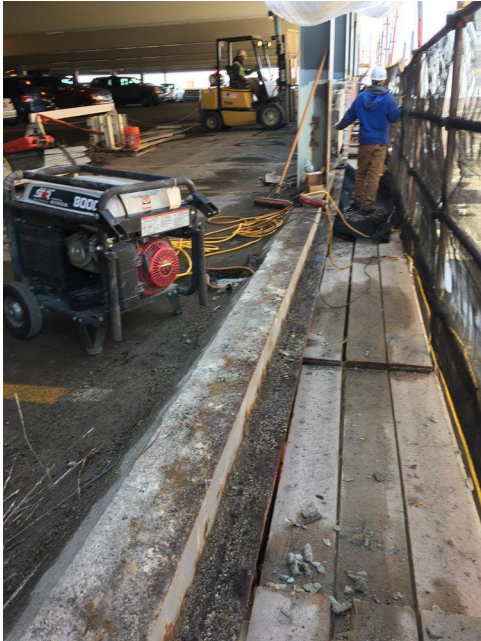
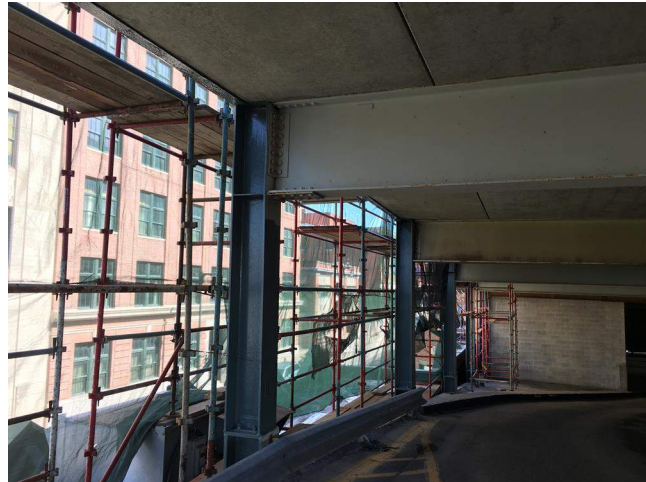
3. KISC has moved the majority of the staging from the roof to level three and completed roughly half of the brick and CMU façade demo. They anticipate completing the demo by the end of the week. (See photo below).

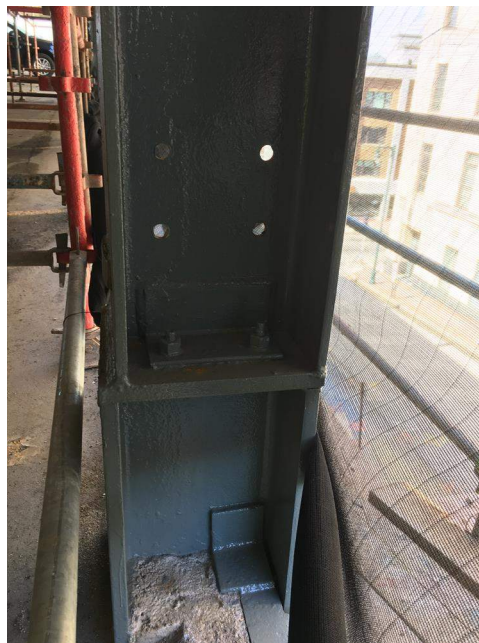
4. Painting has been completed at levels 1, 2 and a portion of the roof level. Level 3, the roof level column extensions and touchup painting is all that remains to be completed. (See photo above).
5. SCF is in the process of drilling cable and bolt holes at levels 1 & 2. (See photo below).
