Re: Condition of The Gateway Garage

BECKER
STRUCTURAL ENGINEERS

RE: Gateway Garage, Portland, Maine

RE: Gateway Garage, Portland, ME

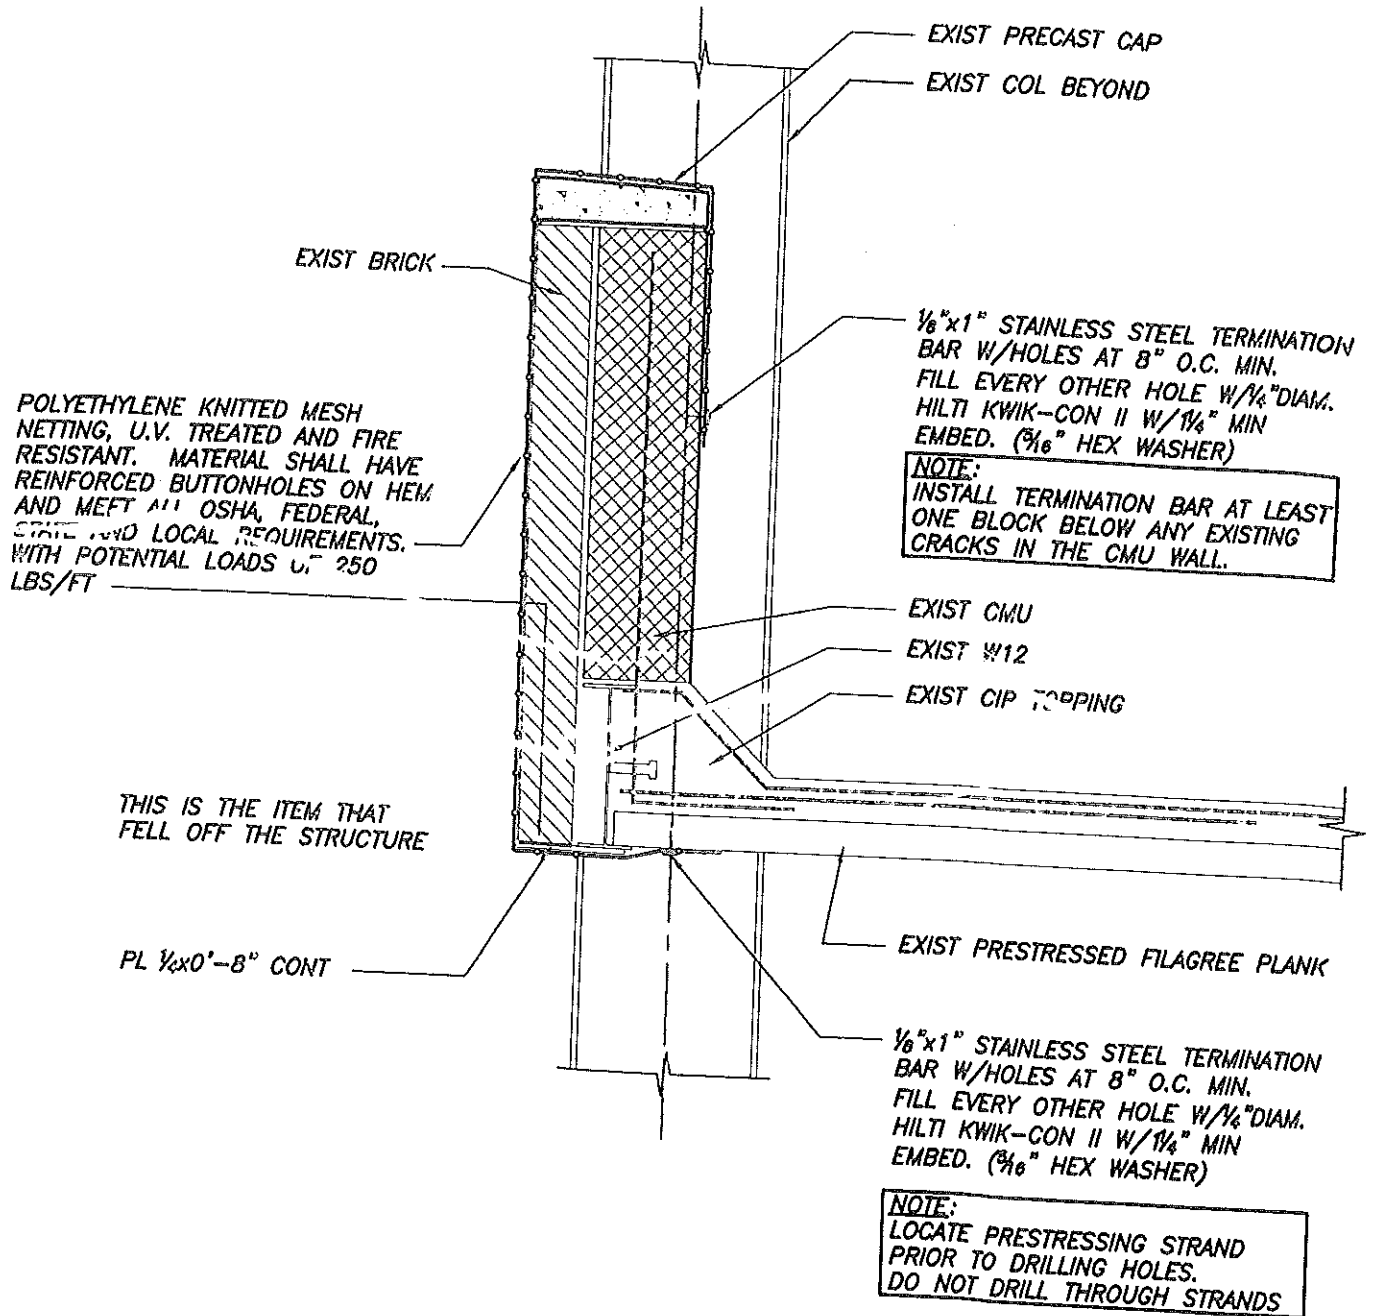
NETTING DETAIL

We spent a significant amount of our day looking at the façade of this structure which consist of a brick veneer and CMU back-up and capped by precast concrete cap. The wall is supported by a steel beam embedded in the slab and a steel plate that is attached to the bottom flange of the beam. This plate cantilevers out to support the brick façade and was the item that fell from the structure last week. Based on our review we do have some concerns about the long term stability of the façade system. During our review we removed loose pieces of mortar, brick, precast and CMU. We also noted several areas where we were concerned about the connection of the plate to the steel beam. Based on our limited review of the structure it would be impossible for us to predict or speculate on whether or not more plates are going to fail in the near future. We do believe that it would be prudent to install some temporary protection, especially at the areas directly above walking and driving areas, as soon as possible. This will offer protection to pedestrians and parkers as we work to develop repair details and continue our review of the façade. Based on our discussions with the Owners we will work with the contractor to install netting at the areas of highest risk as a temporary measure until permanent repairs can be installed.

As noted above we believe that the areas that have the highest risk should be protected. We should also continue the process of reviewing the façade and removing all the loose material.
