JOB NAME: 30 Preble Street
JOB NO.: 15013.05
DATE OF VISIT: Aug 13, 2015
WEATHER: 85°, clear
CLIENT: Port Property Management
OBSERVERS: David Tetreault, SDC

I performed a visual assessment of the existing fire escape located at 30 Preble Street, Portland, ME.

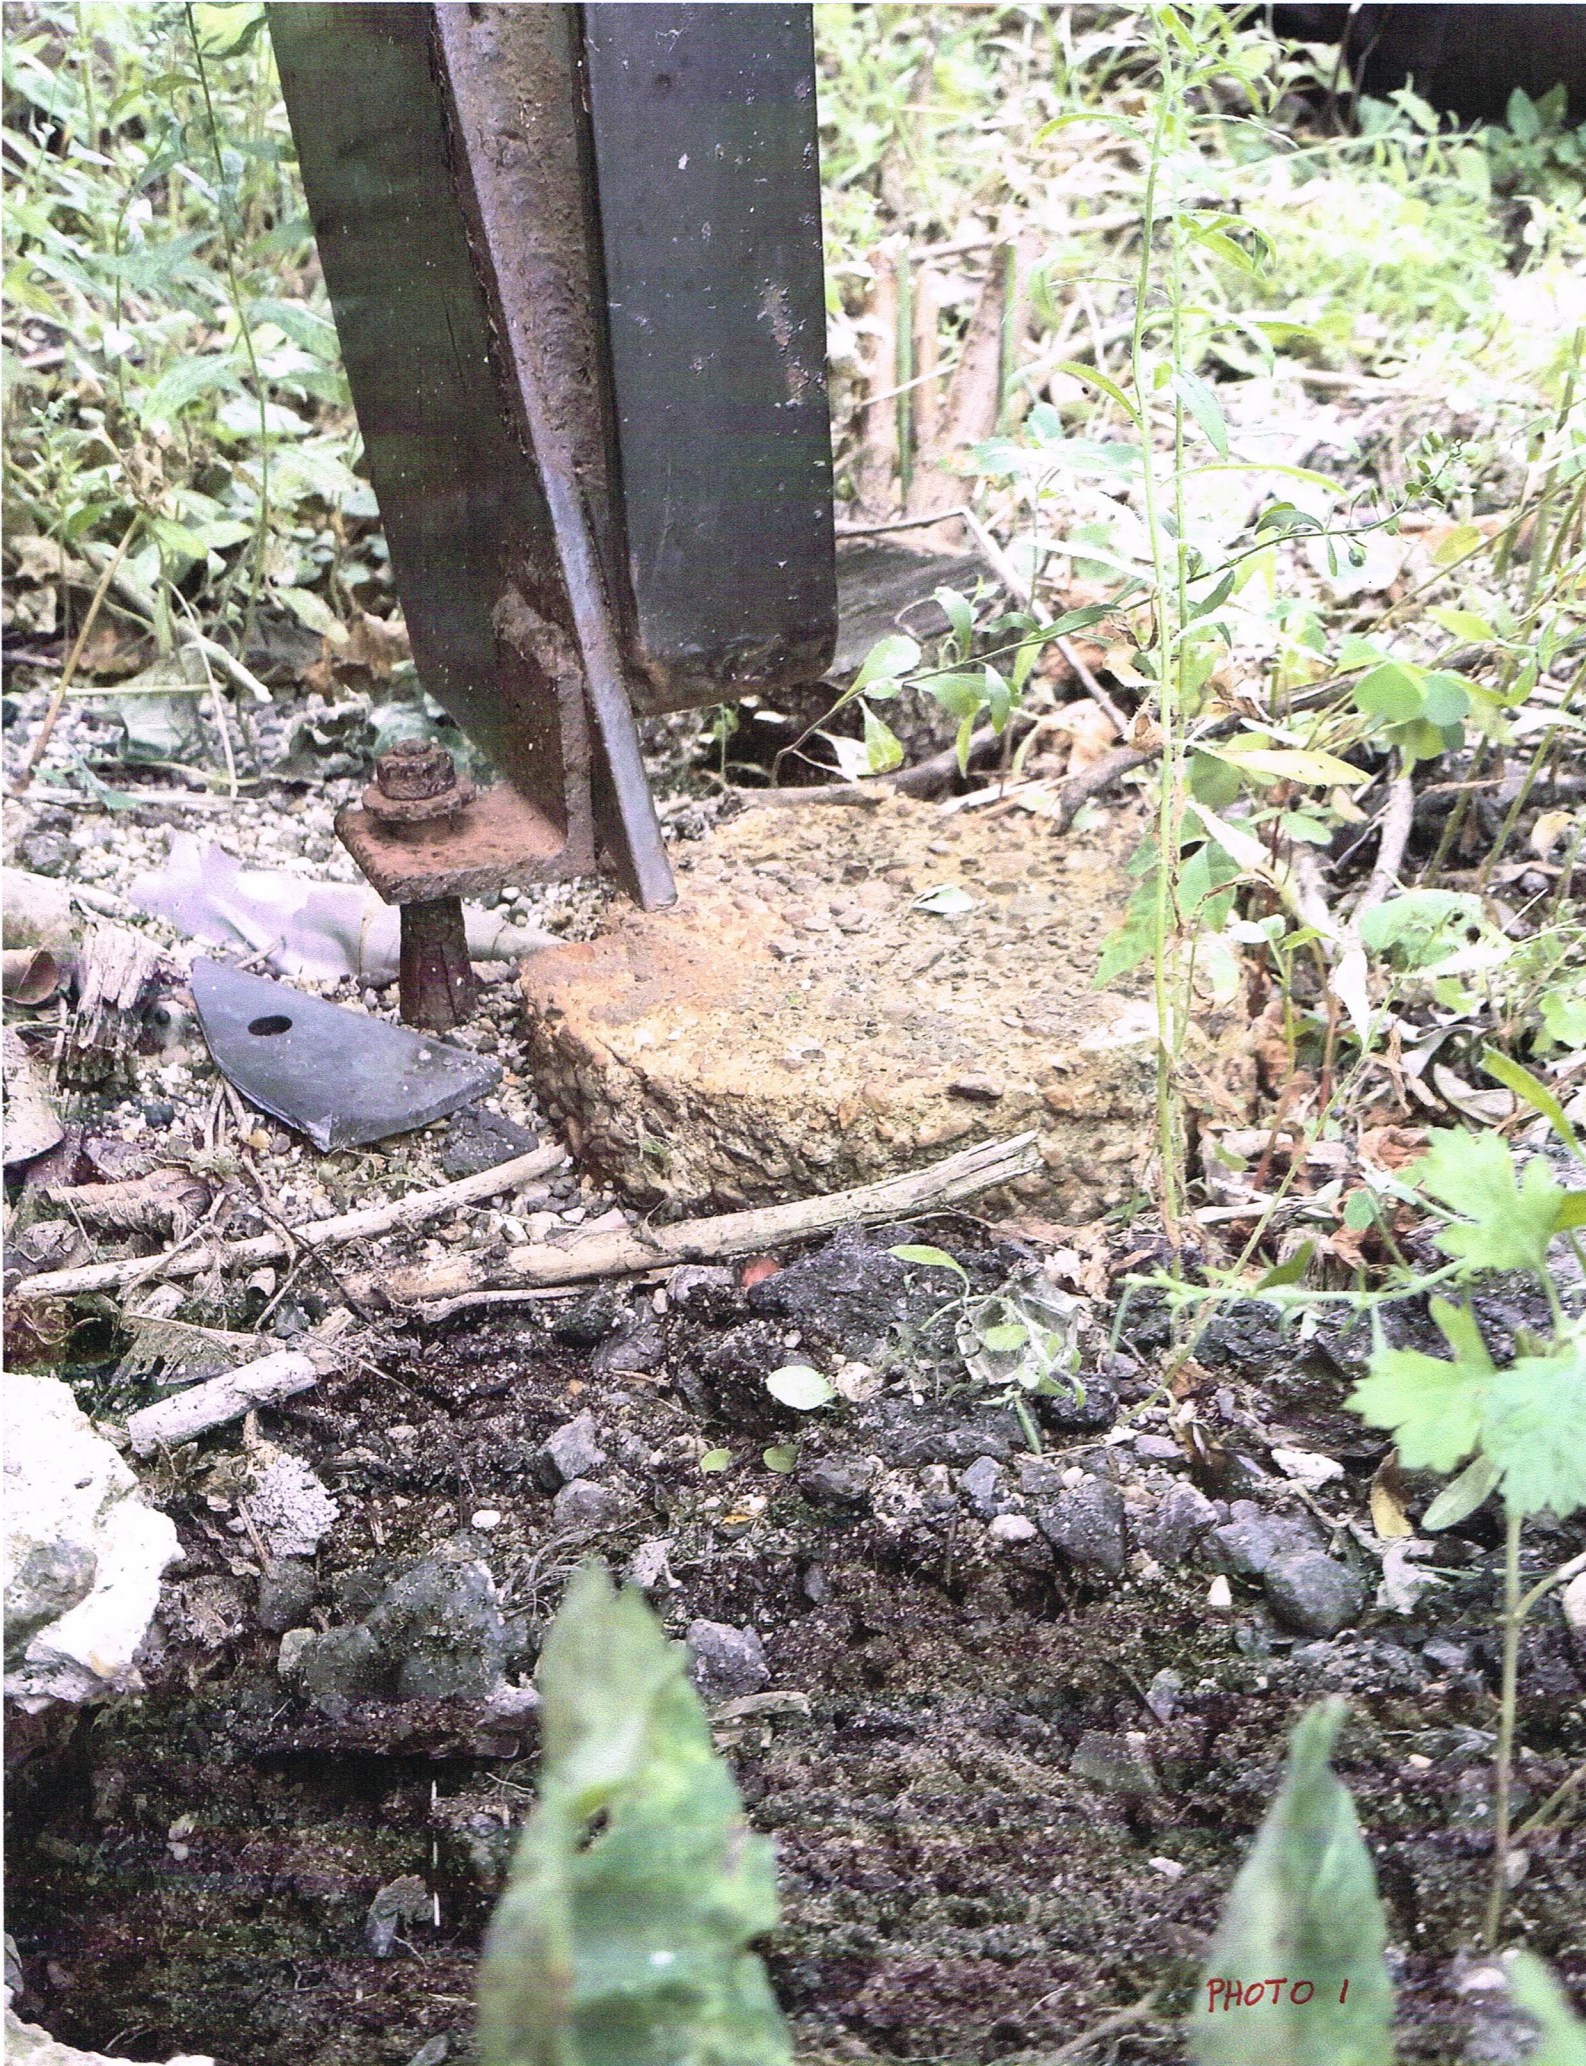
PHOTO 1

The bottom of one of the stair stringers at ground level does not land on the supporting concrete base (see photo 1). A positive connection must be made between the base of the stringer and a concrete base.

The fire escape was in acceptable condition. No repairs other than the stringer base connection were required at the time of the assessment.
