ASBESTOS / LEAD DETERMINATION REPORT

**110 Free Street
Portland, Maine**

October 5, 2009

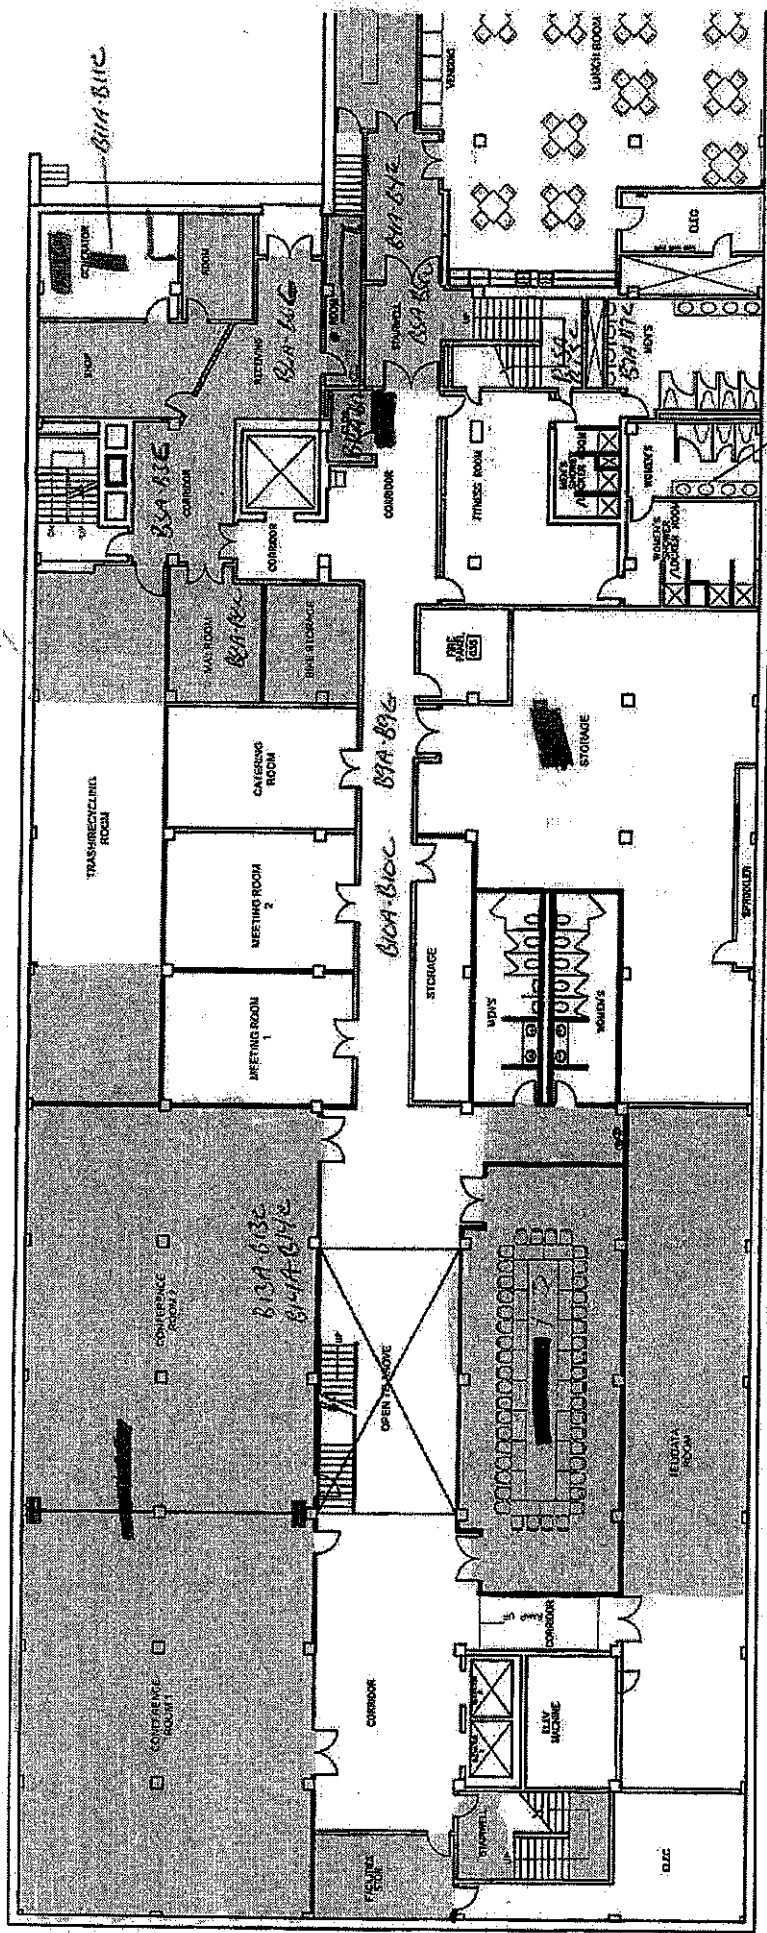
SCHEME 2 - BASEMENT FLOOR PLAN

ASBESTOS CONTAINING FIBRILS

ASBESTOS CONTAINING THERMAL SYSTEM
INSULATION - MURDED FITTINGS PIPE INSULATION
EXHAUST BRACES/HANGING

ASBESTOS CONTAINING 12" X 12" FT
