Prepared For:  
**LAFAYETTE PROPERTIES, LLC**  
 155 LITTLEFIELD STREET  
 BANGOR, MAINE 04401

Project:  
**Holiday Inn**  
 88 Spring Street  
 Portland, ME

Date: June 30, 2017  
 Scale: As indicated  
**MASONRY REPAIR**

**BE1A**

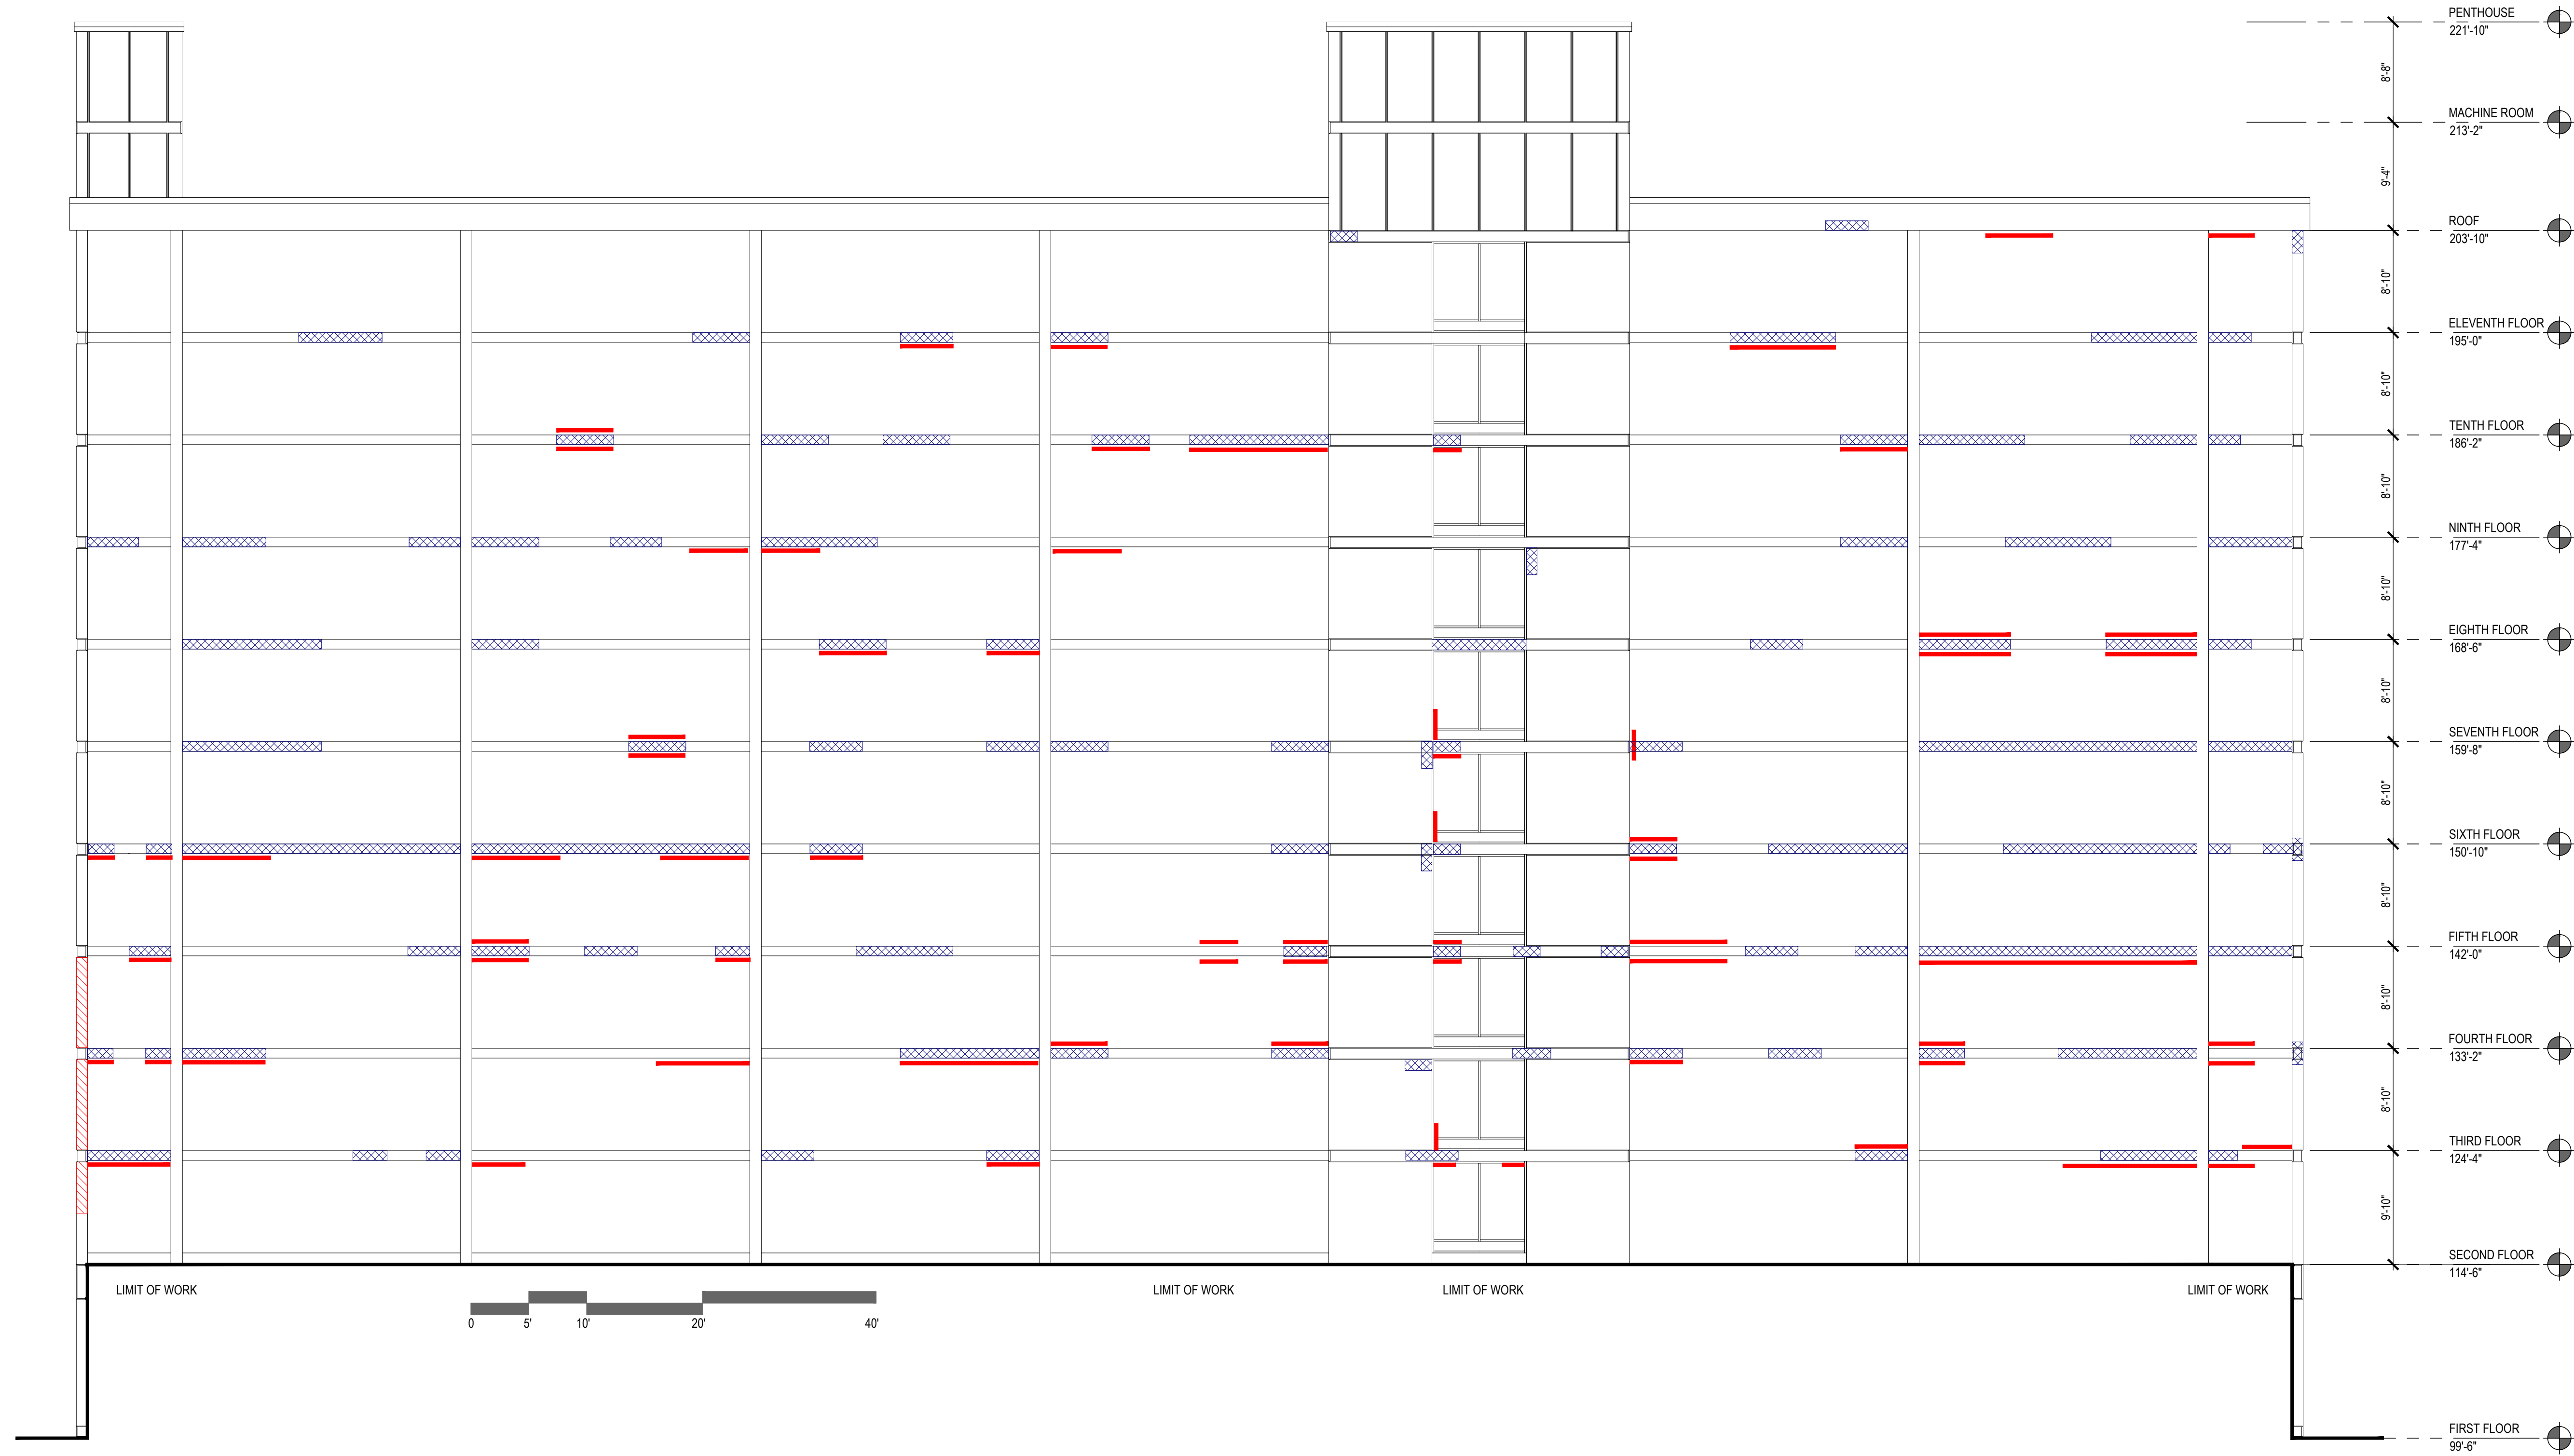
**5**

**CONCRETE REPAIR WEST ELEVATION**

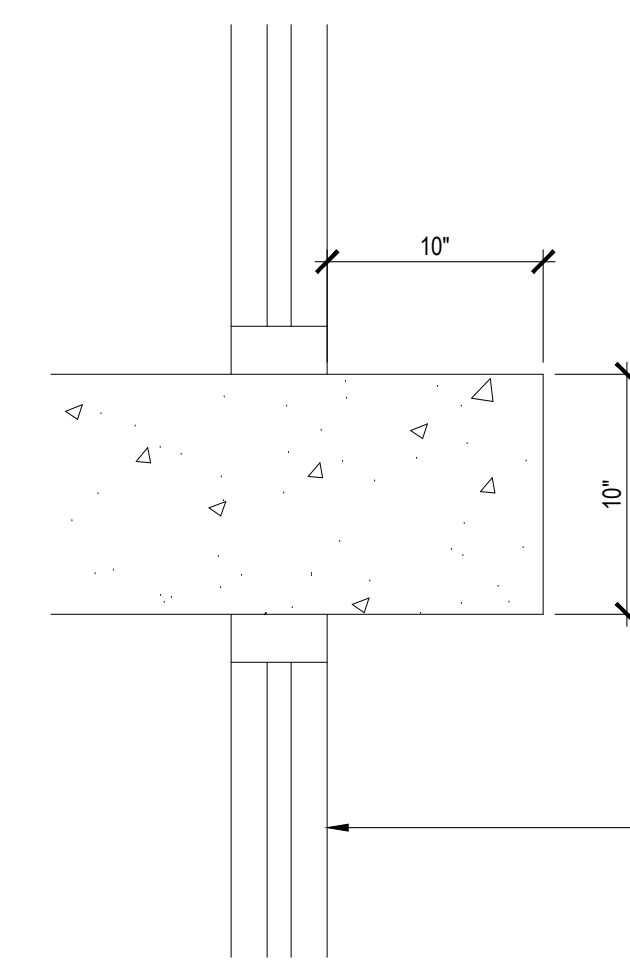
**3**

**TYPICAL LEDGE SECTION EXISTING CONDITION**

- EXISTING EDGE OF SLAB CONDITION AS SHOWN.
- REMOVE ALL COATINGS AND LOOSE MATERIAL
  - REMOVE AND REPAIR ALL SPALLING AND DETERIORATED CONCRETE AS INDICATED IN THE ELEVATIONS
  - STABILIZE ALL REINFORCING OR REPLACE IN KIND WITH NEW MATERIAL
  - FORM AND PRESSURE INJECT CEMENTITIOUS GROUT INTO ALL DAMAGED AREAS.
  - NOTE THERE IS AN ADDITIONAL INFORMATION IN THIS DRAWING SET TO APPLY SELF LEVELING MATERIAL TO ALL BAYS PRIOR TO CURTAIN WALL INSTALLATION.
  - REVIEW OF MASONRY DOES NOT EXTEND BEYOND THE EXTERIOR FACE OF EXISTING FENESTRATION AT EXTERIOR WALL

EXISTING FENESTRATION TO BE REMOVED.
