UST CLOSURE SITE ASSESSMENT REPORT SUMMARY COVER SHEET

Facility Name: Harborview Citgo

Location 101 York St. Portland Maine

Purpose of Site Assessment: Document removal of a gasoline UST at the site.

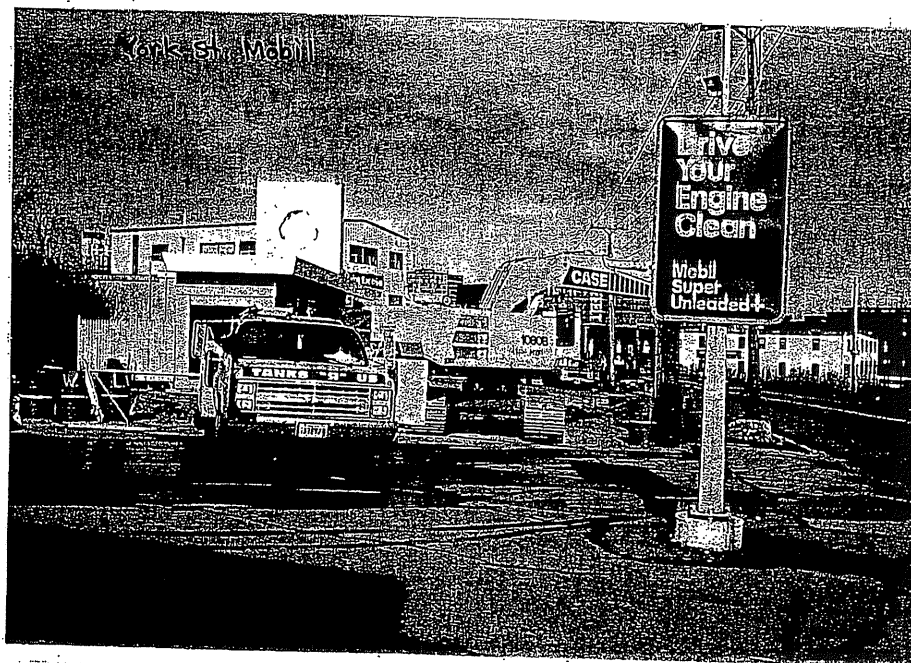
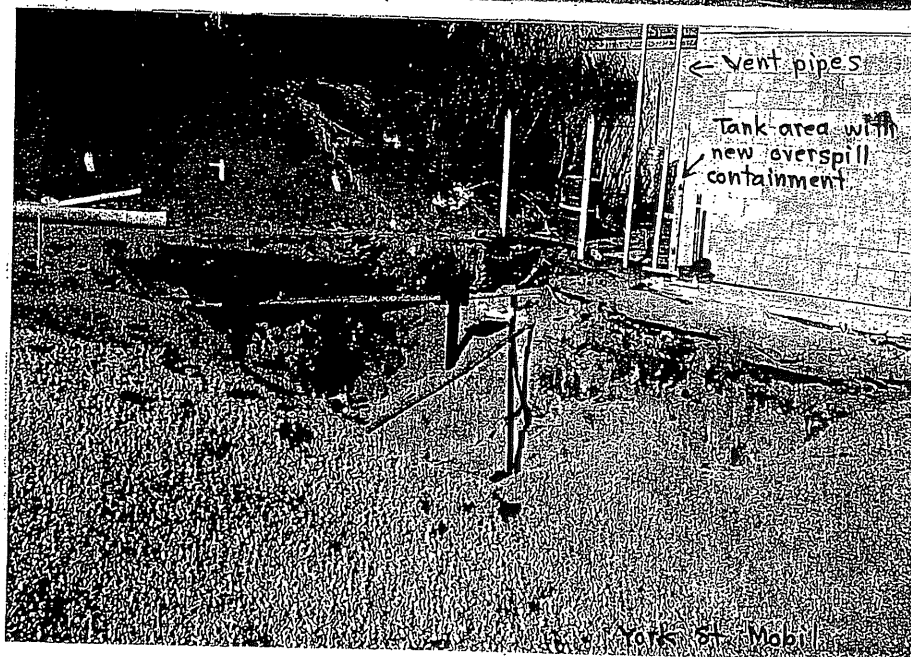
P-061-91
Photos by SGB 2/4/91

↑ Installing new product lines.
