**Report No. SI-003**

Date: July 17, 2013  
Project: Portland Marriott 08-0494.2  
Project Number: 13018  
Time at Site: 10:30 am – 11:30 am  
Weather: Sunny, upper 80's °F  
Present at Site: Matthew J. Miller, P.E. (M2SE)

**Area of Observation: 4<sup>th</sup>, 5<sup>th</sup> and 6<sup>th</sup> Floor and Roof Framing - Grid Lines G-L Lines 1-8**

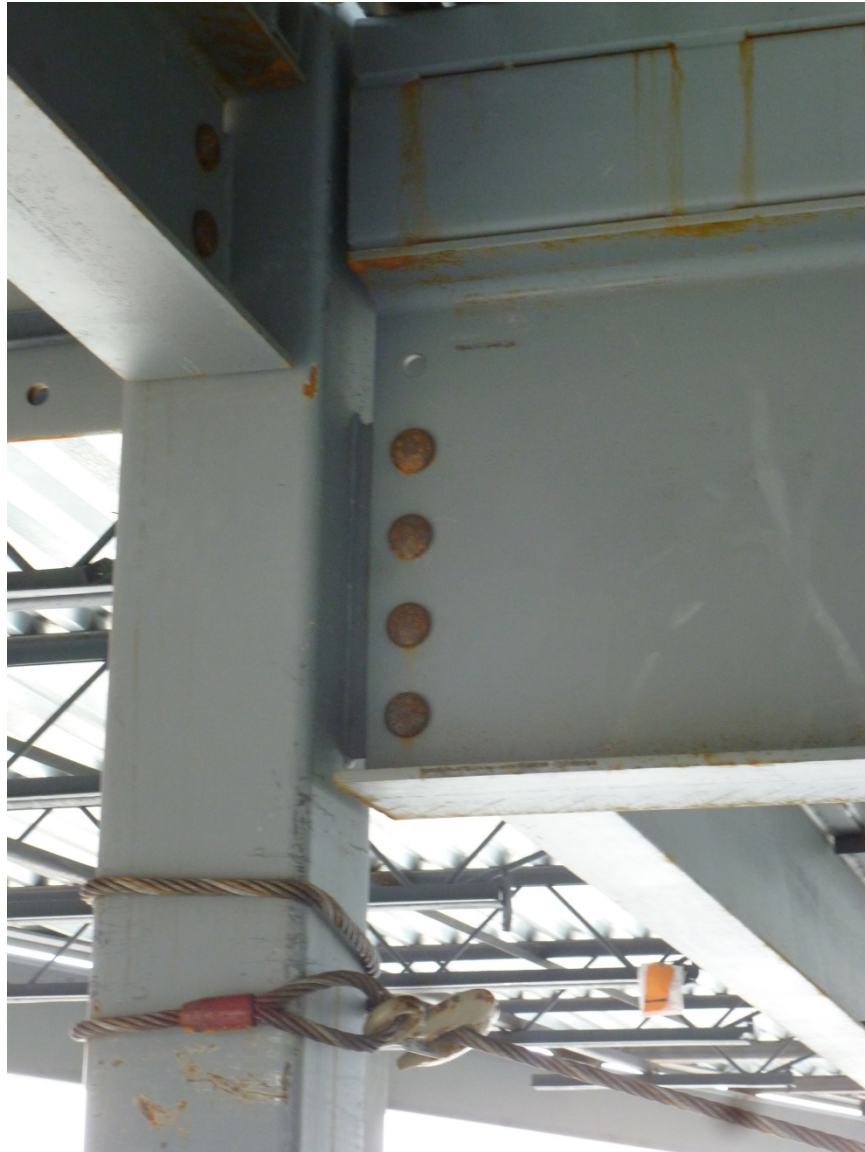
- Structural Steel erection in the areas observed was substantially complete. In general, the work observed was in conformance with the contract documents.
- The connection of the W18 to the steel column at Grid Line K/5 on the 6<sup>th</sup> floor contained 4 bolts. The W18 beam was punched for a 5 bolt connection, but the shear tab on the column only had four corresponding bolt holes leaving the upper most hole in the beam unused. EOR shall review this connection to verify that the 4 bolt connection is acceptable or provide additional information required to increase the connection capacity.

**Photo 1: Missing Bolt at W18 to Steel Column 6th Floor Grid K/5**

Observations are fine as is per email titled  
"Eml fr JSN re Steel Observations OK Marriott Portland 07-18-13"
