Inspection and Testing Certificate

Merrill's Wharf

254 Commercial St.

The equipment specified herein was inspected and tested according to the NFPA 72 standard for fire alarm and signaling systems, with the inspection completed on Tuesday, July 23, 2019

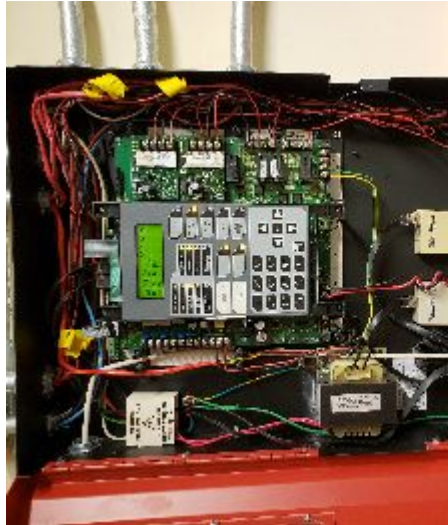
EQUIPMENT TYPE	ADDRESS	DESCRIPTION	METHOD	DATE/TIME
Fire Alarm Panel		GE EST backside of building	Manual	6/12/2019 2:56 PM
	Comment:
