NOTE: THE INTERIOR FINISH REPAIRS IS ADD. ALTERNATE #4. PROVIDE SEPARATE PRICING FOR THIS WORK ON BID FORM.

INTERIOR FINISH GENERAL NOTES

Checked Becker Job Number EAR 3230.01

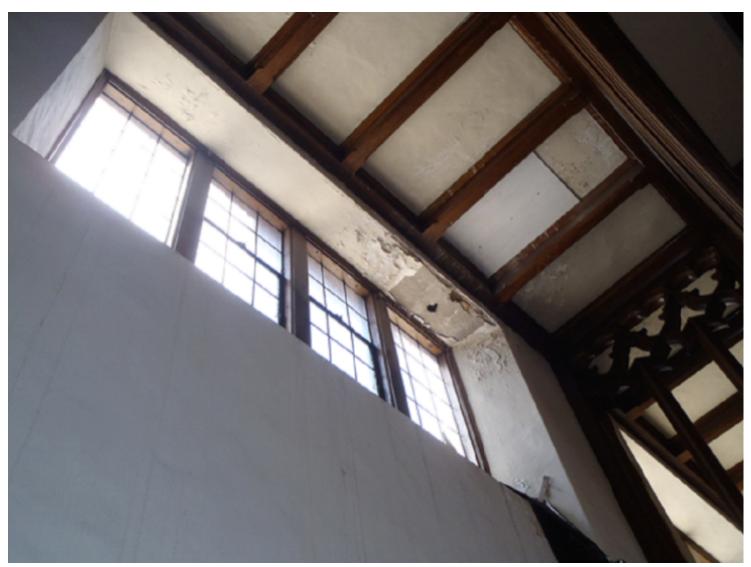
SOUTH WALL EXTENDING FROM WINDOW SILL TO CEILING, INCLUDING WINDOW PERIMETER 175 SF

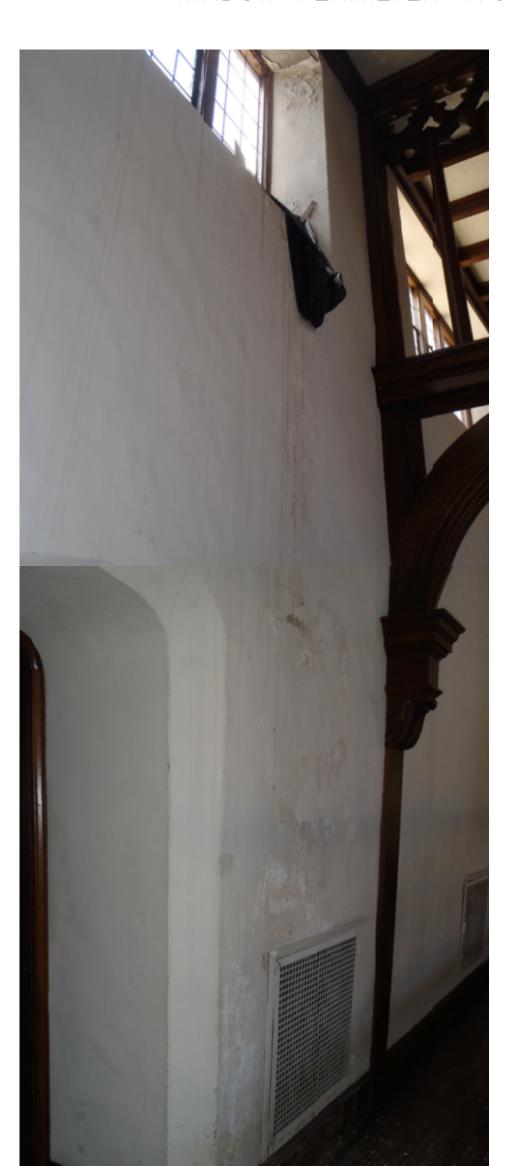
SOUTH WALL EXTENDING FROM BALCONY TO WINDOW SILL 100 SF

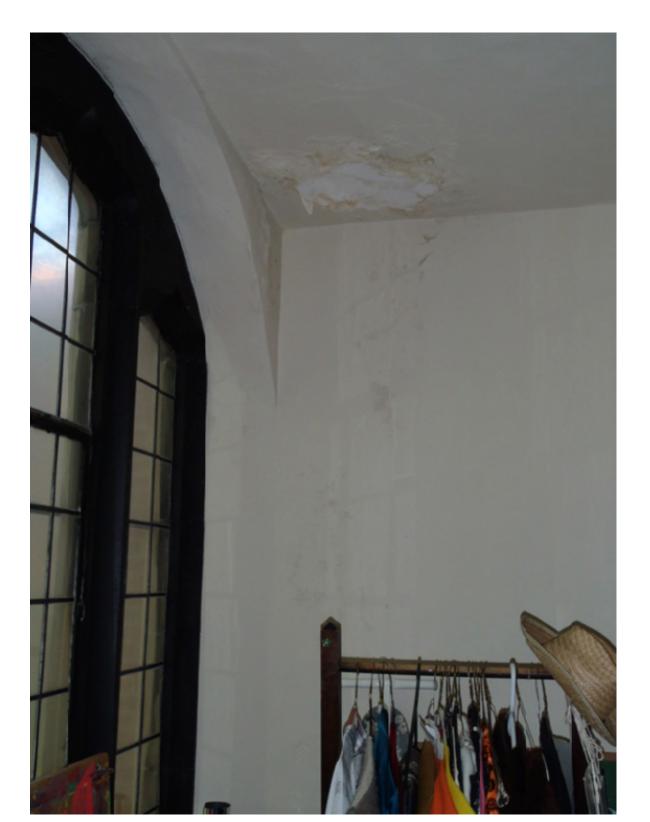
NORTHWEST CEILING/WALL CORNER 50 SF

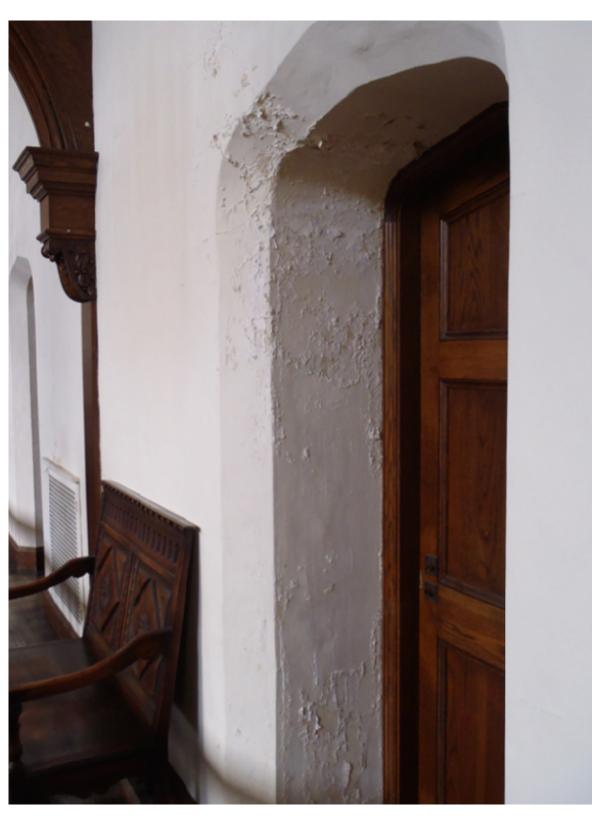
NORTH DOOR 50 SF

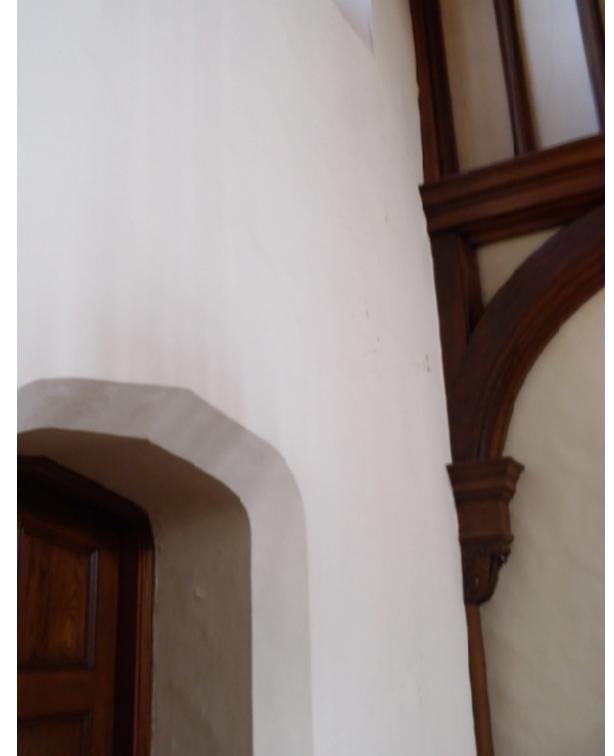
NORTH WALL ADJACENT TO DOOR 45 SF

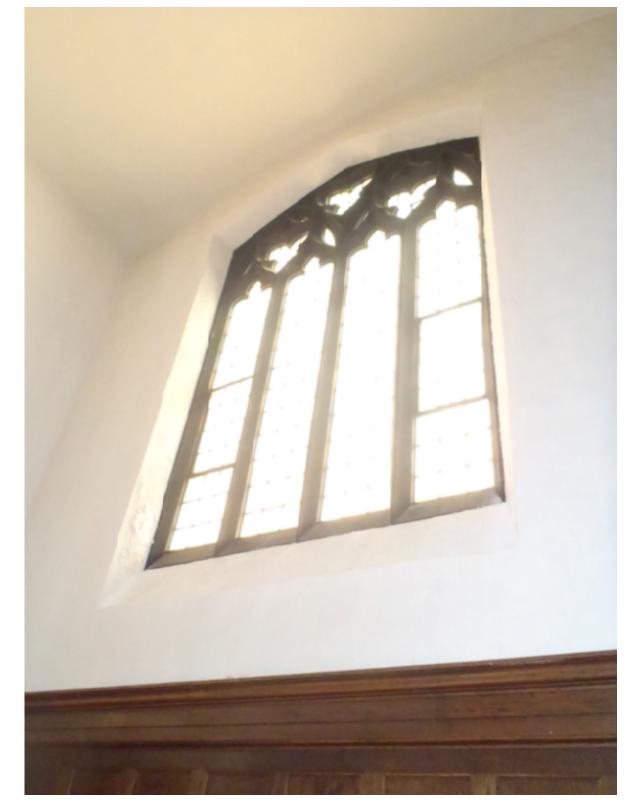
EAST WALL WINDOW PERIMETER 125 SF AND CRACK IN NORTHEAST CORNER 20 LF
